## LKK Auto Consultants Pte Ltd

### 1. Policy Particulars :- THIRD PARTY CLAIM

## ADJUSTMENT ON REPAIR COST FOR VEHICLE NO. SKU 2916D

PHOTOGRAPHS FOR VEHICLE NO. SKU 2916D

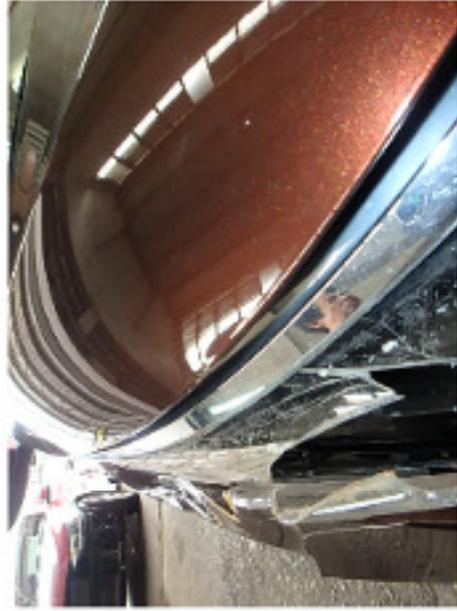
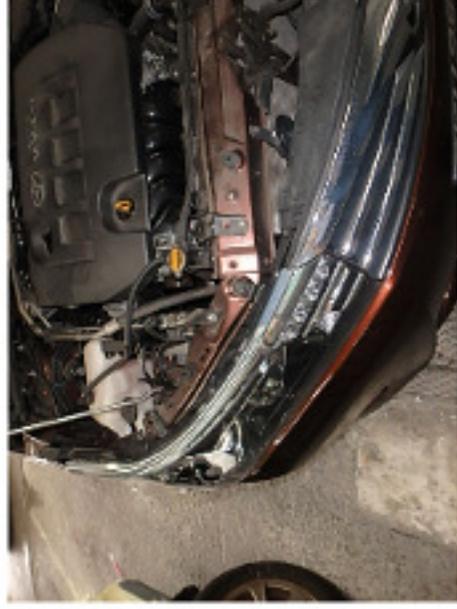
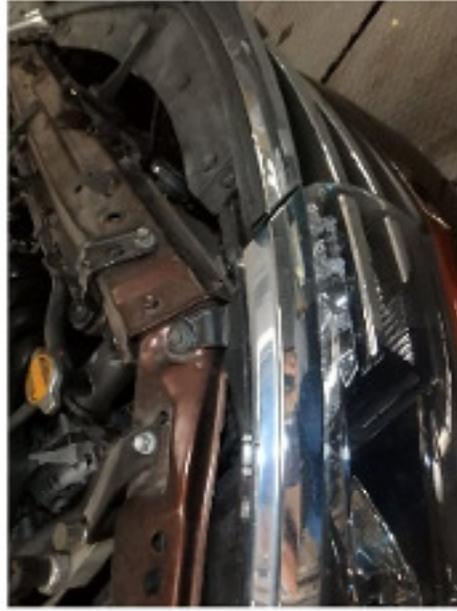
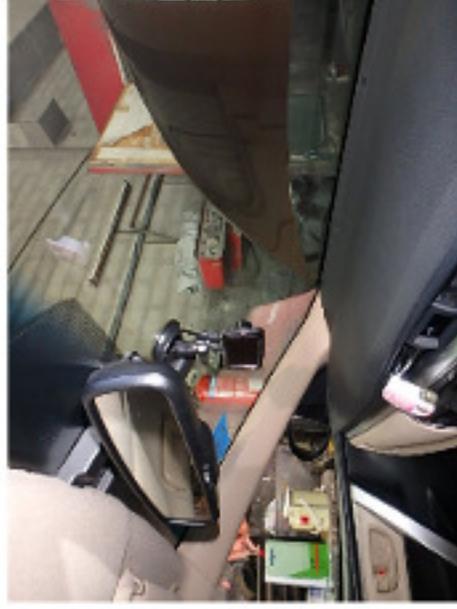
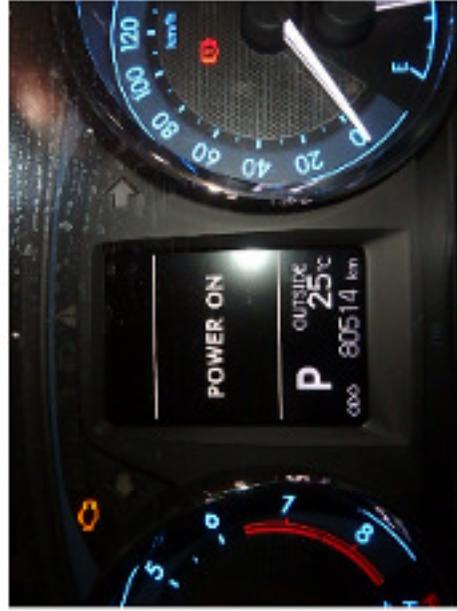
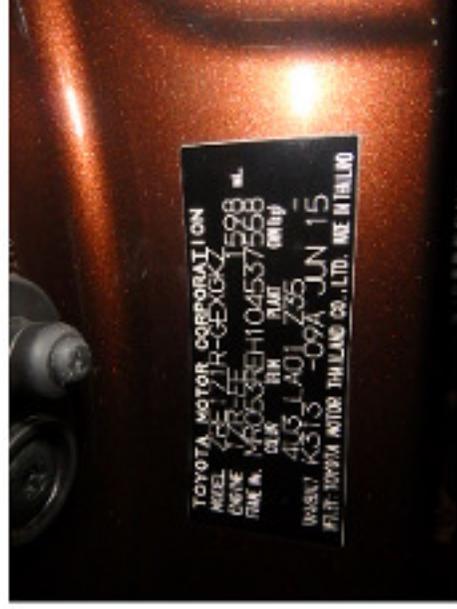
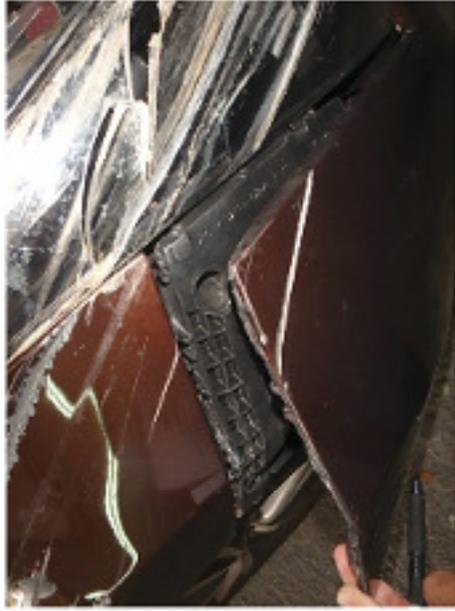
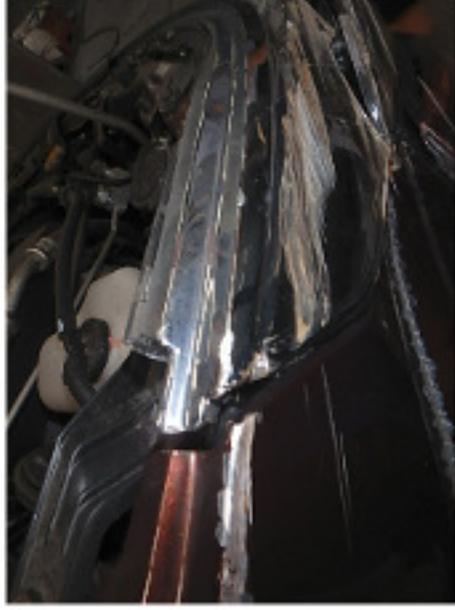
THE VEHICLE SUSTAINED DAMAGES AT THE O/S FRONT PORTION. DAMAGES SEE DETAILS.
--	---------------------------------------------------------------------------------
