Your Ref: TP/IP/60999/2019
Our Ref : CI/TPD19018770/P

14th November 2019

MECHANICAL INSPECTION REPORT OF MOTOR TRAILER VR 3460

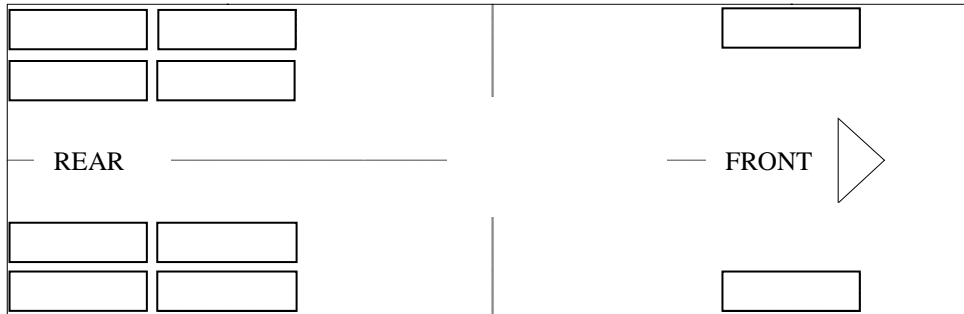
Motor Trailer

Nextyre 295/80 R22.5 (12.8mm)

Destone 295/80 R22.5 (12.4mm)

Nextyre 295/80 R22.5 (11mm)

Firestone 295/80 R22.5 (11.7mm)

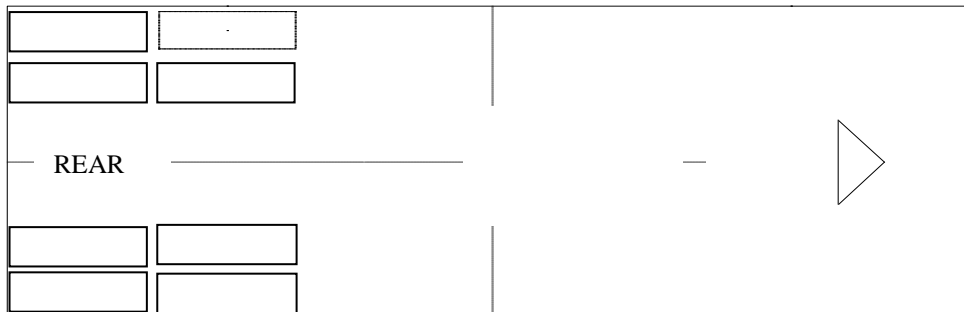
Trailer

Akina 295/80 R22.5 (10.6mm)

Akina 295/80 R22.5 (12.1mm)
