13 November 2019

Fatal Accident Investigation Team

**INSPECTION REPORT OF BICYCLE (WHITE & BLUE) - TRAFFIC POLICE
POUND REPORT NO. 4340/19**

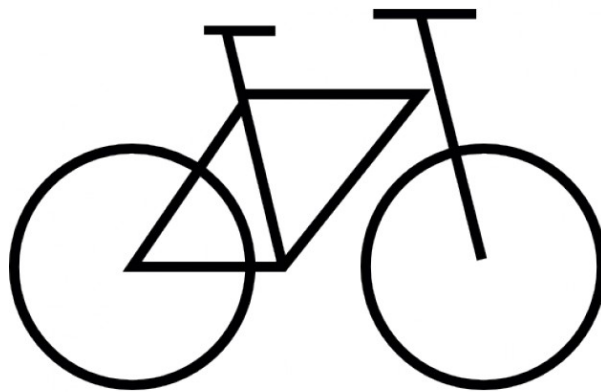
5. The condition of the Bicycle's front & rear tyres was observed to be in serviceable condition. The tread pattern of the 2 tyres was clearly visible. We did not observe any tear, burst mark(s) and/or punctured hole(s) on the sidewalls as well as across the tread of the 2 tyres. The front tyre was observed to be sufficiently inflated for vehicular operation. However the rear tyre was observed to be deflated. The tyre brand, tyre size and remaining tread depth of the 2 tyres were recorded as follows:-

CST 32 - 530 (27 X 1)
(Deflated)

CST 32 - 530 (27 X 1)
