Your Ref: TP/IP/68527/2019
Our Ref : CI/TPD19020443/P

Fatal Accident Investigation Team

MECHANICAL INSPECTION REPORT OF MOTOR TRAILER XB 6778E

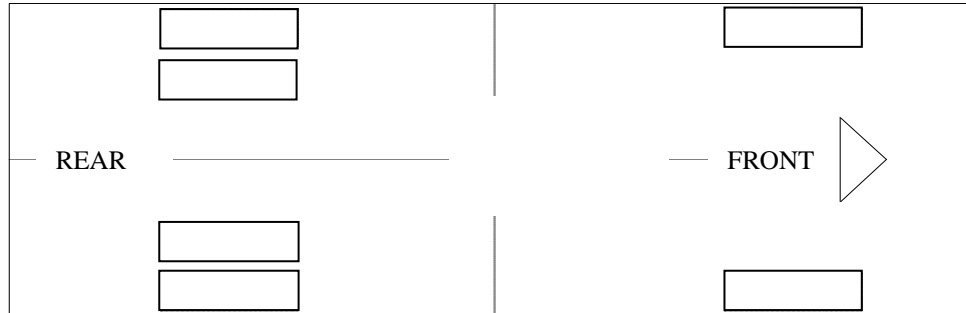
Motor Trailer

Firenaza 295/80 R22.5 (5.4mm)

Firenaza 295/80 R22.5 (7.8mm)

Powertrac 295/80 R22.5 (11.3mm)

Firenaza 295/80 R22.5 (9.8mm)

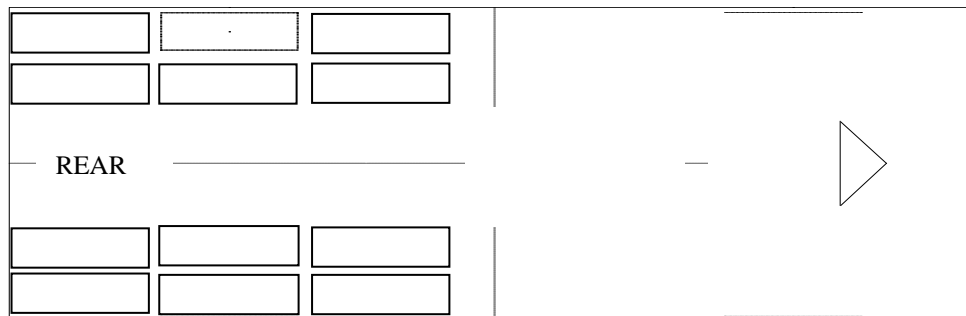
Trailer

Linglong 10.00/R15 (10.9mm)

Linglong 10.00/R15 (9.7mm)
