Your Ref: TP/IP/69653/2019
Our Ref : CI/TPD19020444/P

30th December 2019

MECHANICAL INSPECTION REPORT OF MOTOR BUS SBS 6430D

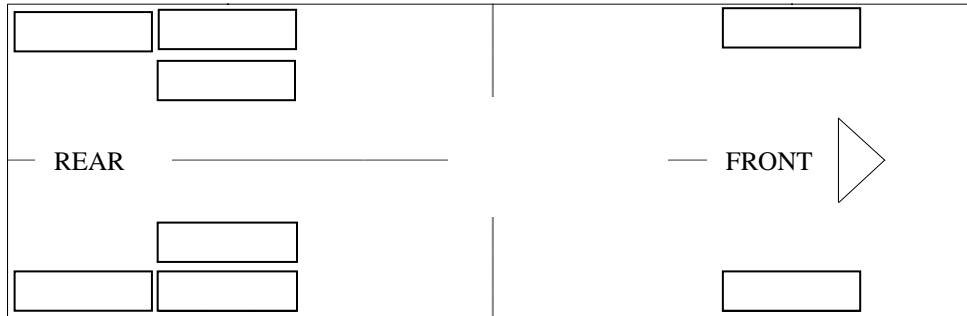
Continental 275/70R22.5 (12.6mm)

Continental 275/70R22.5 (12.3mm)

Continental 275/70R22.5 (11.8mm)

Continental 275/70R22.5 (11.7mm)
