## LKK Auto Consultants Pte Ltd

## ADJUSTMENT ON REPAIR COST FOR VEHICLE NO. GBC 2715T

PHOTOGRAPHS FOR VEHICLE NO. GBC 2715T

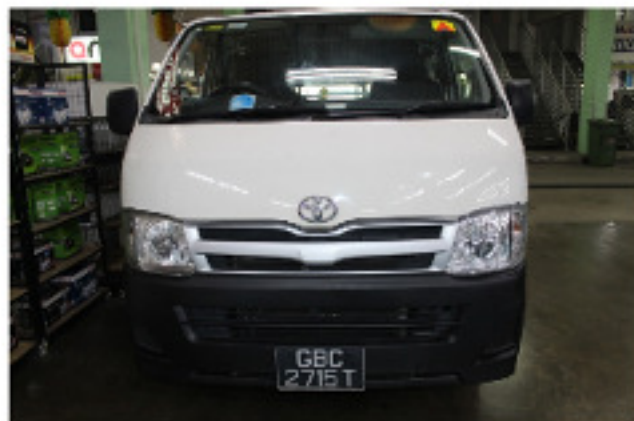
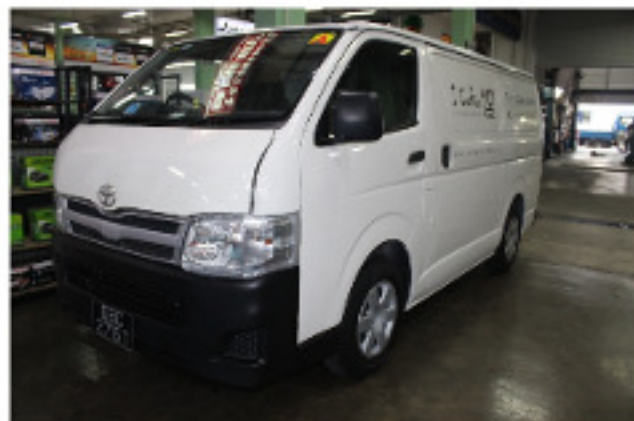
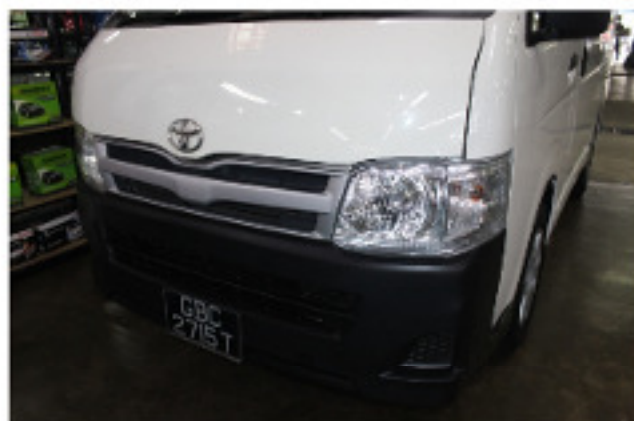
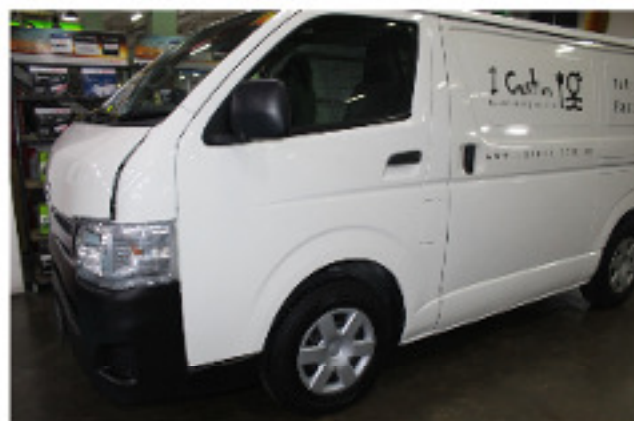
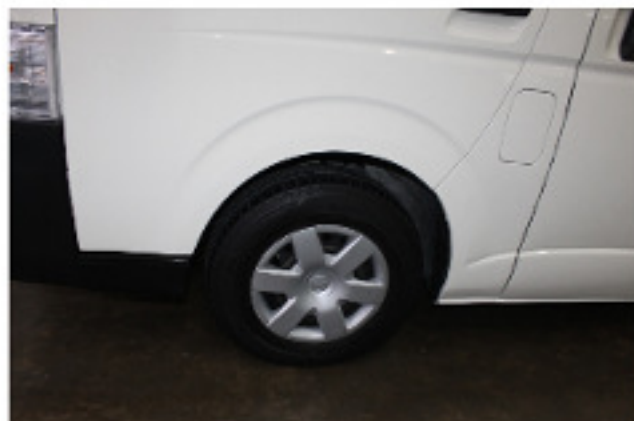
RE-INSPECTION

THE VEHICLE SUSTAINED DAMAGES AT THE N/S FRONT PORTION AND N/S BODY. THE UNDERCARRIAGE AFFECTED DUE TO COLLISION.  DAMAGES SEE DETAILS.
---
