Your Ref: TP/IP/65989/2019  
Our Ref : CI/TPD19020762/P

**Fatal Accident Investigation Team**

**MECHANICAL INSPECTION REPORT OF MOTOR LORRY YP 9377Z**

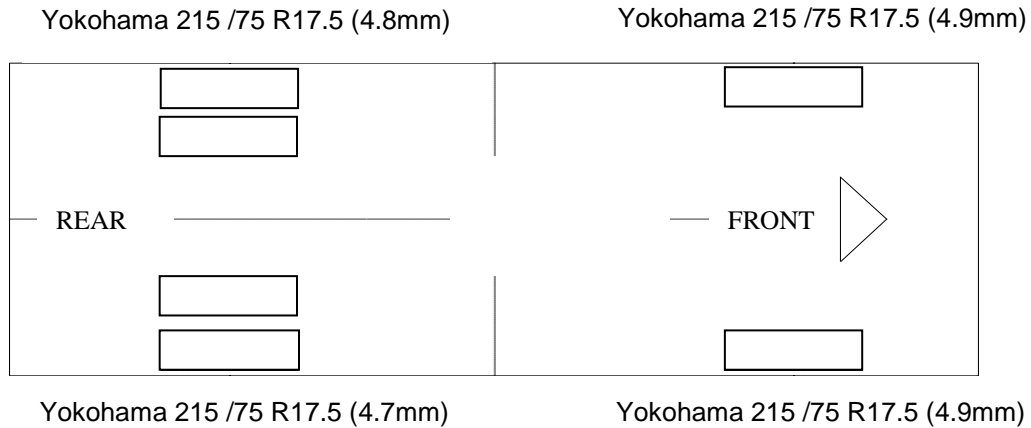
6. The condition of the 6 tyres of the Motor Lorry were observed to be in serviceable condition and sufficiently inflated for vehicular operation. I did not find any tear, cut or burst mark(s) on the outer and the inner sidewalls as well as across the tread of the 6 tyres. The tyre brand, tyre size and remaining tread depth of the 6 tyres of the Motor Lorry were recorded as follows:-
