Your Ref: Honda Engine  
(number R18A1748243)  
Our Ref : CI/TP19021207/D

02 December 2019

### **INSPECTION REPORT OF A HONDA ENGINE WITH NUMBER R18A1748243**

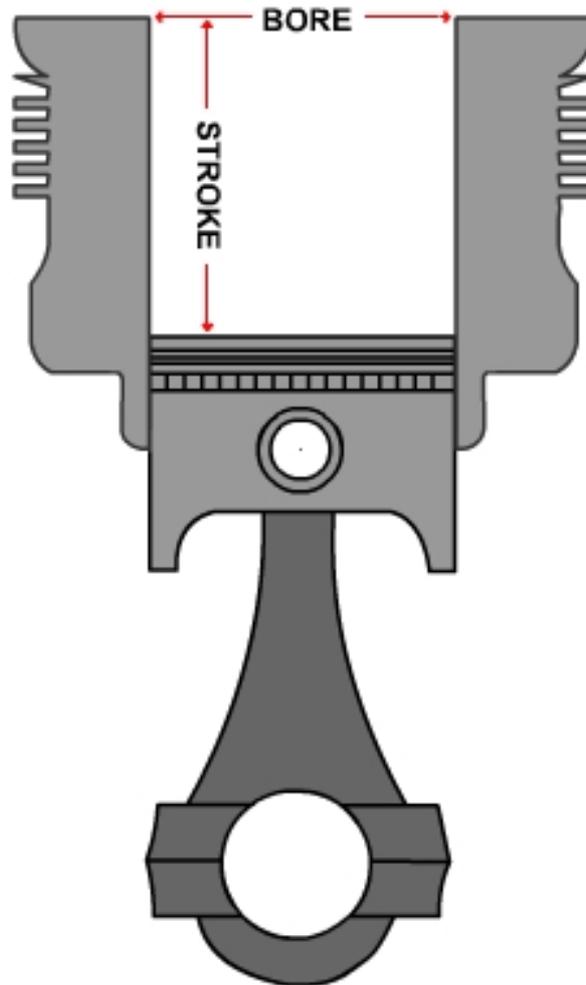
9. The bore of an engine refers to the measurement of the inside diameter of the cylinder while the stroke refers to the distance the piston moves in one direction of upward or downward movement in the cylinder. See diagram below for illustration purposes.
