Your Ref: A-190617230642-S
Our Ref : CI/TPD19021325/P

15th January 2020

MECHANICAL INSPECTION REPORT OF MITSUBISHI FORKLIFT

MECHANICAL INSPECTION REPORT OF KOMATSU FORKLIFT

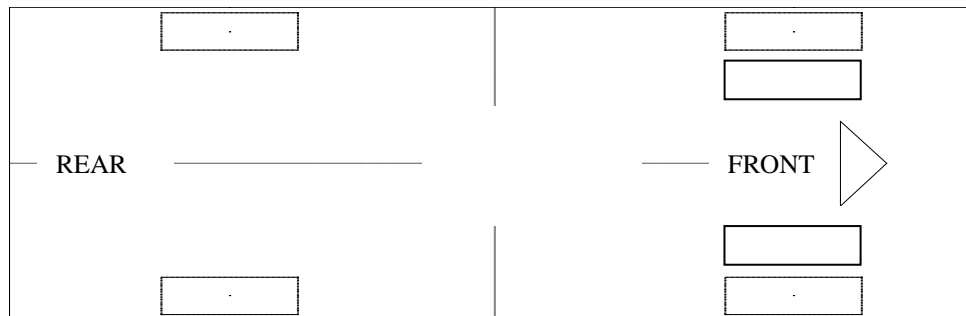
6. The condition of the Mitsubishi Forklift's 6 tyres was observed to be in serviceable condition. I did not find any tear, cut or burst mark(s) on the outer and the inner sidewalls as well as across the tread of the 6 tyres. The 6 tyres were also observed to be sufficiently inflated for vehicular operation. The tyre brand, tyre size and remaining tread depth of the 6 tyres were recorded as follows:-

Tantor 8.25-15 (7mm)

Tantor 8.25-15 (10.6mm)

Tantor 8.25-15 (8.5mm)
