Vehicle No. SKX 3203E  
Insured Veh. SBZ 2800J  
Claim No. SNM19D205914C02/0  
Policy No. DMPCSN1106131908  
Accident Date 11/12/2019  
Inspection Date 17/12/2019

### 1. Policy Particulars :- THIRD PARTY CLAIM

## ADJUSTMENT ON REPAIR COST FOR VEHICLE NO. SKX 3203E

PHOTOGRAPHS FOR VEHICLE NO. SKX 3203E

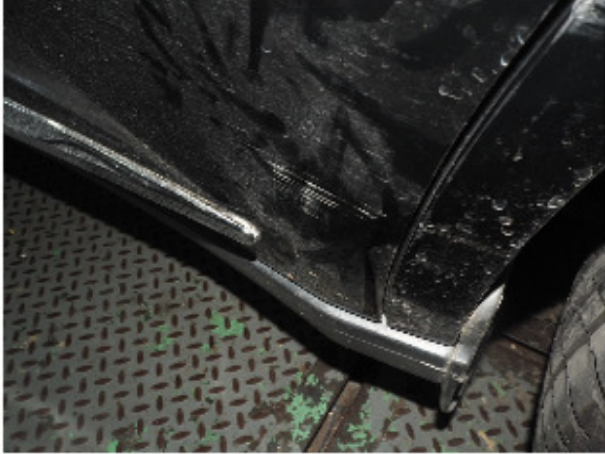
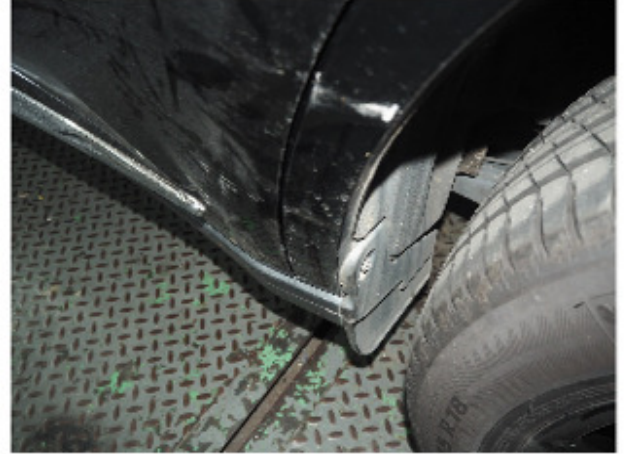
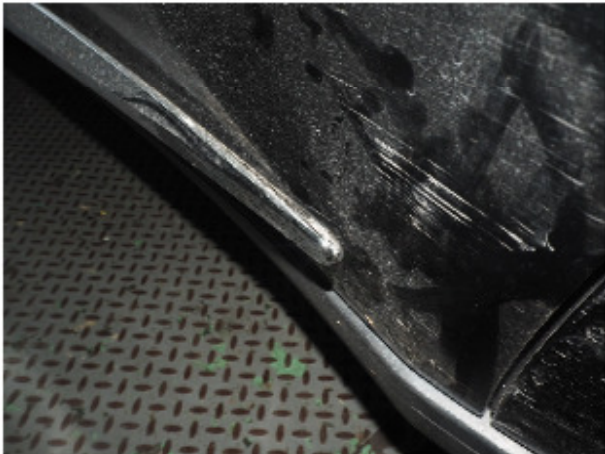
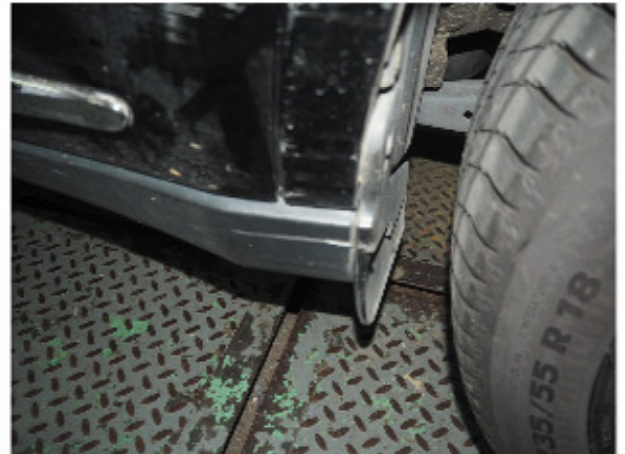
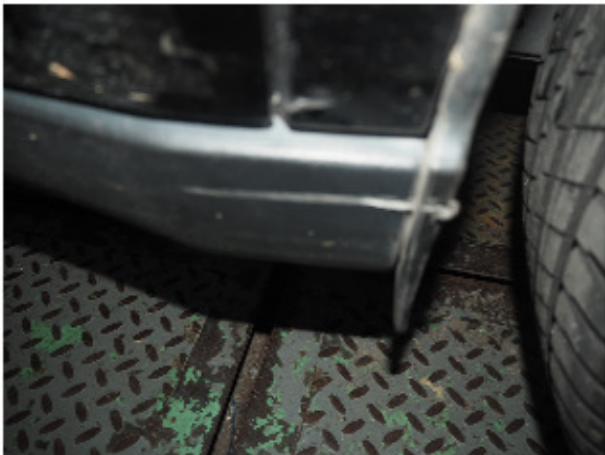
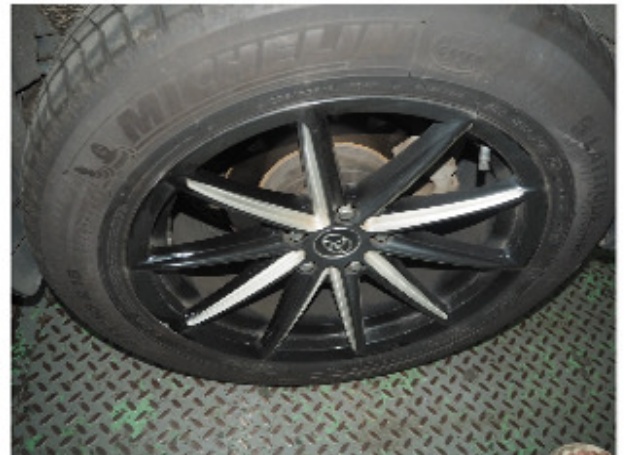
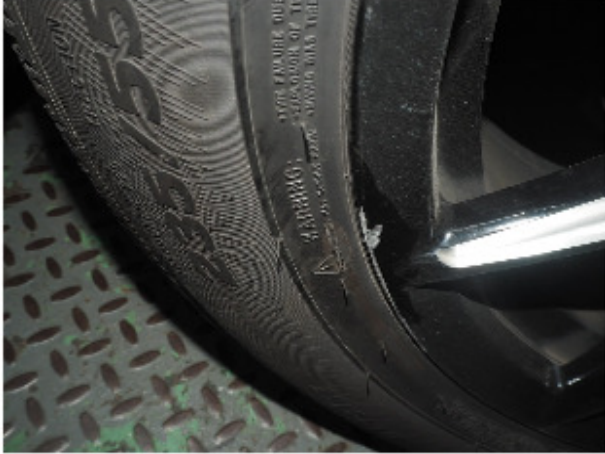
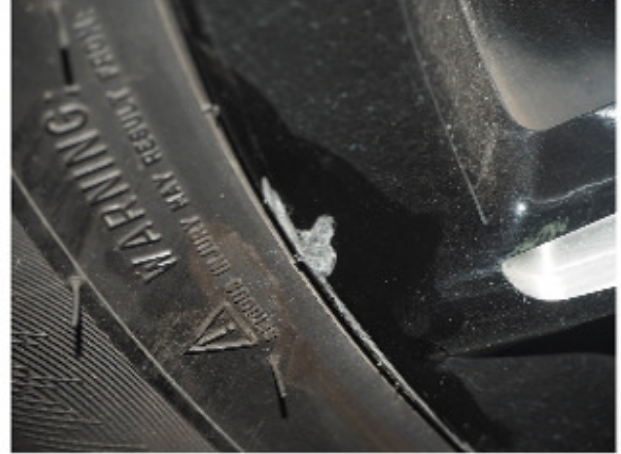
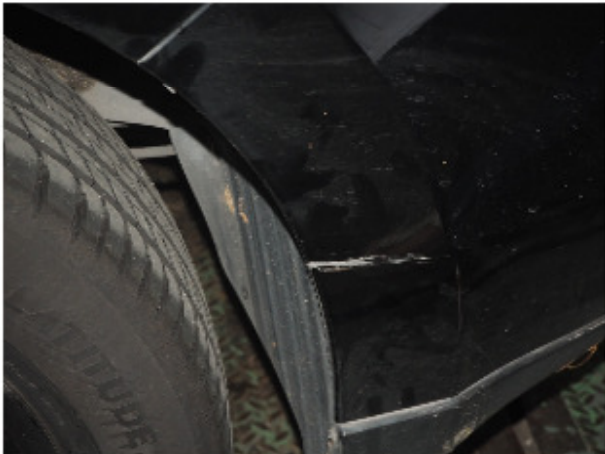
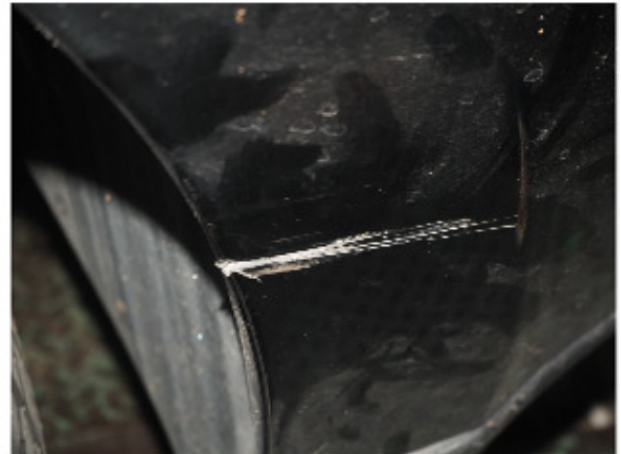
THE VEHICLE SUSTAINED DAMAGES AT THE N/S BODY.

Qty	Description of Parts	Condition	Estimate By Workshop (\$)	Our Adjusted (\$)
	<b><u>REPLACEMENT OF PARTS</u></b>			
1	SIDE SKIRT LH	CUT	890.00	699.00
1	REAR DOOR LH	DENTED	1,855.50	1,569.00
1	REAR DOOR OUTER CHROME GARNISH LH	DEFORMED	320.00	250.00
1	REAR FENDER LH	TO REPAIR SEE LABOUR	1,422.20	-
1	REAR FENDER MUD FLAG LH	CUT	88.30	88.30
1	REAR QUARTER GLASS WITH MOULDING	NOT NECESSARY	820.00	-
1	REAR BUMPER	TO REPAIR SEE LABOUR	1,533.20	-
1	REAR BUMPER SIDE RETAINER LH	NOT NECESSARY	62.40	-
	LESS 25% DISCOUNT		-1,747.90	-651.58
			5,243.70	1,954.72
	<b><u>SPECIAL NETT ITEMS</u></b>			
1	SET REAR FENDER MUD FLAP CLIP (SN)	NOT NECESSARY	30.00	-
1	QUARTER GLASS SEALANT (SN)	NOT NECESSARY	80.00	-
1	SET REAR BUMPER CLIP (SN)	NOT NECESSARY	30.00	-
1	REAR WHEEL RIM LH (SN)	CUT	850.00	500.00
1	REAR WHEEL TYRE LH (SN)	NOT NECESSARY	450.00	-
			1,440.00	500.00
	<b><u>LABOUR</u></b>			
	PANEL BEATING ,REMOVAL AND REPLACING PARTS.INCLUSIVE OF THE REPAIR OF REAR FENDER LH AND REAR BUMPER .		1,200.00	500.00

Qty	Description of Parts	Condition	Estimate By Workshop (\$)	Our Adjusted (\$)
	FOUR WHEEL ALIGNMENT.		120.00	80.00
			3,220.00	1,400.00
GRAND TOTAL			9,903.70	3,854.72
RECOMMENDED COST OF LUMP SUM REPAIRS (TO ITS PRE-ACCIDENT CONDITION)				3,000.00
