### DAMAGE ASSESSMENT REPORT

## ADJUSTMENT ON REPAIR COST FOR VEHICLE NO. SLE 8868S

PHOTOGRAPHS FOR VEHICLE NO. SLE 8868S

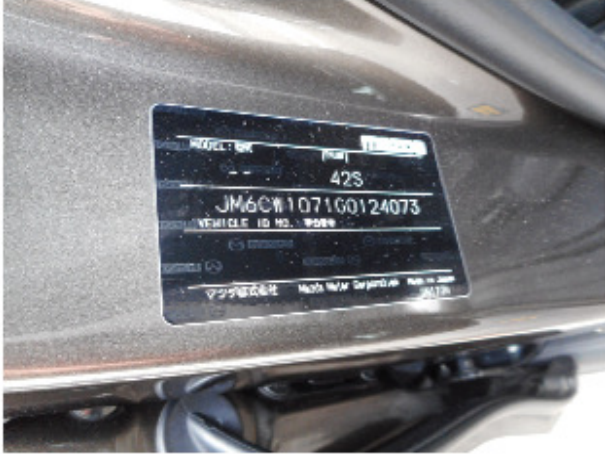
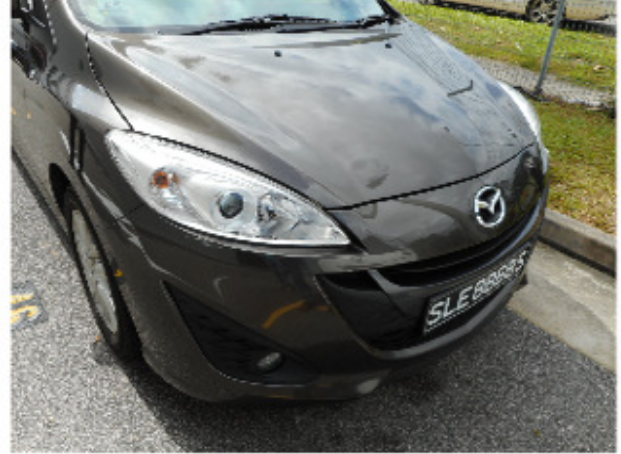
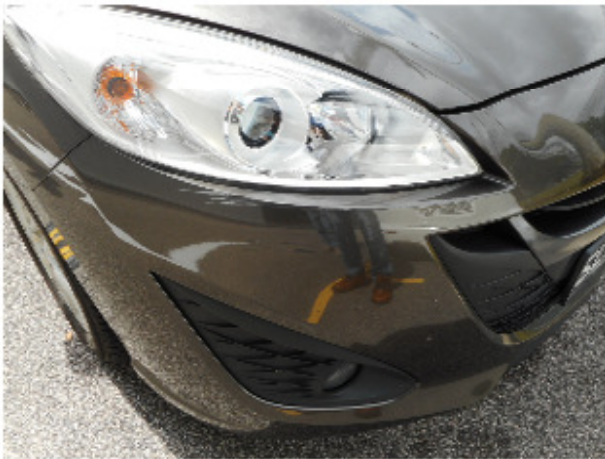
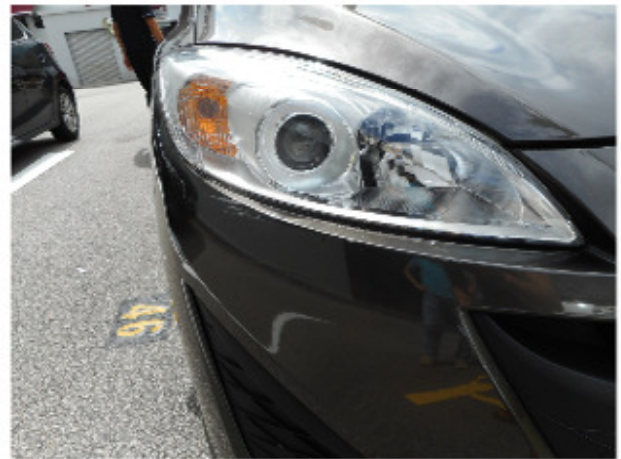
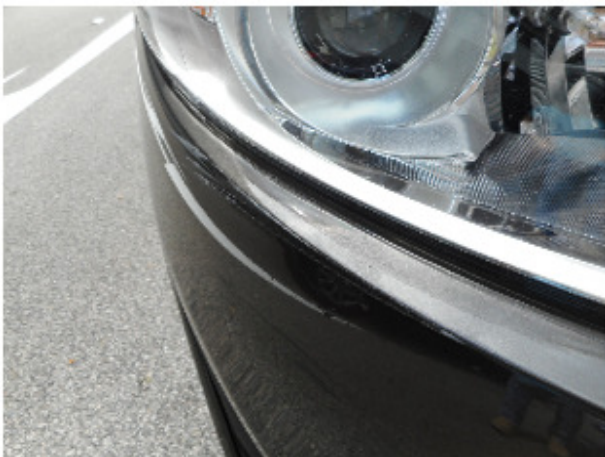
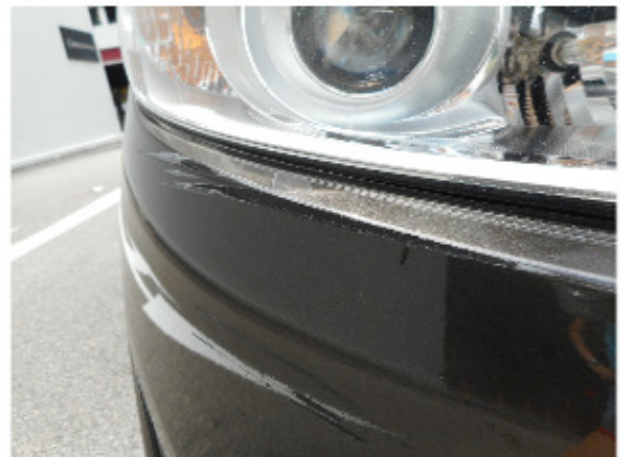
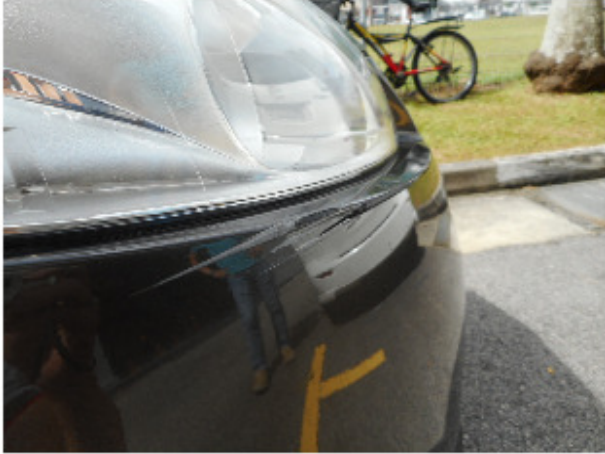
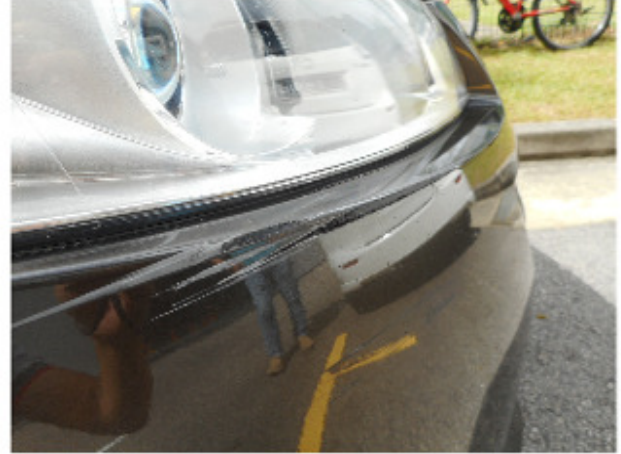
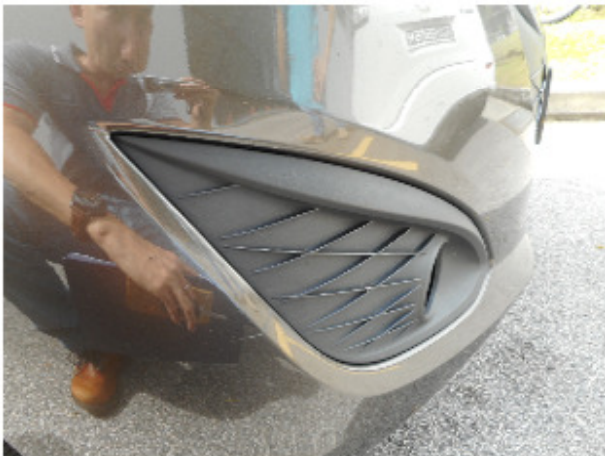
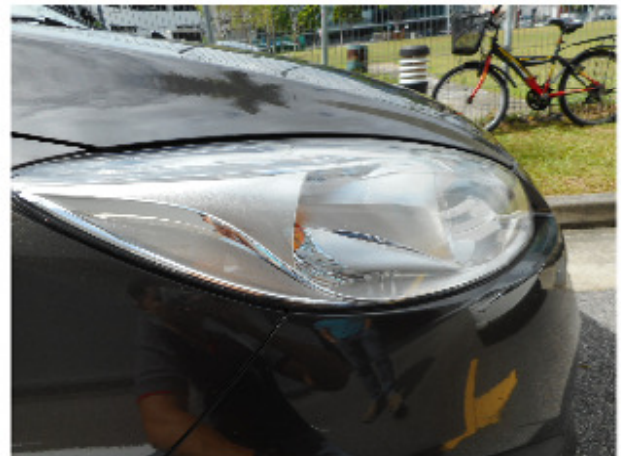
THE VEHICLE SUSTAINED DAMAGES AT THE FRONT O/S PORTION.  DAMAGES SEE DETAILS.
-------------------------------------------------------------------------------------

Qty	Description of Parts	Condition	Estimate By Workshop (\$)	Our Adjusted (\$)
	<b><u>REPLACEMENT OF PARTS</u></b>			
1	FRONT BUMPER (SN)	CUT	1,108.20	1,108.20
1	BRACKET RHS,FRONT BUMPER (SN)	NOT NECESSARY	42.30	-
1	COVER RHS,FOGLAMP (SN)	NOT NECESSARY	78.20	-
10	CLIP,FRONT BUMPER (SN)	NECESSARY	37.00	37.00
1	GROMMET,FRONT BUMPER (SN)	NECESSARY	16.20	16.20
4	RIVET,FRONT BUMPER (SN)	NECESSARY	22.80	22.80
4	RIVET,FRONT BUMPER (SN)	NECESSARY	32.00	32.00
1	FOAM,FRONT REINFORCEMENT (SN)	NOT NECESSARY	79.20	-
2	FASTENER,FRONT REINFORCEMENT (SN)	NECESSARY	12.40	12.40
1	FRONT REINFORCEMENT (SN)	NOT NECESSARY	531.60	-
1	HEADLAMP RHS (SN)	NOT NECESSARY	1,482.00	-
3	CLIP,HEADLAMP (SN)	NOT NECESSARY	19.50	-
1	RIVET,HEADLAMP (SN)	NOT NECESSARY	3.50	-
1	SUNDRIES (SN)	NECESSARY	100.00	20.00
			3,564.90	1,248.60
	<b><u>LABOUR</u></b>			
	TO REPLACE FRONT BUMPER AND FRONT REINFORCEMENT.REPAIR ALL AREAS AFFECTED BY THE ACCIDENT.		1,320.00	660.00

TO RESPRAY FRONT BUMPER,FRONT REINFORCEMENT AND FRONT FENDER RH.		1,890.00	630.00
	TO CARRY-OUT BODY CAVITY PRESERVATION.	NOT NECESSARY	250.00	-
	TO CHECK ELECTRICAL SYSTEM FOR PROPER FUNCTIONING.		250.00	150.00
	TO REPROGRAMME AFTER THE ACCIDENT REPAIR WORKS.		350.00	180.00
