## LKK Auto Consultants Pte Ltd

### ADJUSTMENT ON REPAIR COST FOR VEHICLE NO. SLJ 2624S

PHOTOGRAPHS FOR VEHICLE NO. SLJ 2624S

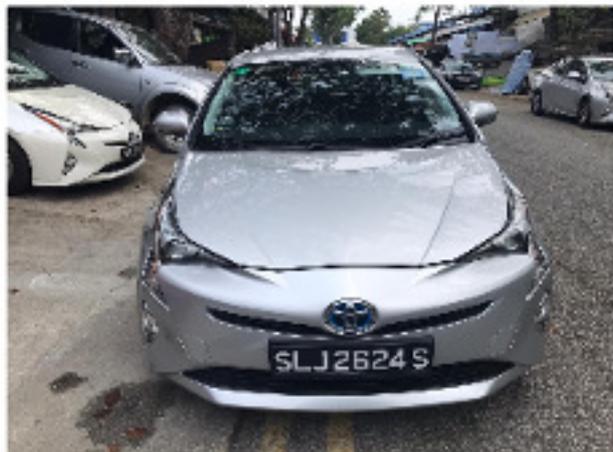
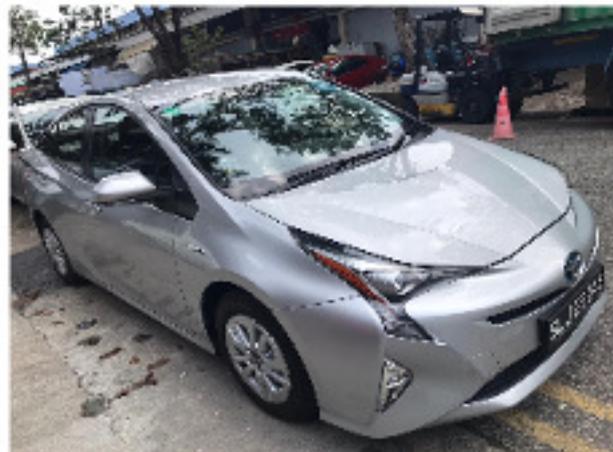
PHOTOGRAPHS FOR VEHICLE NO. SLJ 2624S

THE VEHICLE SUSTAINED DAMAGES AT THE O/S FRONT PORTION AND UNDERCARRIAGE. DAMAGES SEE DETAILS.
--	---------------------------------------------------------------------------------------------------

RE-INSPECTION
