Your Ref: TP/IP/71925/2019  
Our Ref : CI/TPD20001850/N

9 March 2020

**Fatal Accident Investigation Team**

**INSPECTION REPORT OF MOTORCYCLE FY 7959K**

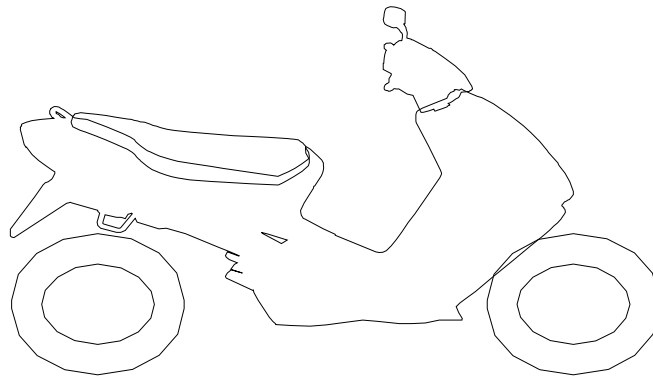
6. The condition of the 2 tyres of the Motorcycle was observed to be in serviceable condition. We did not observe any tear, burst mark(s) and/or punctured hole(s) on the sidewalls as well as across the tread of the 2 tyres. Both the tyres were observed to be sufficiently inflated for vehicular operation.
7. The tyre brand, tyre size and remaining tread depth of the 2 tyres were recorded as follows:-

Michelin 80/90 - 17 (3mm)

Michelin 70/90 - 17 (4mm)
