Your Ref: TP/IP/00573/2020
Our Ref :CI/TPD20001856/N

3 April 2020

INSPECTION REPORT OF MOTORCYCLE FBG 6445A

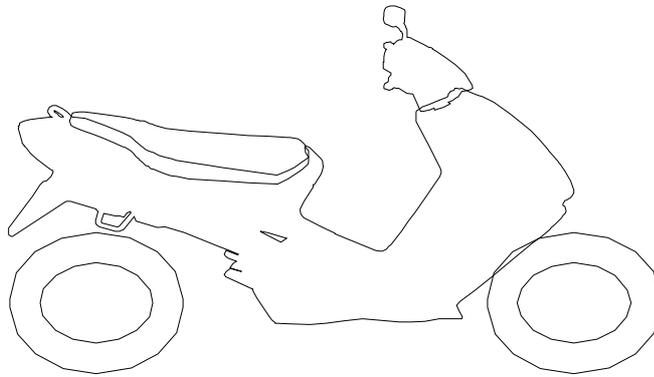
6. The condition of the Motorcycle's 3 tyres was observed to be in serviceable condition. The tread pattern of the 3 tyres was clearly visible. We did not observe any tear, burst mark(s) and/or punctured hole(s) on the sidewalls as well as across the tread of the 3 tyres. The 3 tyres were both observed to be sufficiently inflated for vehicular operation. The tyre brand, tyre size and remaining tread depth of the 3 tyres were recorded as follows:-

Michelin 140/60 - 14 (3mm)

Michelin 120/70 - 12 (3mm) (FLT)
