Your Ref: TP/IP/77615/2019
Our Ref : CI/TPD20001934/P

MECHANICAL INSPECTION REPORT OF MOTOR TRAILER MCT 9184

1. I refer to your request on 3rd February 2020 to conduct a physical inspection of a Motor Trailer bearing registration number MCT 9184 (herein referred to as "**Motor Trailer**"), which was involved in a fatal road traffic accident on 16th December 2019.
2. The objective of this inspection is to determine if there was any possible mechanical failure to the Motor Trailer that may have contributed to the accident.
3. Following the request, I had carried out a visual inspection of the Motor Trailer on 14th May 2020 at the premises of Traffic Police vehicle pound, 517 Airport Road Singapore 539942. I now set out below my observations and comments with respect to this inspection.

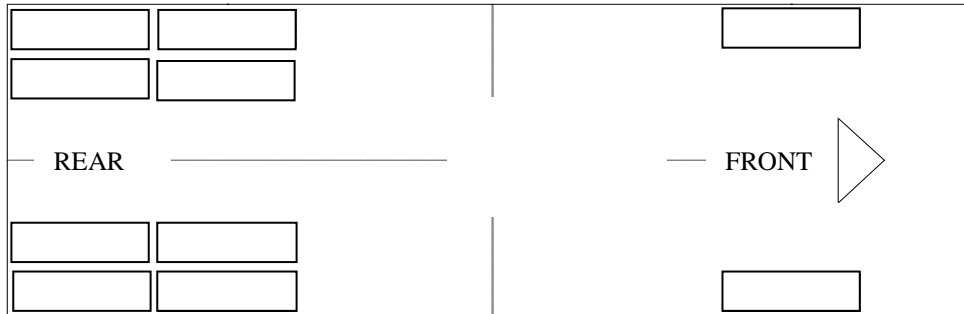
Motor Trailer

ChaoYang 295/80 R22.5 (10.9mm)

Bridgestone 295/80 R22.5 (11.4mm)

Bridgestone 295/80 R22.5 (9mm)

Bridgestone 295/80 R22.5 (11mm)

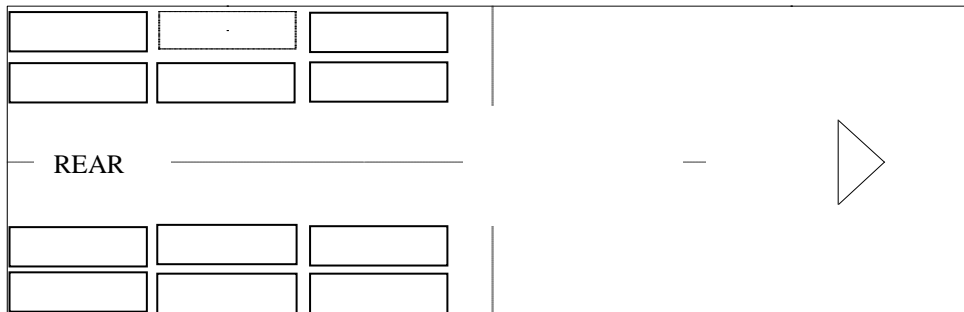
Trailer

JoyAll 295/80 R22.5 (6.8mm)

Michelin 295/80 R22.5 (4mm)
