VEHICLE APPRAISAL REPORT

Registration No.	: SMN 5844X	Chassis Frame No.	: GP7-2002487
Make / Model	: Honda Shuttle Hybrid 1.5(A)	Engine No. (Logcard)	: LEB7103295
Year of Manufacture/Reg	: 2019	Odometer Reading	: 50,927 KM
Colour	: Silver		
Class / Type	: MPV		1796 cc

**EVALUATION REPORT (PAPER SURVEY) OF ACCIDENT VEHICLE NO: SMN 5844X
INSURED VEHICLE: YN 3998G ACCIDENT DATE: 13/12/2019**

ADJUSTMENT ON REPAIR COST FOR VEHICLE NO. SMN 5844X

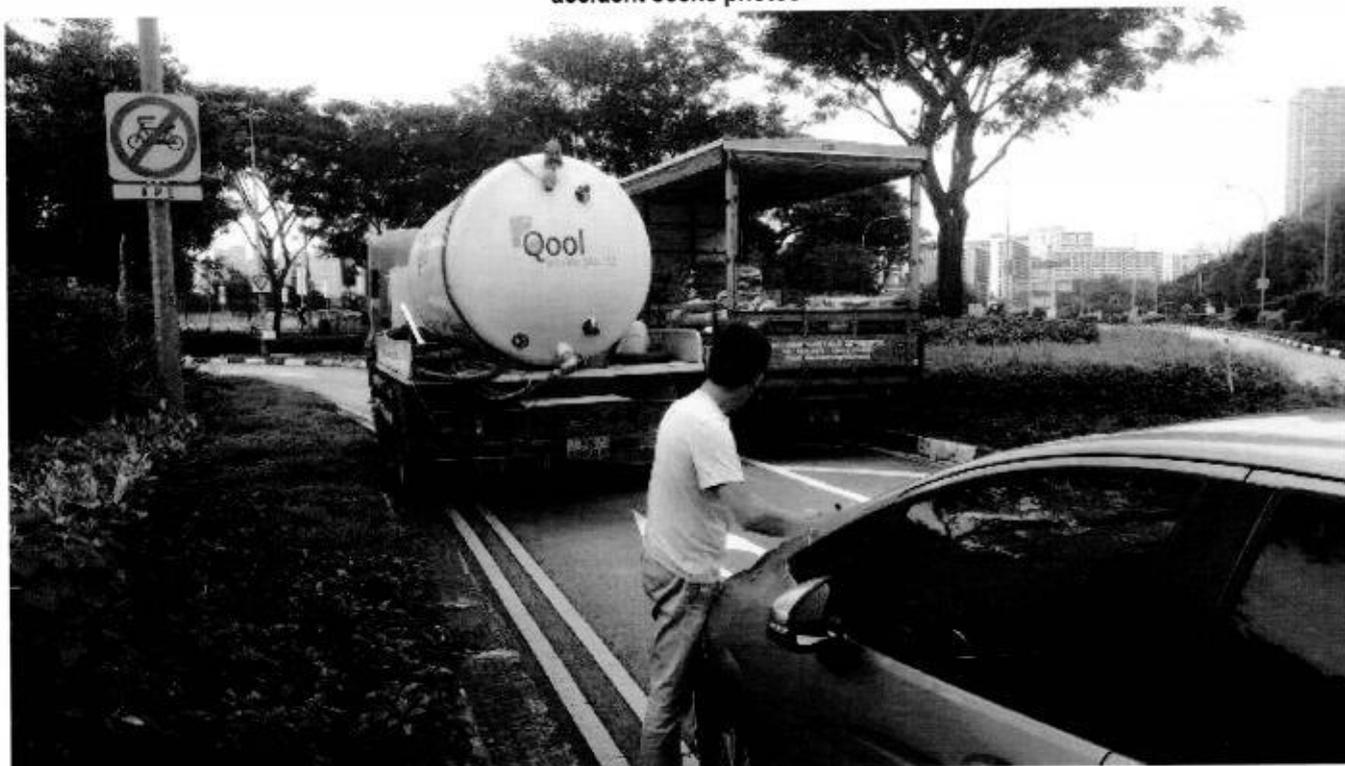
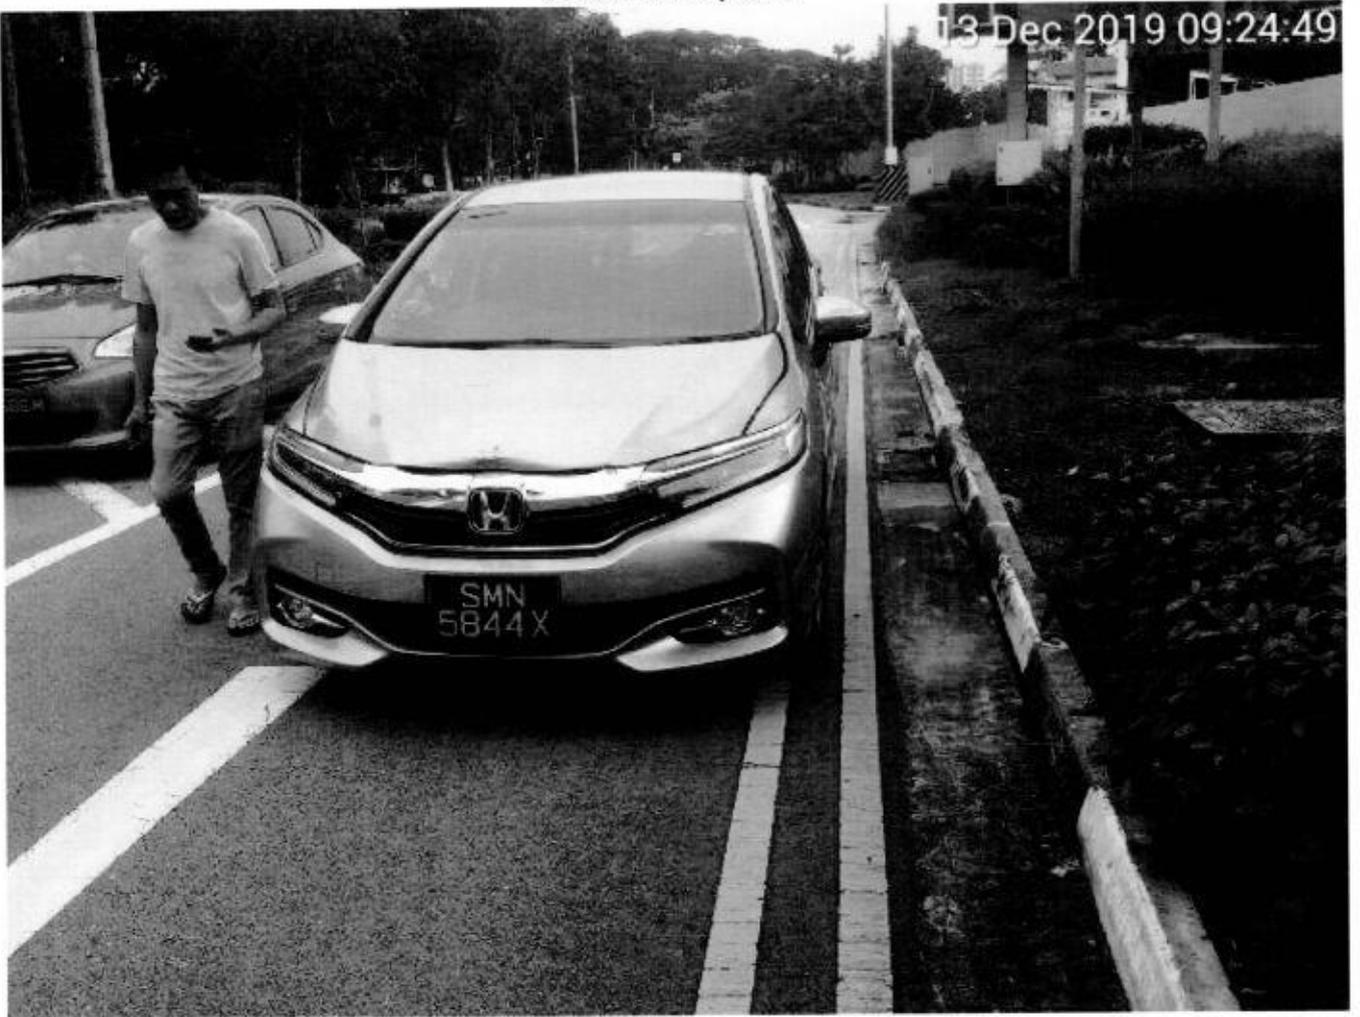
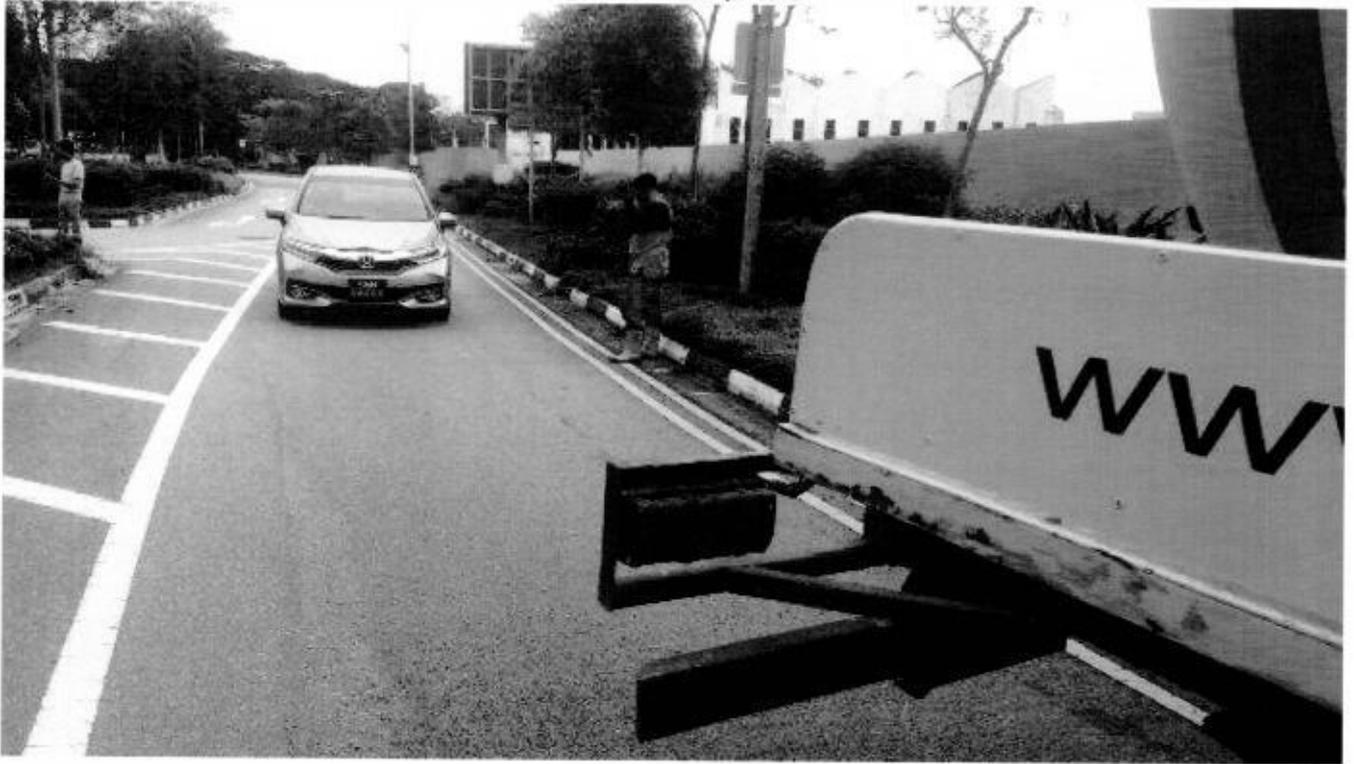
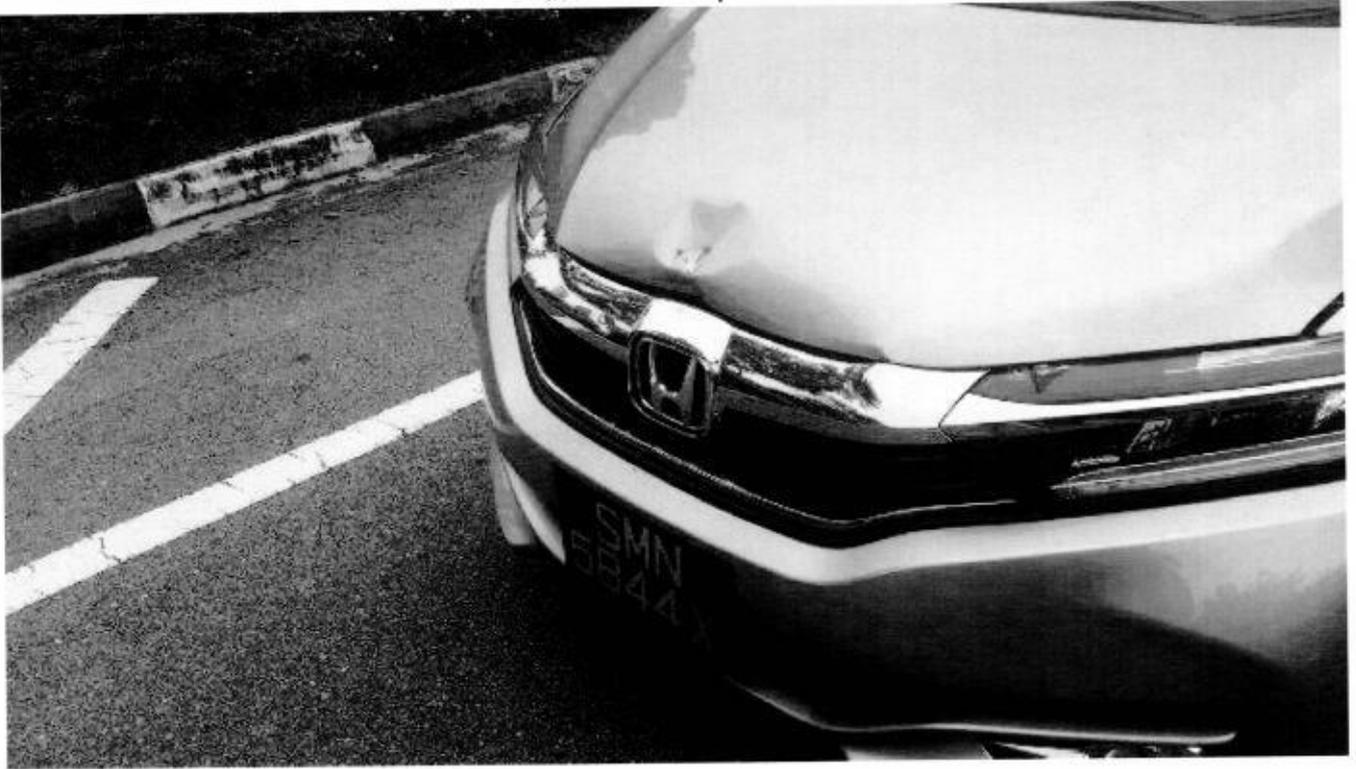
accident scene photos
