Vehicle No. GBF 2595G
Insured Veh. GBE 1849L
Claim No. SNM20D200827
Policy No. DMCVSN3064531900
Accident Date 12/02/2020
Inspection Date 14/02/2020

2. Vehicle Particulars & Condition				
Make & Model	FIAT DOBLO (M)	c.c	1248	
Engine No.	HIDDEN	Year of Reg.	2016	
Chassis No.	ZFA26300006C58109	Colour	WHITE	
Odometer	145916 KM	Steering	IN ORDER	
Brakes	IN ORDER	Modification	NIL	
General	GOOD

ADJUSTMENT ON REPAIR COST FOR VEHICLE NO. GBF 2595G

PHOTOGRAPHS FOR VEHICLE NO. GBF 2595G

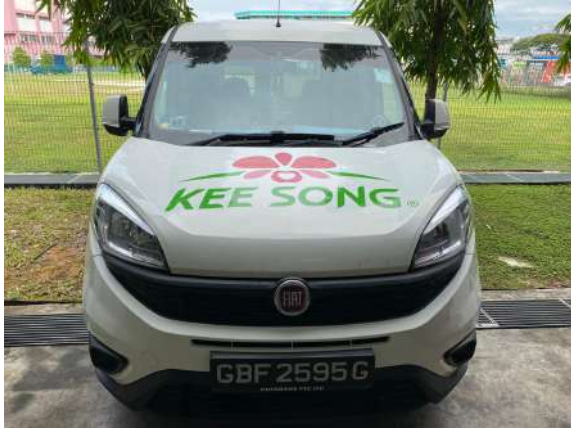
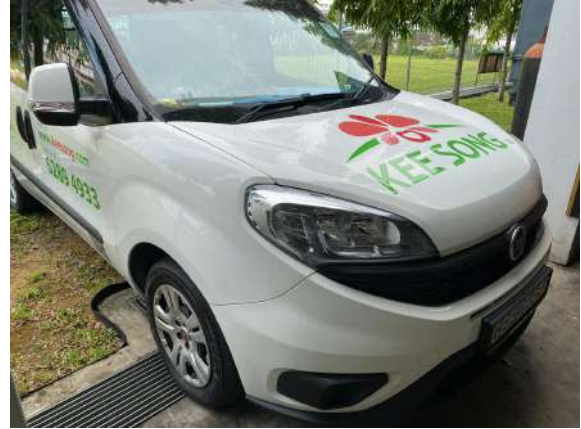
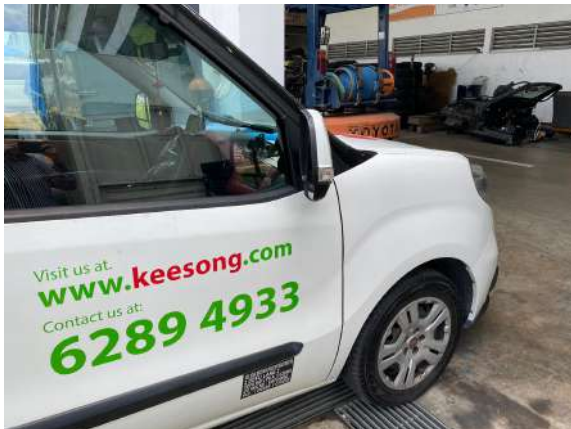
RE-INSPECTION

4. Description of Damages				
THE VEHICLE SUSTAINED DAMAGES AT THE O/S FRONT PORTION. DAMAGES SEE DETAILS.				
5. General Information				
Accident Date	12/02/2020	Inspection Date	14/02/2020	
Survey held at	MOTORVIVA PTE LTD 10 TUAS AVENUE 18 SINGAPORE 638894			
5a. Remarks
