LKK Auto Consultants Pte Ltd

ADJUSTMENT ON REPAIR COST FOR VEHICLE NO. SML 9623B

PHOTOGRAPHS FOR VEHICLE NO. SML 9623B

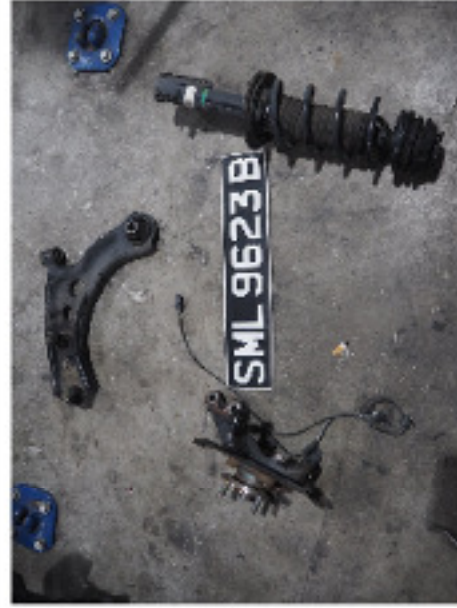
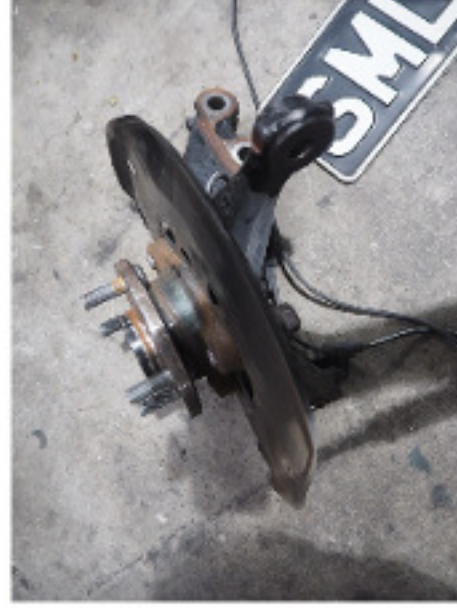
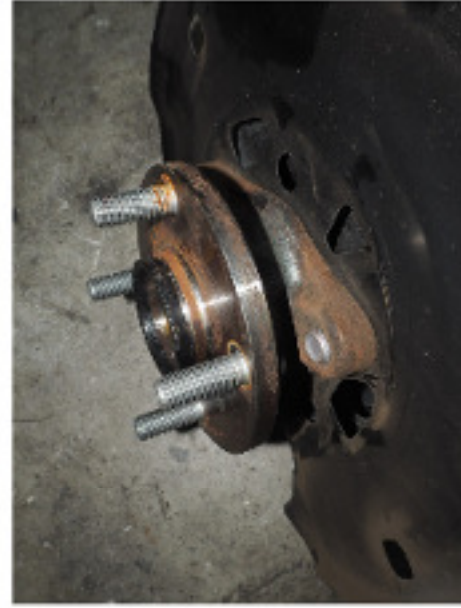
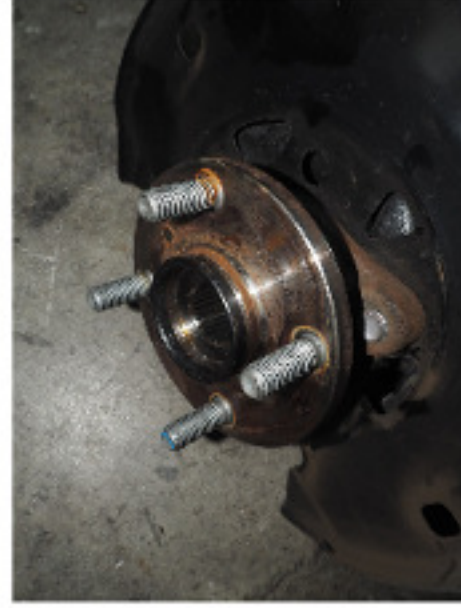
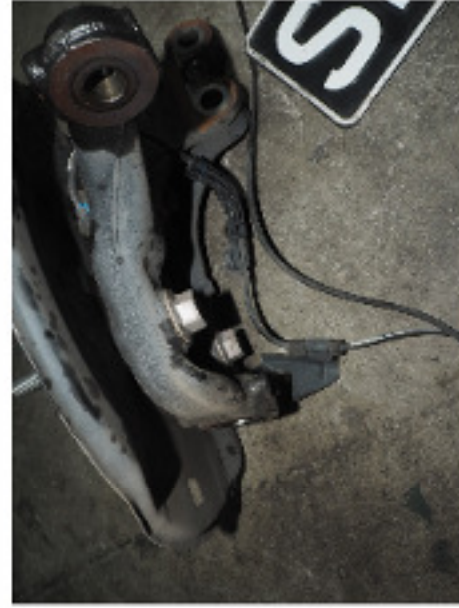
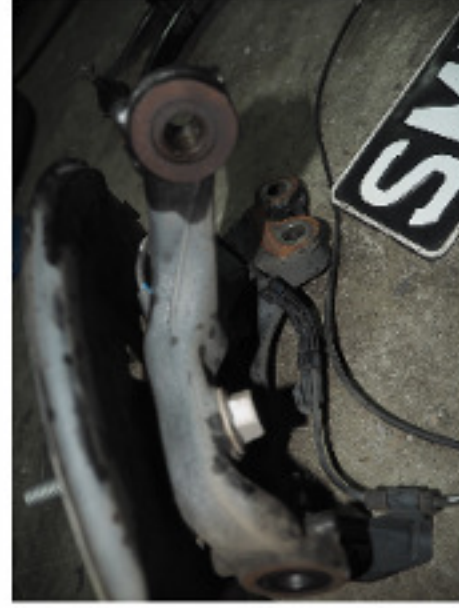
4. Description of Damages				
	THE VEHICLE SUSTAINED DAMAGES AT THE N/S BODY. DAMAGES SEE DETAILS.			
5. General Information				
	Accident Date	18/02/2020	Inspection Date	19/02/2020
	Survey held at	GREEN FOREST AUTOMOBILE PTE LTD 8 KAKI BUKIT AVENUE 4 #05-25 PREMIER @ KAKI BUKIT SINGAPORE 415875		
5a. Remarks				
	A)THE INSPECTION WAS CONDUCTED ON A"WITHOUT PREJUDICE" BASIS. B)IN ACCORDANCE TO YOUR INSTRUCTIONS, WE HAVE NOT AUTHORISED REPAIRS.			
5b. Estimate Days of Repair				
	ESTIMATED NORMAL PERIOD FOR REPAIR:		4 Working Days
