## LKK Auto Consultants Pte Ltd

### 1. Policy Particulars :- THIRD PARTY CLAIM

### ADJUSTMENT ON REPAIR COST FOR VEHICLE NO. SMJ 4913H

PHOTOGRAPHS FOR VEHICLE NO. SMJ 4913H

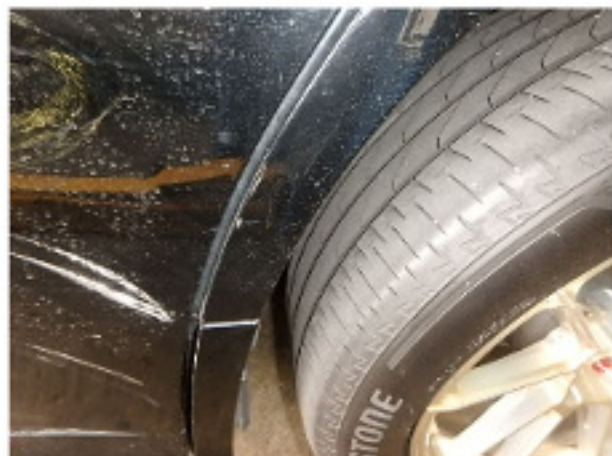
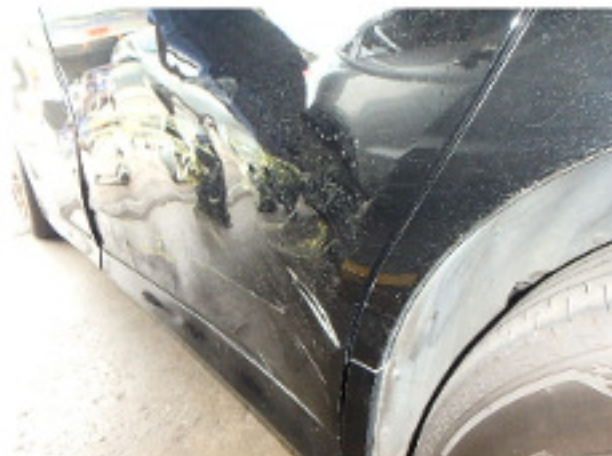
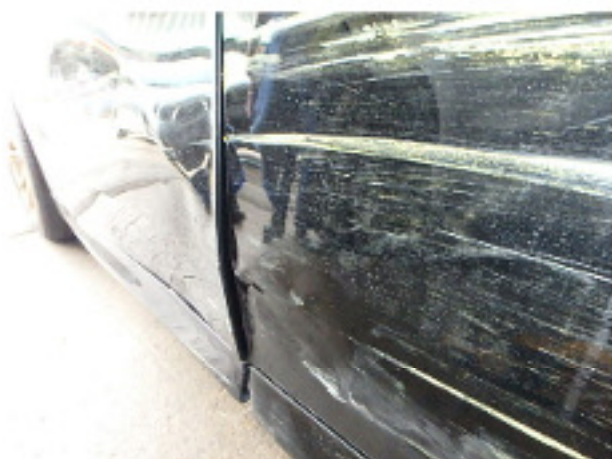
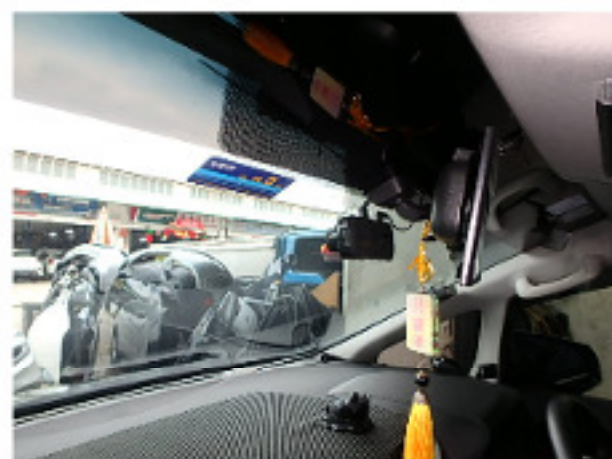
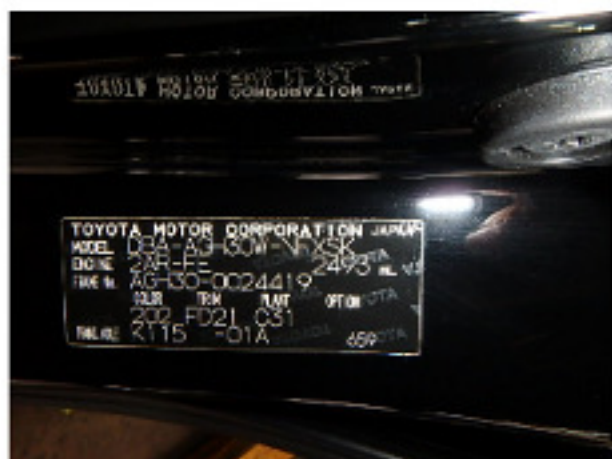
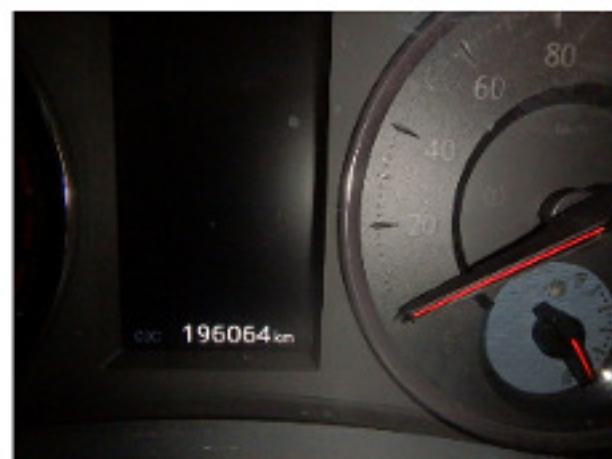
THE VEHICLE SUSTAINED DAMAGES AT THE N/S BODY. DAMAGES SEE DETAILS.
--

665.00	365.00
<b><u>LABOUR</u></b>				
	REMOVE & REFIX FRT LH DOOR, TRANSFER DOOR LOCK ASSY, INNER TRIM BOARD ASSY, RUBBER, REMOVE & REFIX LH SLIDING DOOR, CUT, WELD & RENEW LH DOOR PILLAR, KNOCK & REPAIR LH ROCKER PANEL & REALIGN THE SAME. INCLUSIVE OF THE REPAIR OF LH CENTRE PANEL OUTER.		1,000.00	700.00
	REMOVE & REFIX FRT LH DOOR GLASS.		60.00	60.00
	REMOVE & REFIX LH SLIDING DOOR GLASS.		100.00	80.00
	REMOVE & REFIX CARPET, GARNISH, SAFETY BELT, ETC.	* CHECK	100.00	-
	PUTTY & RESPRAY ON FRT LH DOOR, LH ROCKER PANEL, LH DOOR PILLAR, LH SLIDING DOOR, PROTECTORS & ALL AFFECTED AREAS.		1,000.00	900.00
