LKK Auto Consultants Pte Ltd

Affiliated to Federation Internationale Des Experts En Automobile				
MS FIRST CAPITAL INSURANCE LTD 36 ROBINSON ROAD #16-01 CITY HOUSESINGAPORE 068877			Ref: CC4/FCI20004307/Kea3q2	
			Date: 18/03/2021	
			Code: FCI2

ADJUSTMENT ON REPAIR COST FOR VEHICLE NO. SGV 223A

PHOTOGRAPHS FOR VEHICLE NO. SGV 223A

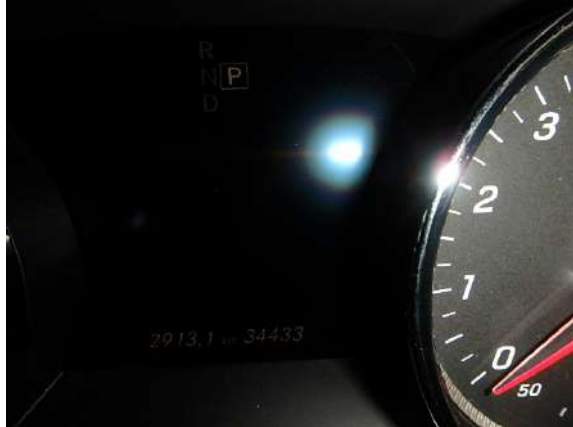
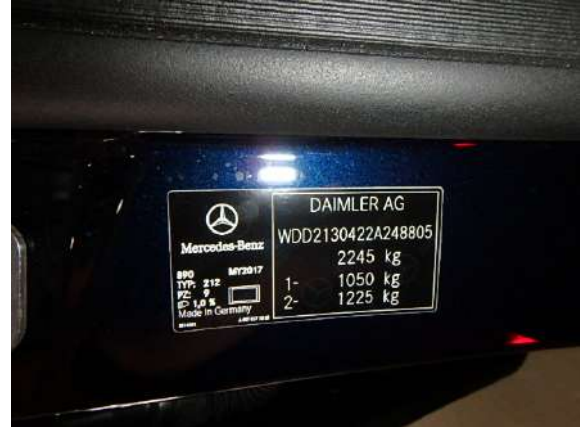
4. Description of Damages				
	THE VEHICLE SUSTAINED DAMAGES AT THE O/S FRONT PORTION. DAMAGES SEE DETAILS.			
5. General Information				
	Accident Date	14/03/2020	Inspection Date	01/04/2020
	Survey held at	LAI HUAT (MENG KEE) MOTOR PTE LTD 160 SIN MING DRIVE #04-01/02 SIN MING AUTOCITY SINGAPORE 575722		
5a. Remarks				
	A)THE INSPECTION WAS CONDUCTED ON A"WITHOUT PREJUDICE" BASIS. B)IN ACCORDANCE TO YOUR INSTRUCTIONS, WE HAVE NOT AUTHORISED REPAIRS.			
5b. Estimate Days of Repair				
	ESTIMATED NORMAL PERIOD FOR REPAIR:		1 Working Days

Qty	Description of Parts	Condition	Estimate By Workshop (\$)	Our Adjusted (\$)
	<u>LABOUR</u> TO RESPRAY FRONT BUMPER .		300.00	250.00
			300.00	250.00
	GRAND TOTAL		300.00	250.00
RECOMMENDED COST OF REPAIRS				250.00
