Your Ref: TP/IP/09681/2020  
Our Ref : CI/TPD20004857/P

**MECHANICAL INSPECTION REPORT OF MOTOR TRAILER BLB 5990**

1. I refer to your request on 2<sup>nd</sup> April 2020 to conduct a physical inspection of a Motor Trailer bearing registration number BLB 5990 (herein referred to as "**Motor Trailer**"), which was involved in a fatal road traffic accident on 19<sup>th</sup> February 2020.
2. The objective of this inspection is to determine if there was any possible mechanical failure to the Motor Trailer that may have contributed to the accident.
3. Following the request, I had carried out a physical inspection of the Motor Trailer on 3<sup>rd</sup> August 2020 at the premises of Traffic Police vehicle pound, 517 Airport Road Singapore 539942. I now set out below my observations and comments with respect to this inspection.

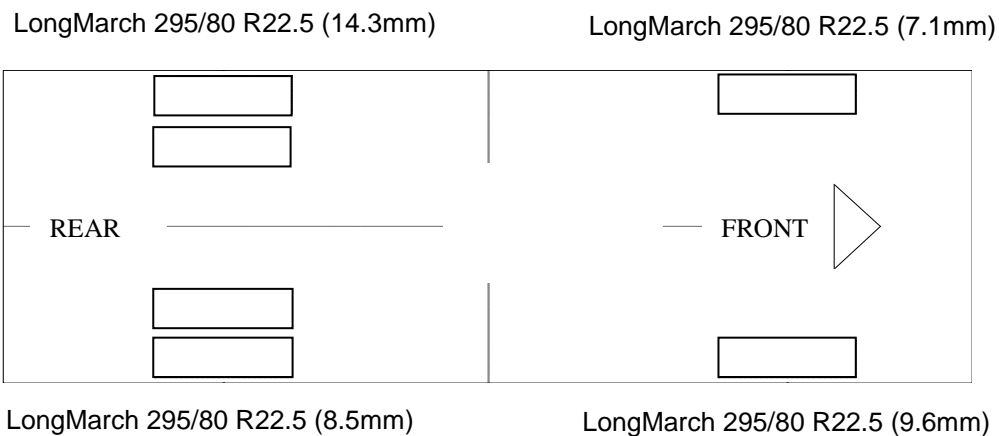
### Motor Trailer

7. The 2 front tyres and 4 rear tyres of the Motor Trailer and 12 tyres of the trailer were observed to be in serviceable condition and sufficiently inflated for vehicular operation. I did not find any tear, cut or burst mark(s) on the outer and the inner sidewalls as well as across the tread of the 6 tyres of the Motor Trailer and the 12 tyres of the trailer. The tyre brand, tyre size and remaining tread depth of the 6 tyres of the Motor Trailer and 12 tyres of the trailer were recorded as follows:-
