Your Ref: TP/IP/11887/2020
Our Ref : CI/TPD20004861/P

Fatal Accident Investigation Team

MECHANICAL INSPECTION REPORT OF MINI BUS PC 8744D

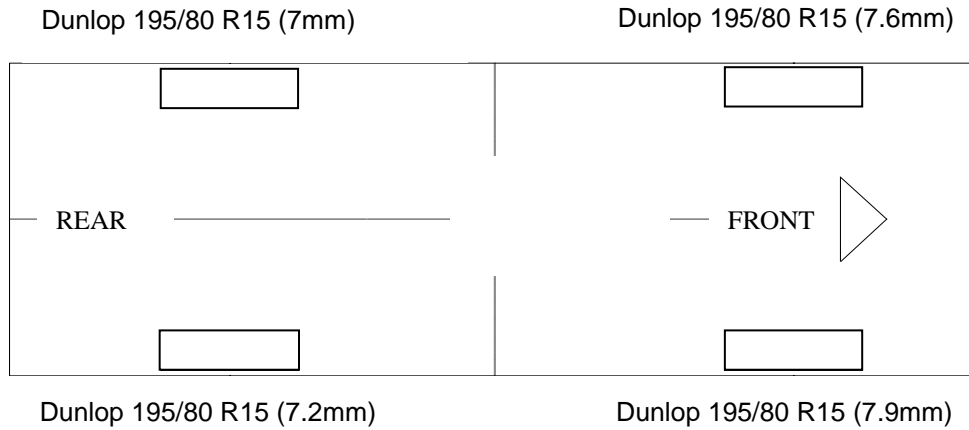
6. The 4 tyres of the Mini Bus were observed to be in serviceable condition and sufficiently inflated for vehicular operation. I did not find any tear, cut or burst mark(s) on the outer and the inner sidewalls as well as across the tread of the 4 tyres. The tyre brand, tyre size and remaining tread depth of the 4 tyres of the Mini Bus were recorded as follows:-

7. The 4 tyres were observed to be wrapped around standard steel wheel rims that were found to be without any damage. See photo 1 – 11 below.
