Your Ref: TP/IP/13045/2020
Our Ref : CI/TPD20004865/P

Fatal Accident Investigation Team

MECHANICAL INSPECTION REPORT OF MOTOR LORRY YM 9961C

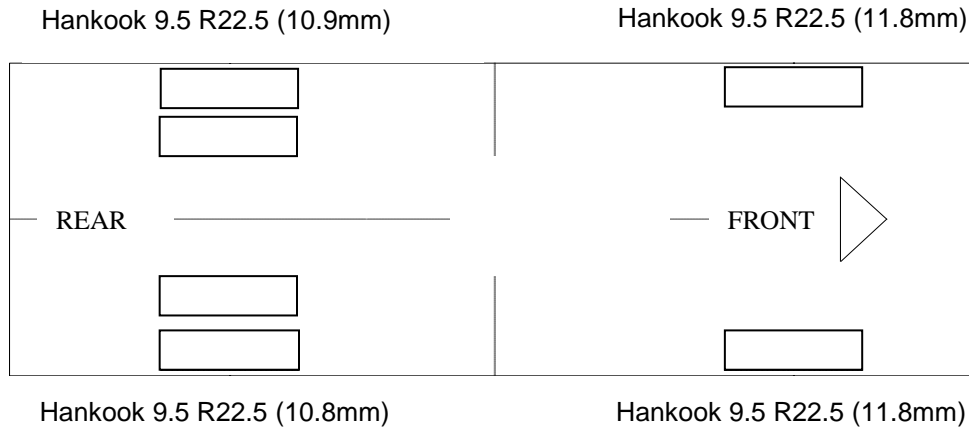
6. The 6 tyres of the Motor Lorry was observed to be in serviceable condition; sufficiently inflated for vehicular operation. I did not find any tear, cut or burst mark(s) on the outer and the inner sidewalls as well as across the tread of the 6 tyres. The tyre brand, tyre size and remaining tread depth of the 6 tyres of the Motor Lorry were recorded as follows:-

7. The 6 tyres were observed to be wrapped around standard steel wheel rims that were found to be without any damage. See photo 1 – 10 below.
