Your Ref: TP/IP/08817/2020  
Our Ref : CI/TPD20004873/P

**Fatal Accident Investigation Team**

**MECHANICAL INSPECTION REPORT OF MOTOR TAXI SHF 74K**

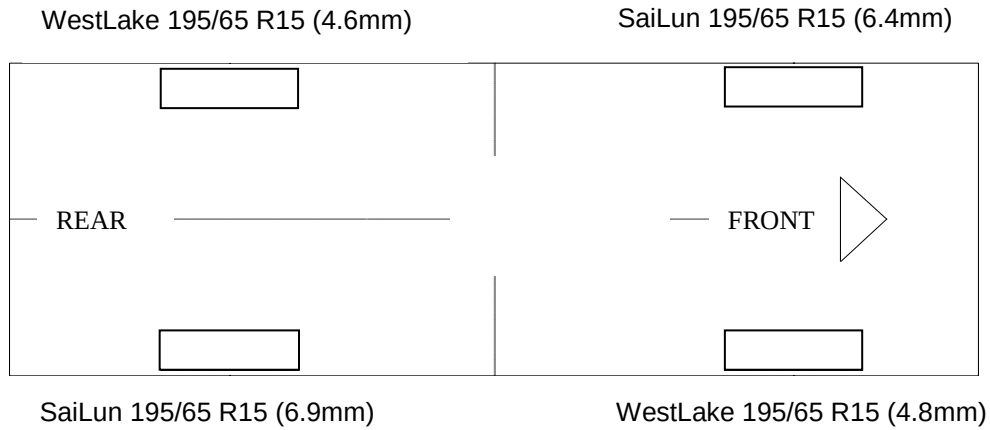
6. The 4 tyres of the Motor Taxi were observed to be in serviceable condition and sufficiently inflated for vehicular operation. I did not find any tear, cut or burst mark(s) on the outer and the inner sidewalls as well as across the tread of the 4 tyres. The tyre brand, tyre size and remaining tread depth of the 4 tyres of the Motor Taxi were recorded as follows:-
