Your Ref: TP/IP/15449/2020
Our Ref : CI/TPD20004876/P

3rd June 2020

Fatal Accident Investigation Team

MECHANICAL INSPECTION REPORT OF MOTOR CAR SMM 4122H

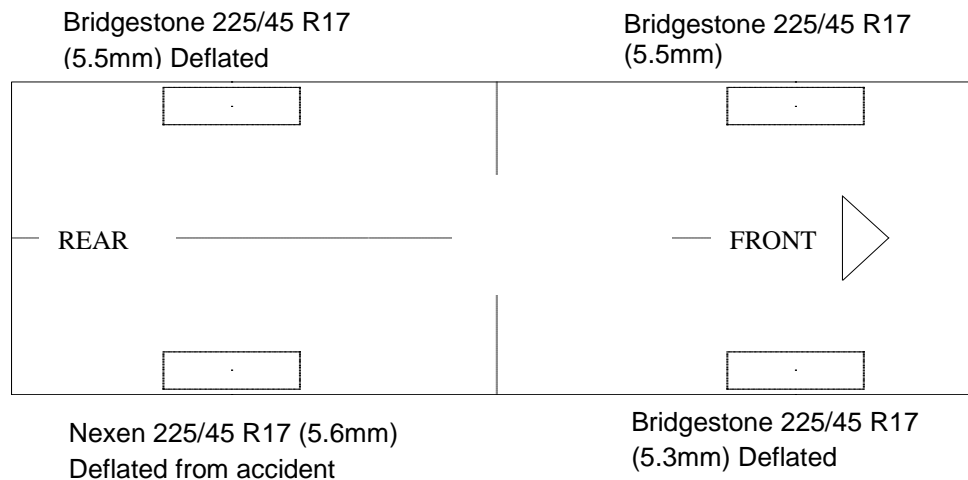
Photo 9 shows the condition of the front right tyre of the Motor Car, which was observed to be in serviceable condition with remaining tread depth of approximately 5.3mm. There was also no tear, cut or burst mark(s) on the outer and the inner sidewalls as well as across the tread of the Motor Car's 4 tyres, however observed to be deflated due to damage to the rims (arrowed).
