VEHICLE DAMAGE INSPECTION REPORT

Our Ref: 340/TP/2018

Reg No:	SJQ7989T	Make &	Toyota
Reg date:	27/5/2009	Model	Corolla Altis 1.6 Auto
Colour:	Silver	Engine No:	3ZZ4884644
Type:	Motor Car	Chassis No:	MR053ZEE106144330
Type of Claims:	Third Party	Odometer No:	76001km
		Engine Cap:	1598cc

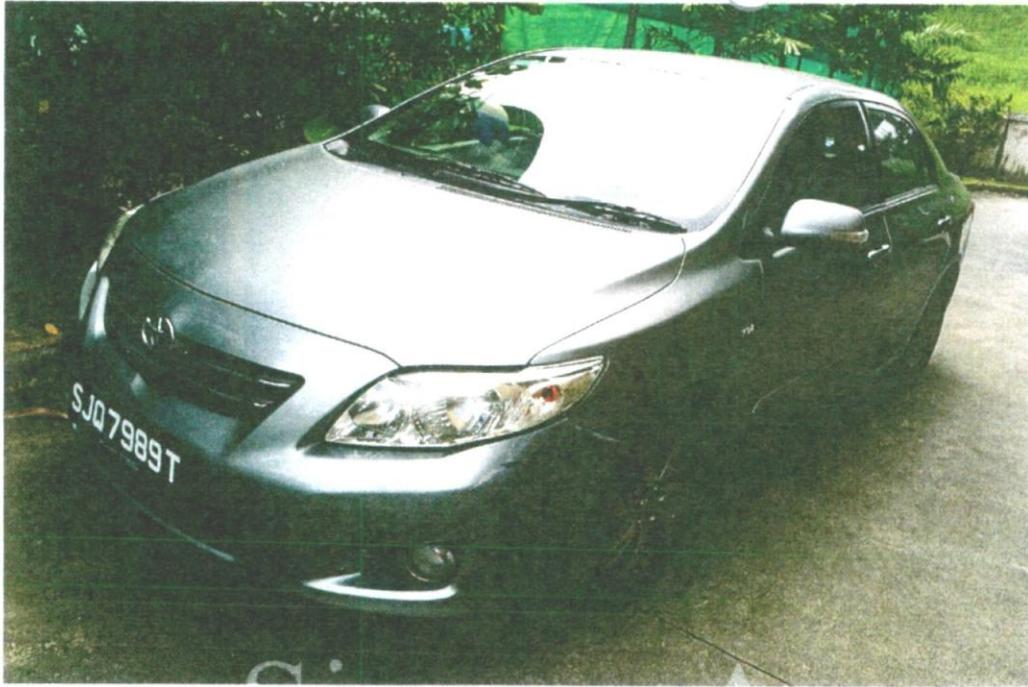
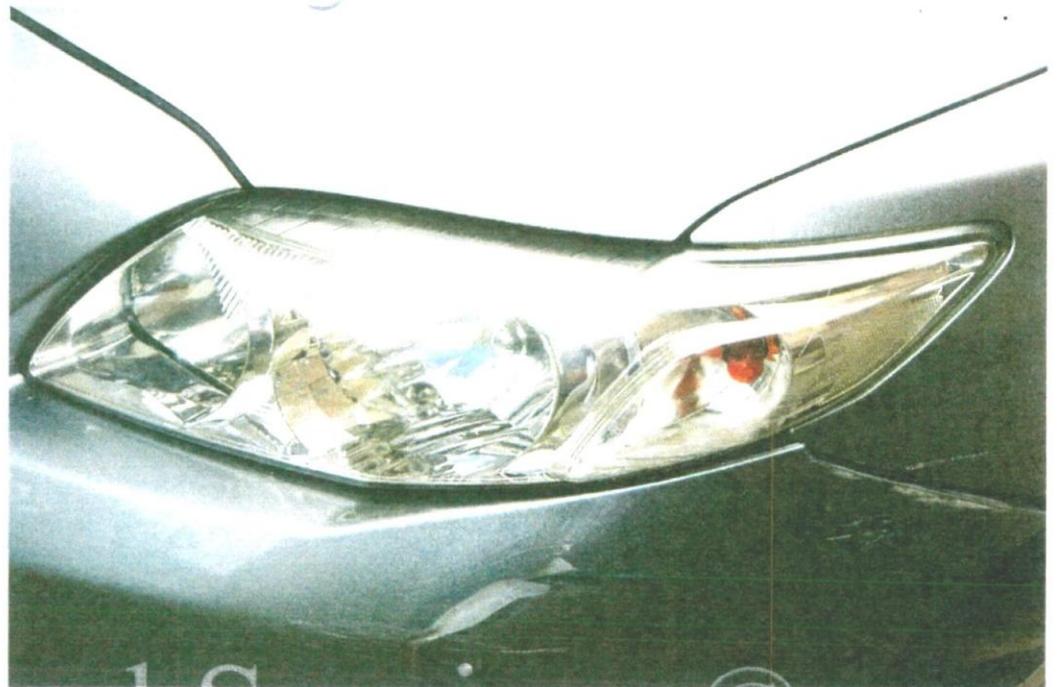
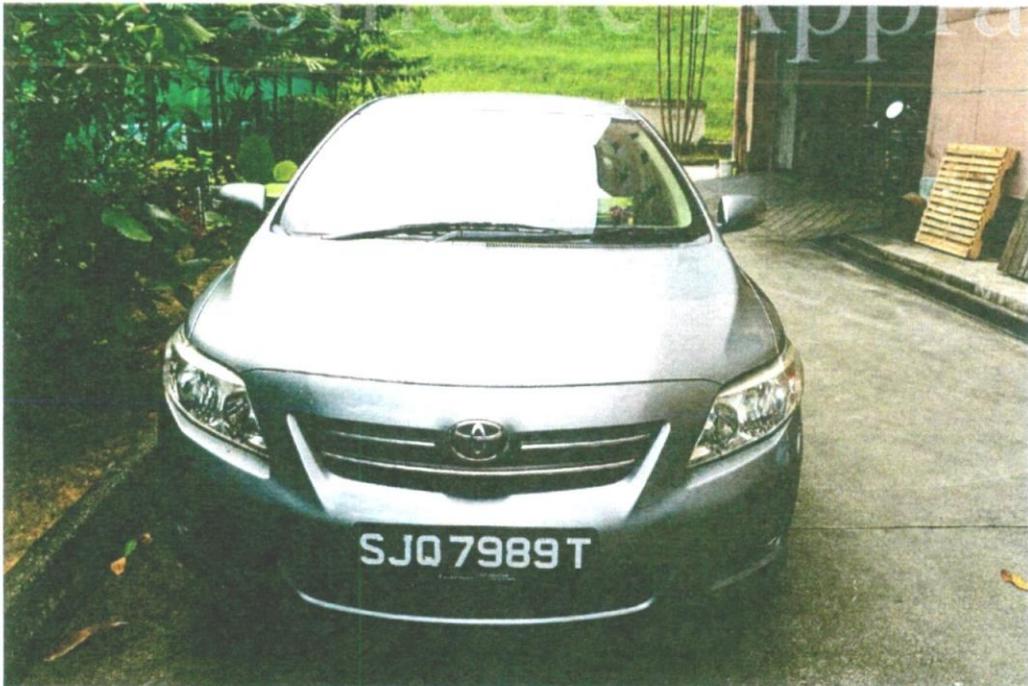
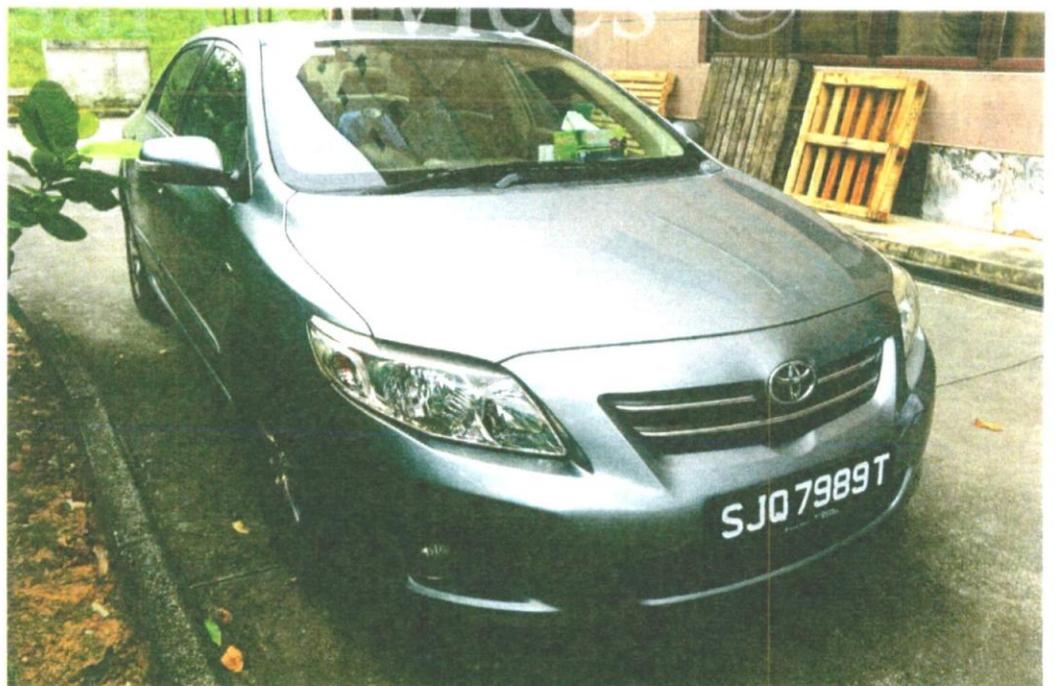
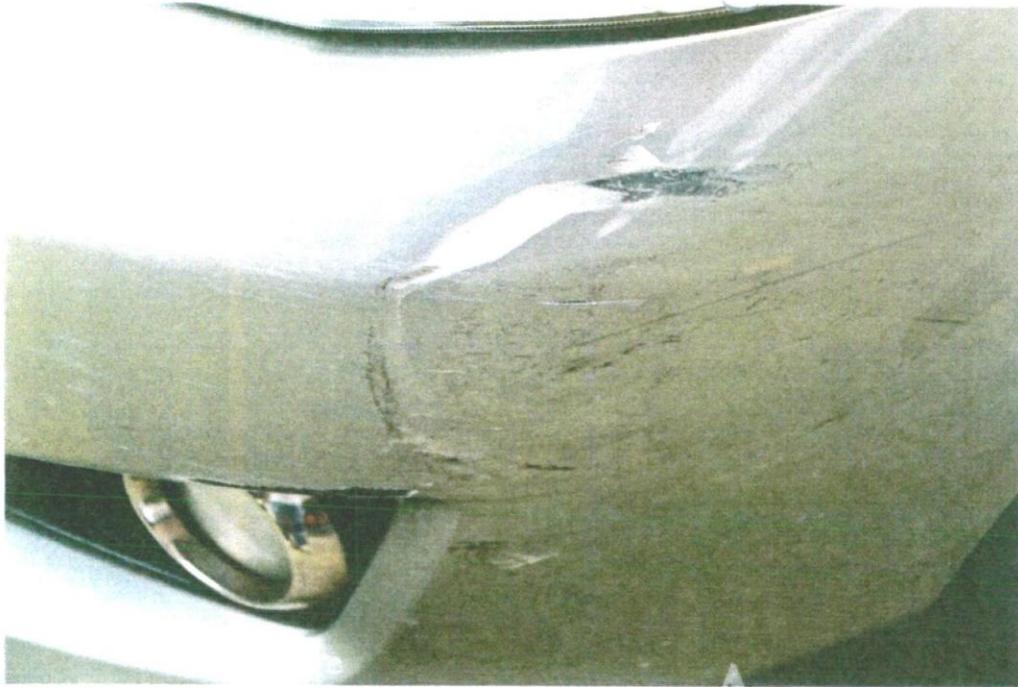
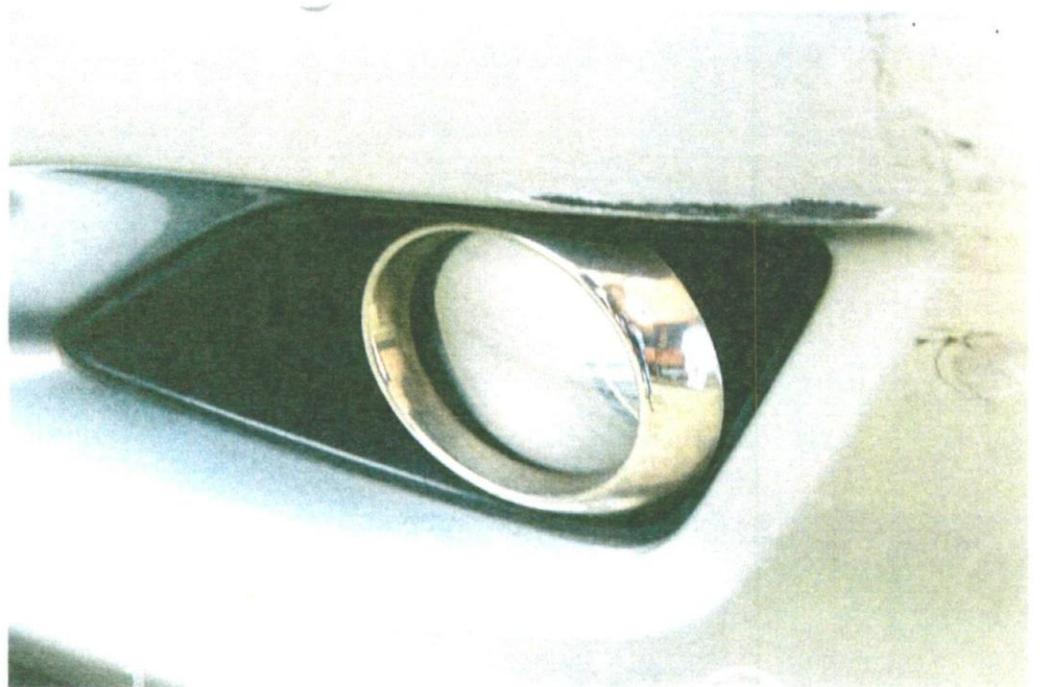
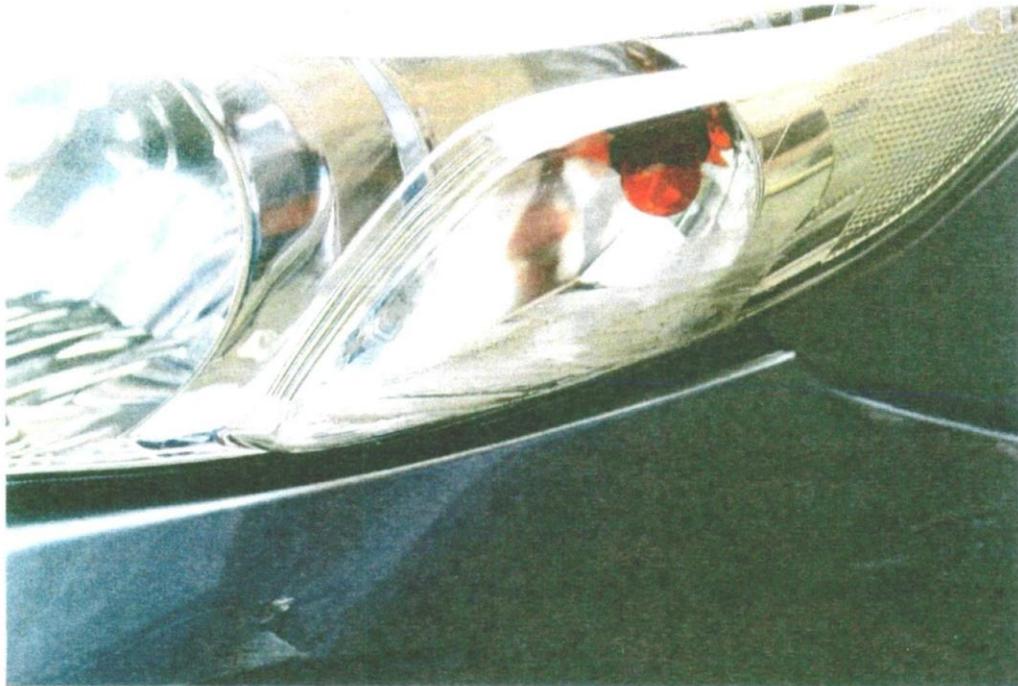
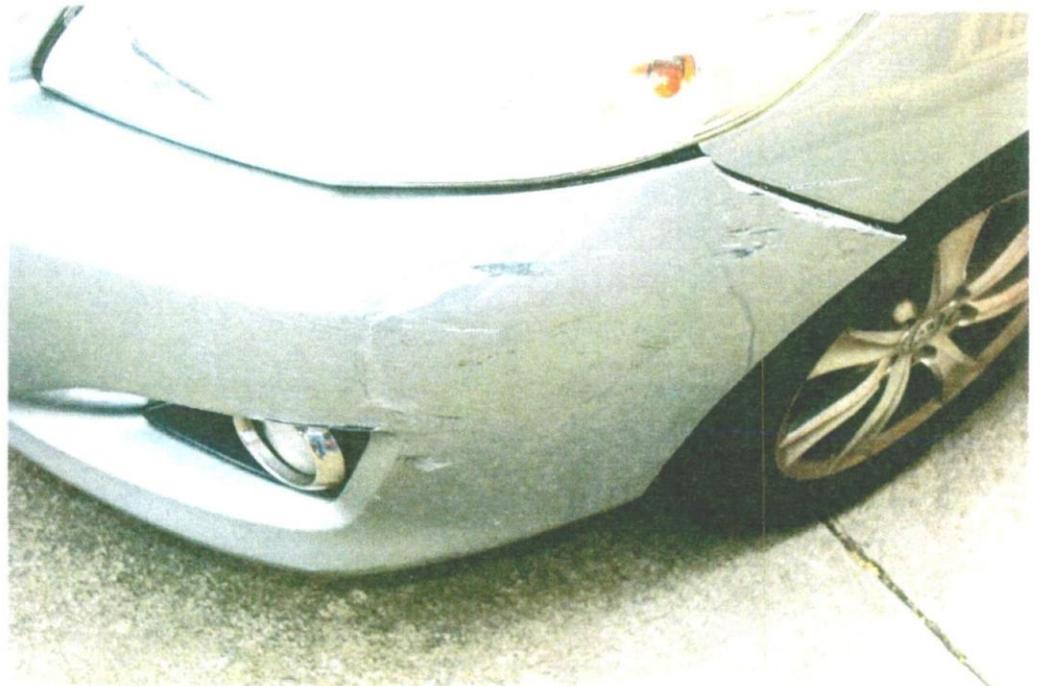
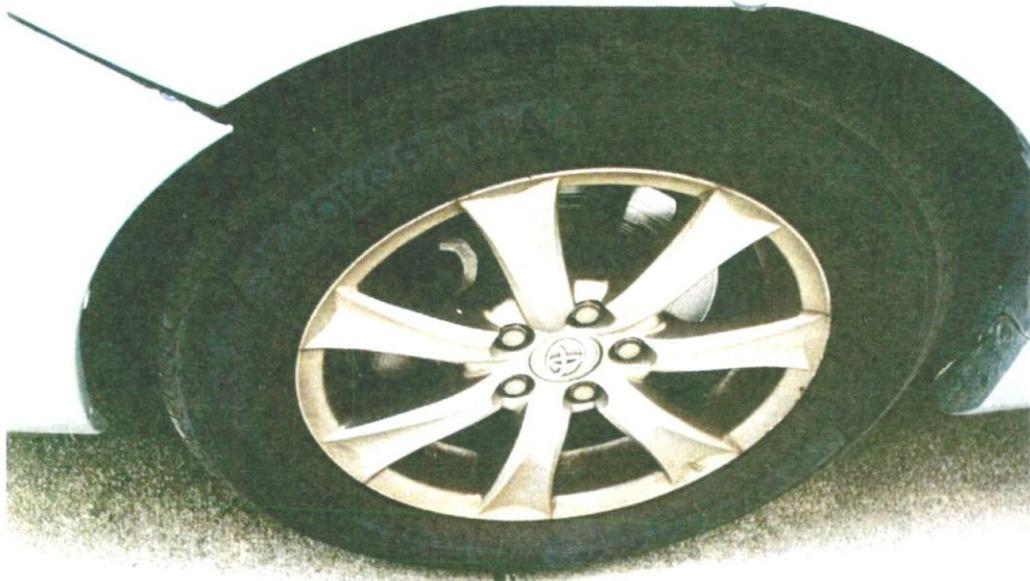
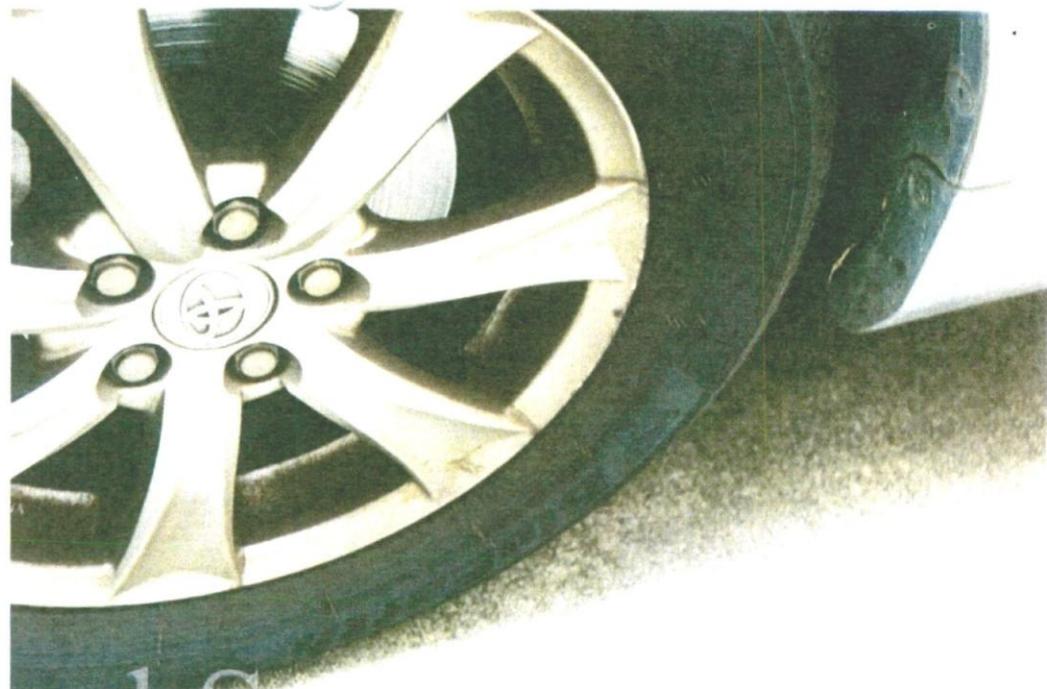
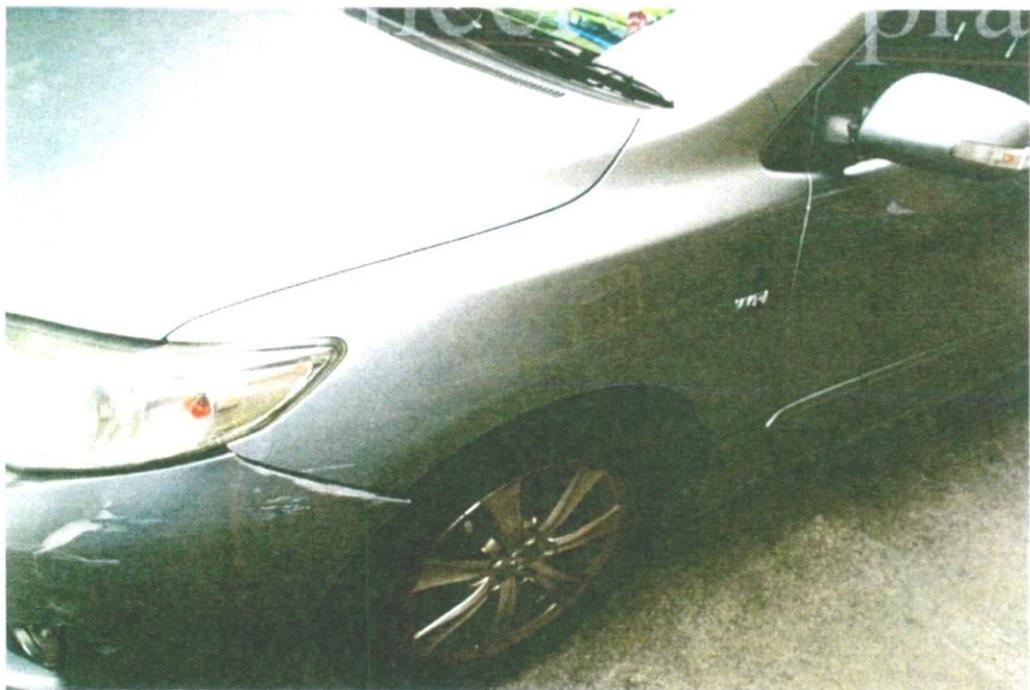
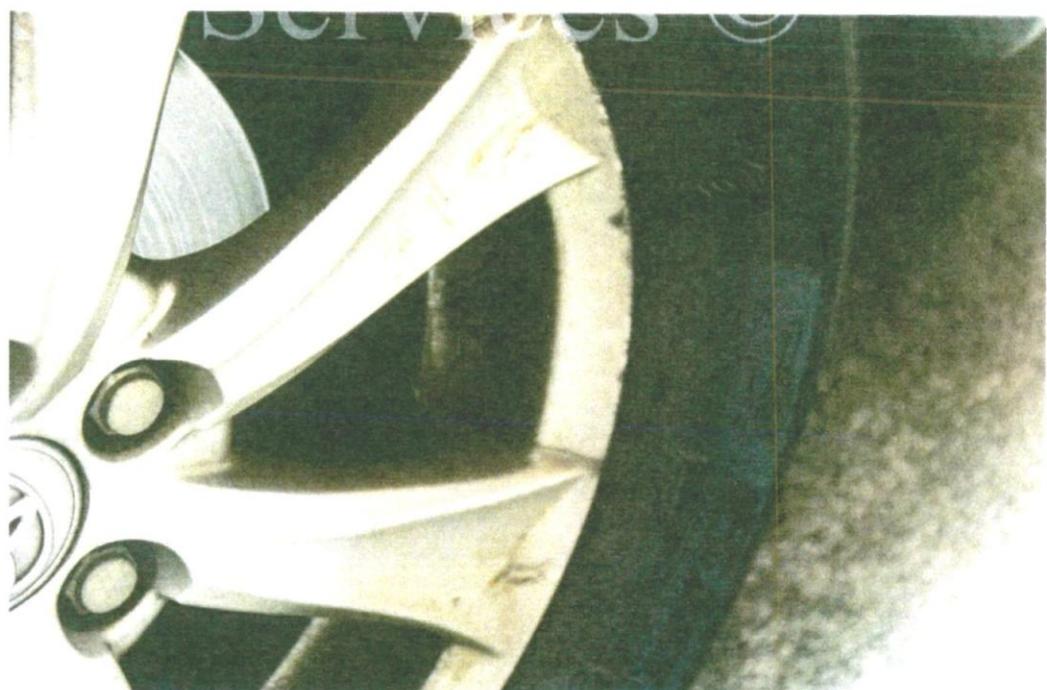
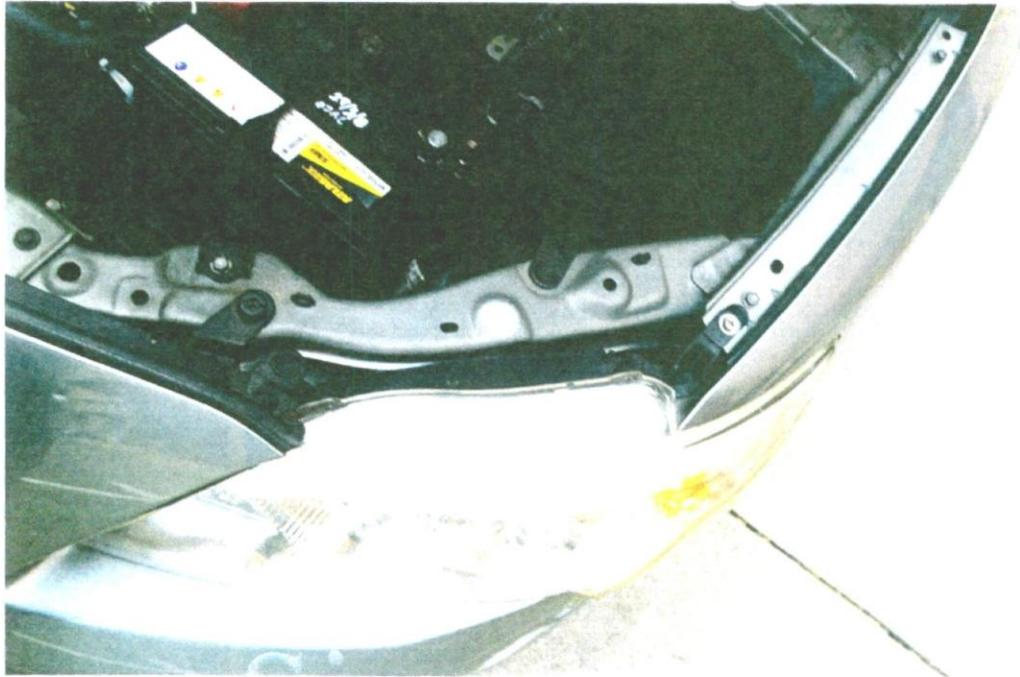
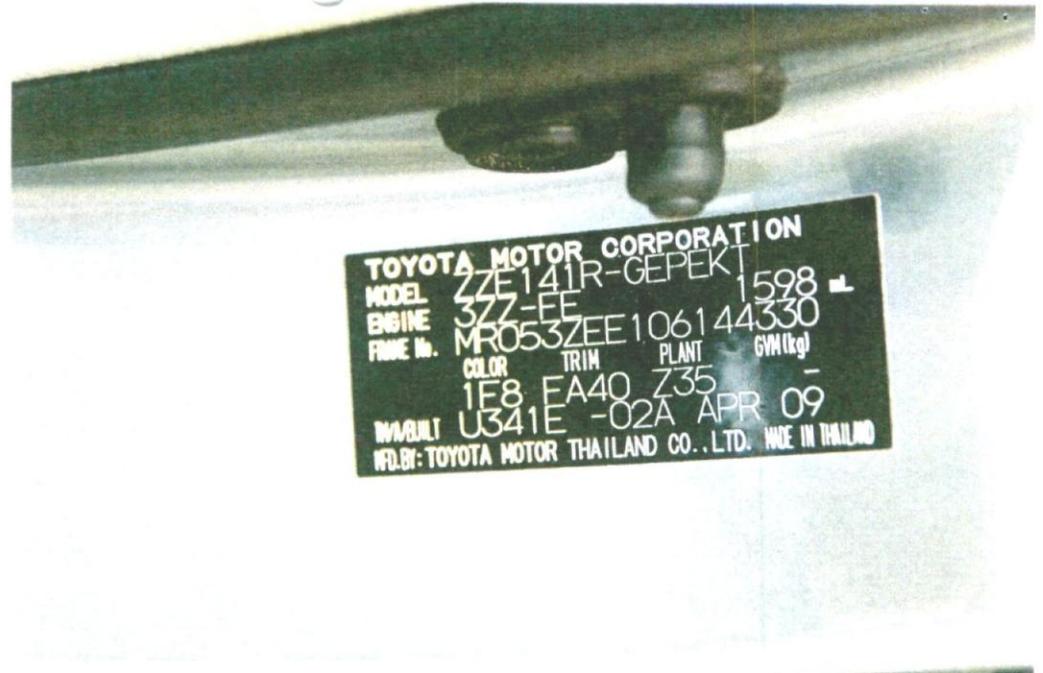
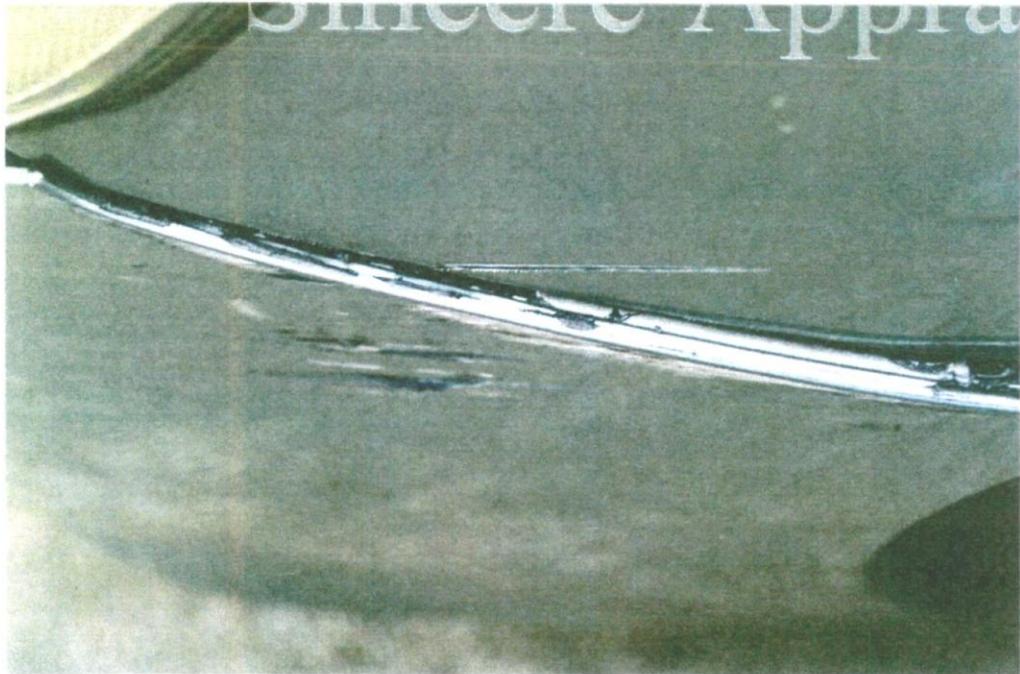
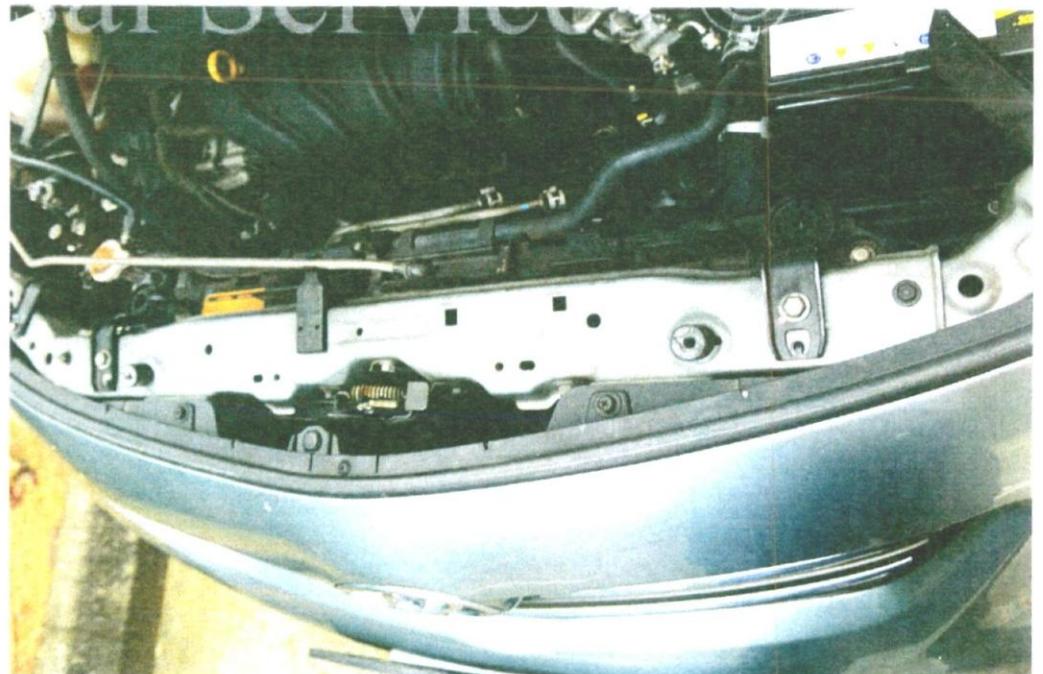
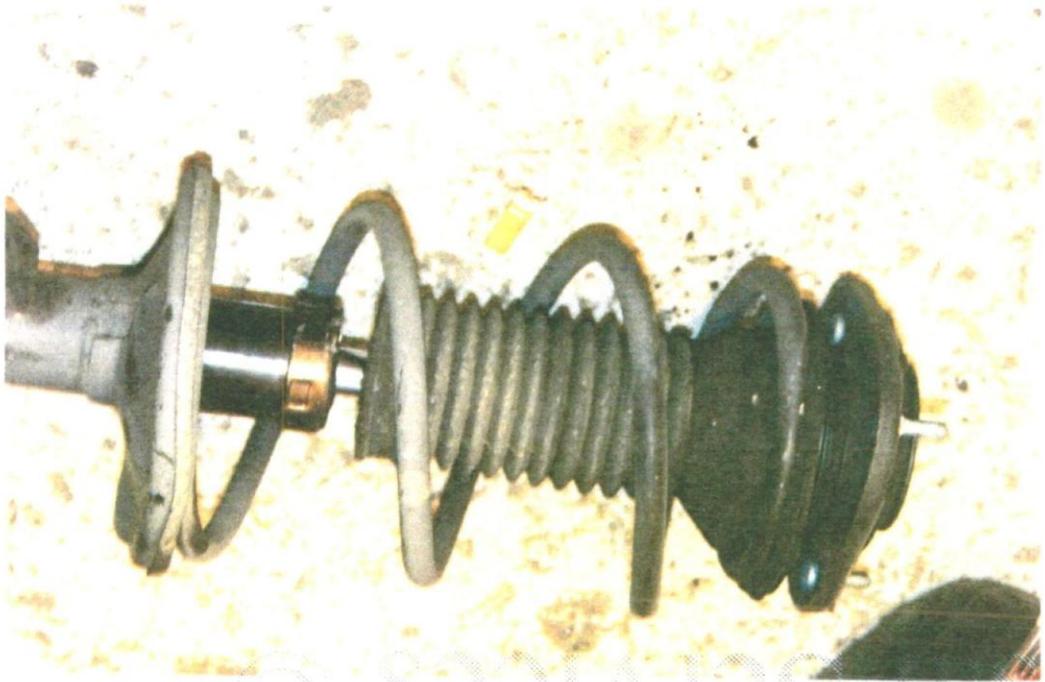
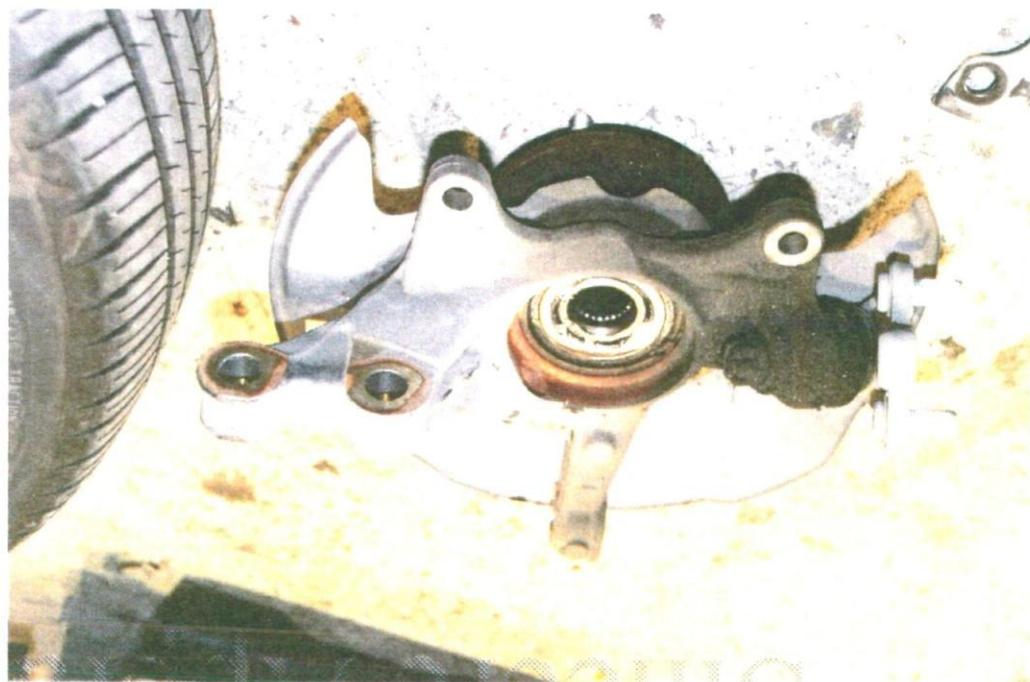
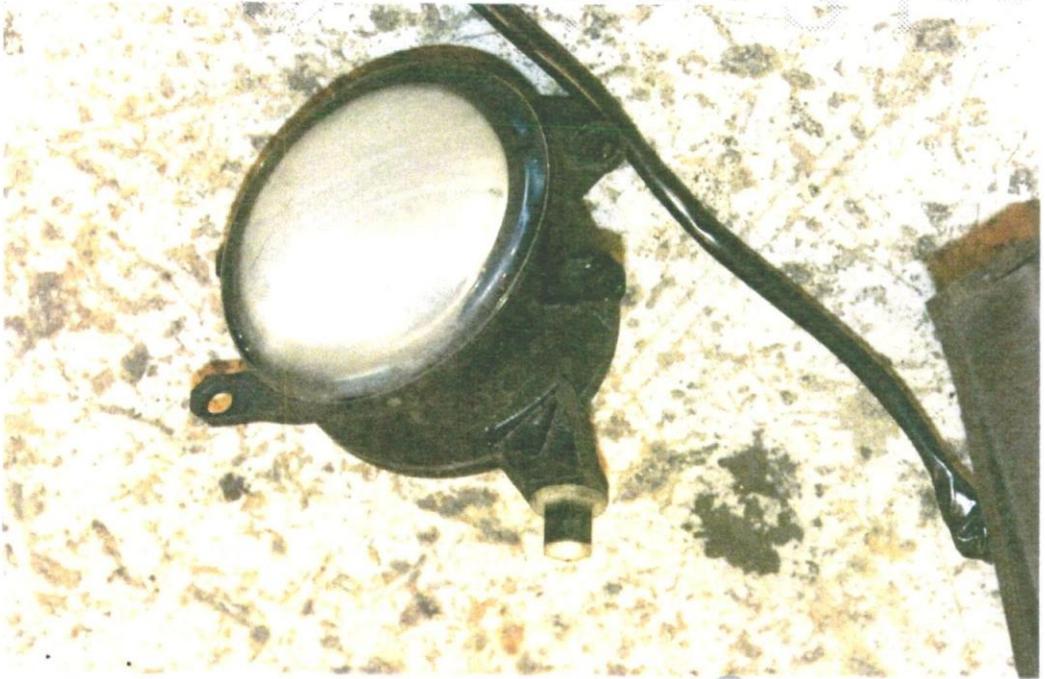
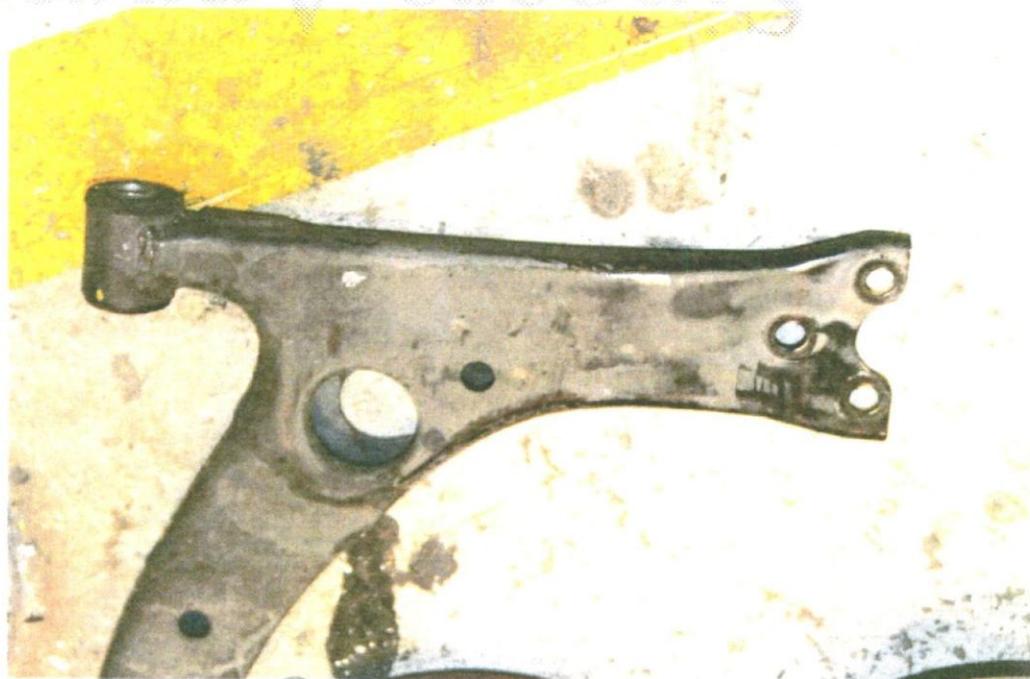
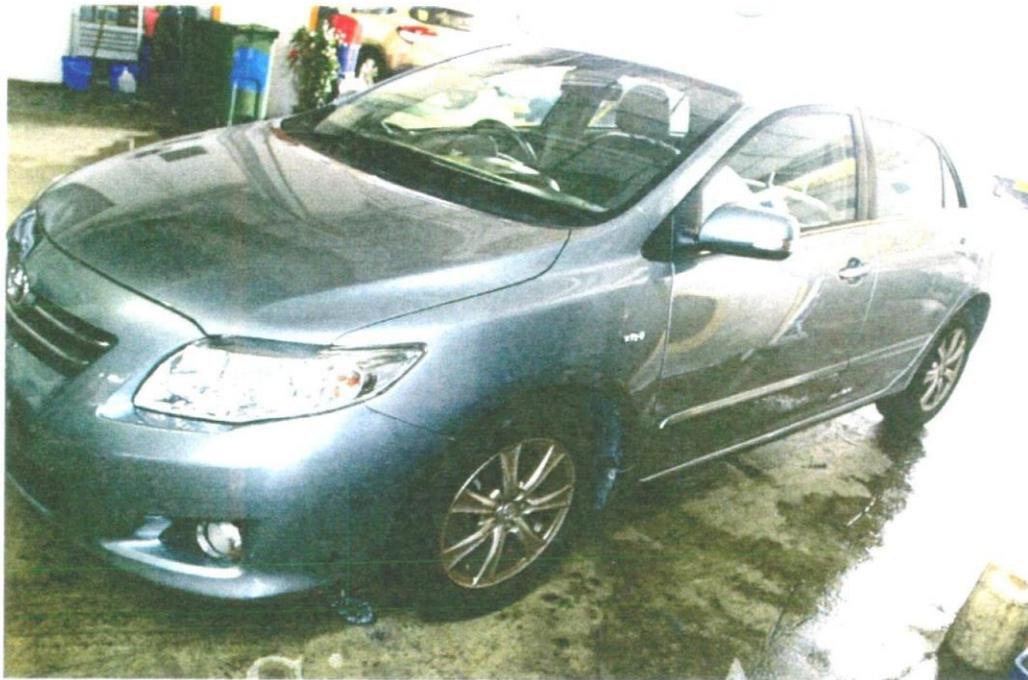
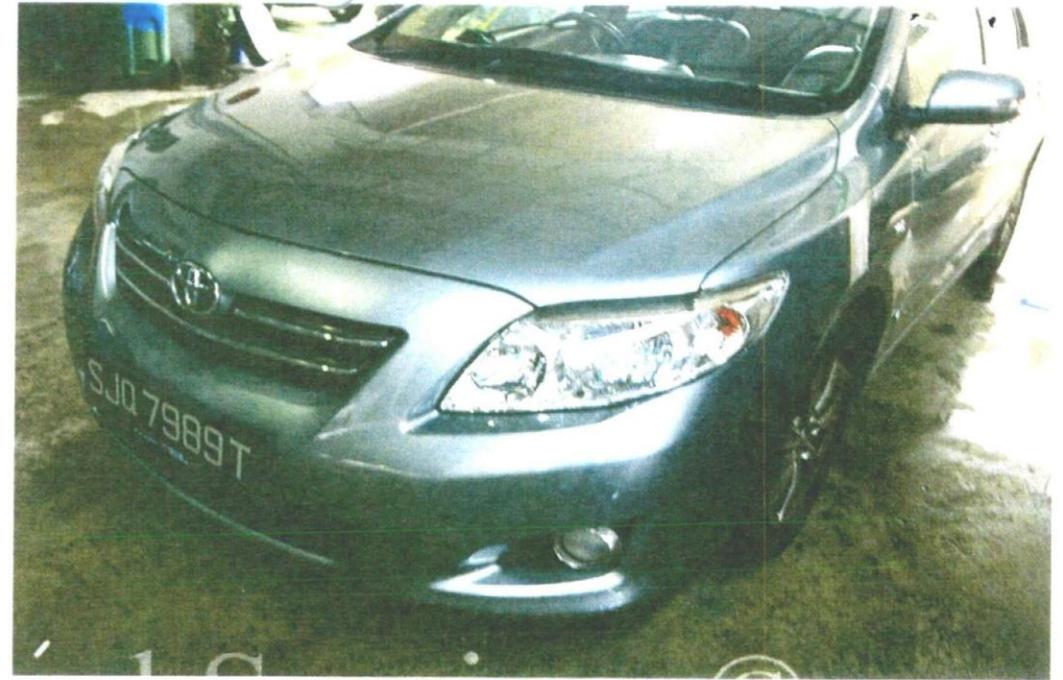
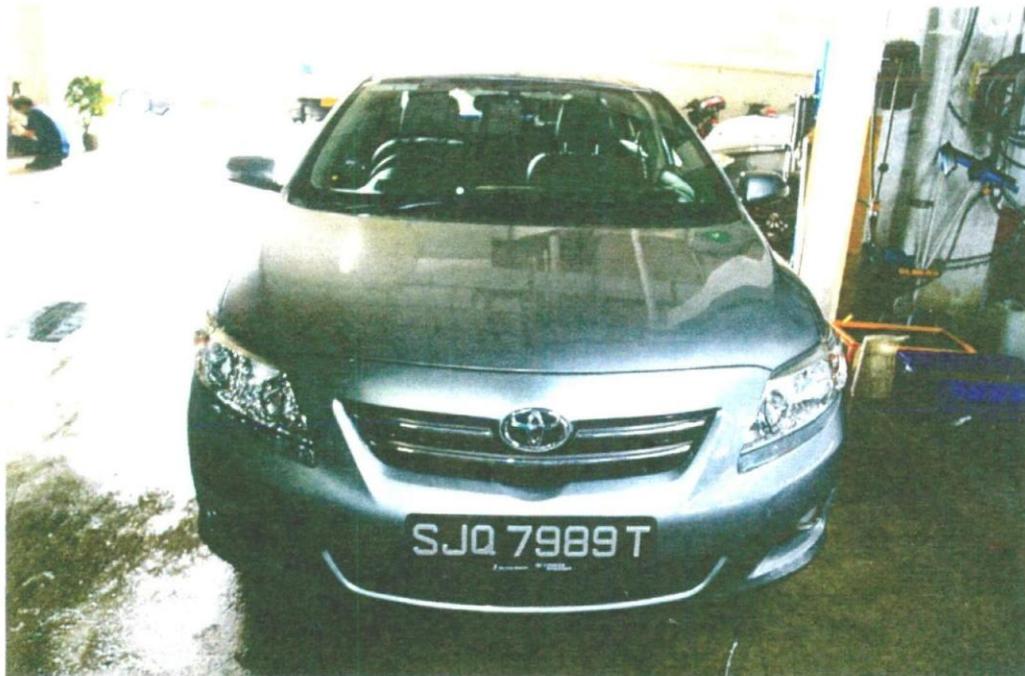
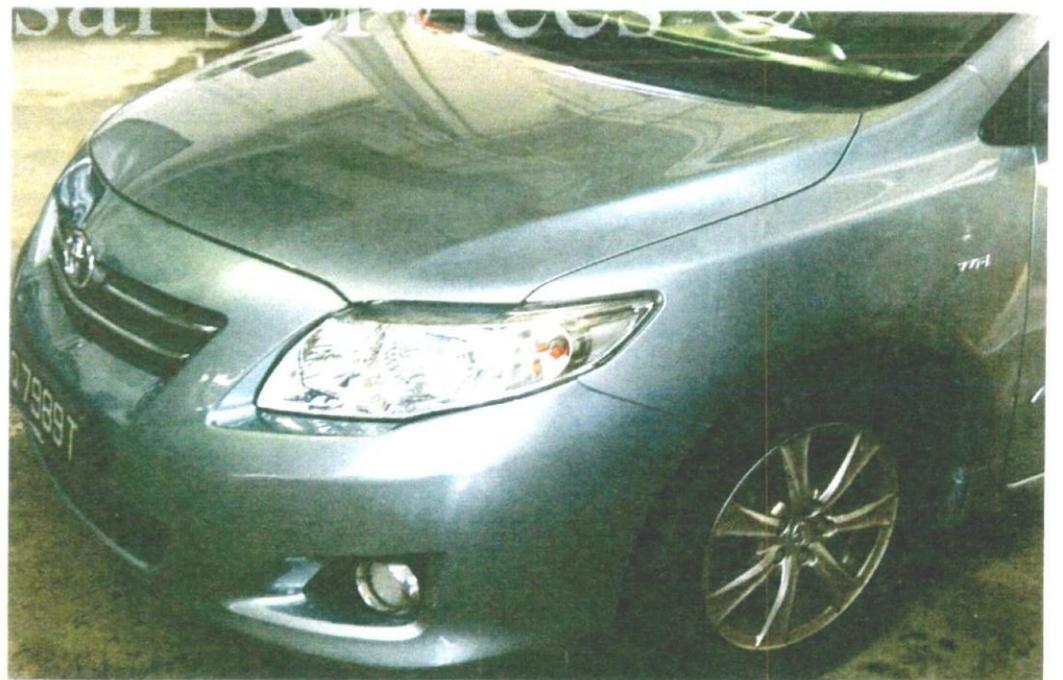
Damaged at the left hand front portion

Our visual inspection of the vehicle revealed that the damages noted are at the left hand front portion.

We have inspected the actual damages found on the vehicle and recommend the replacement of parts and repairs accordingly. The estimated repair cost is \$6,605.25. The repairer has agreed to undertake the repairs at our adjusted lump sum amount of \$5,000.00.
