LKK Auto Consultants Pte Ltd

Ref : CS/SCD20005264/Qsf3e2

1. Policy Particulars :- OWN DAMAGE

PHOTOGRAPHS FOR VEHICLE NO. YN 3693K

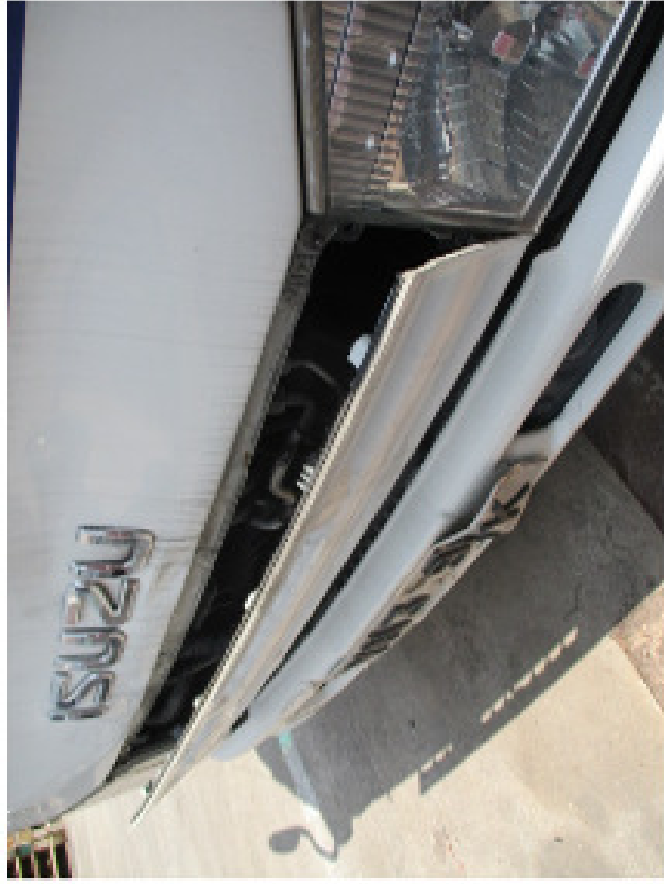
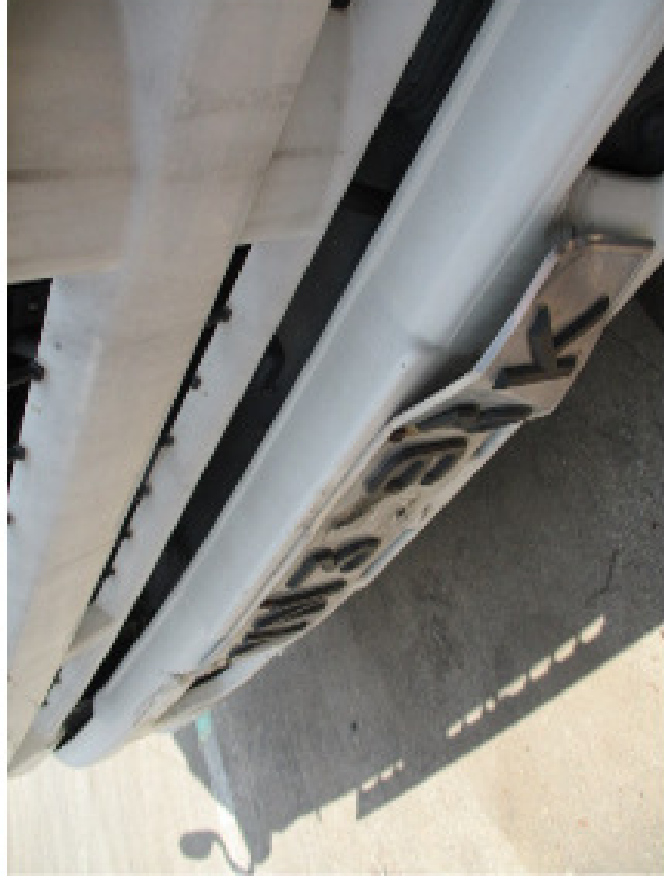
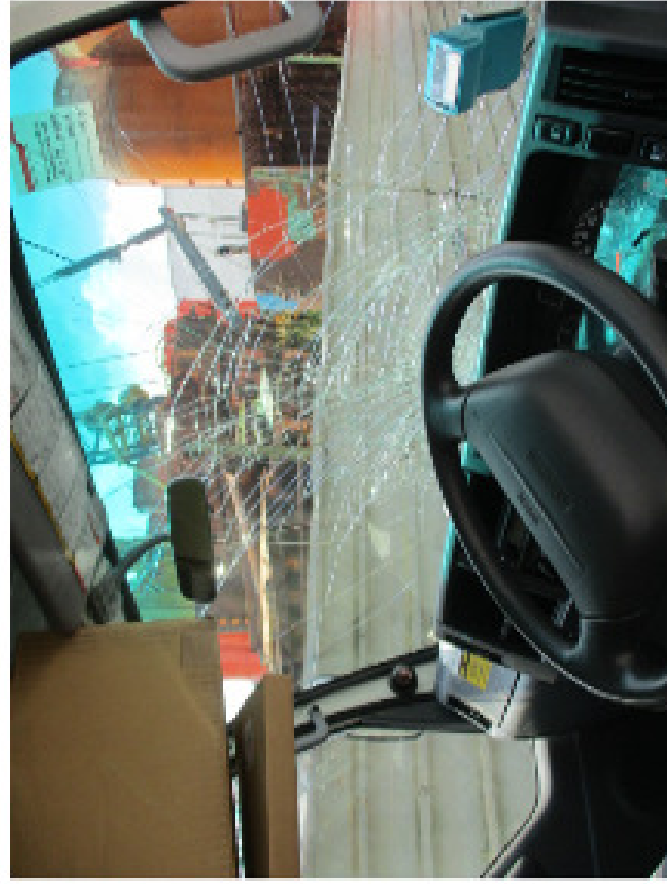
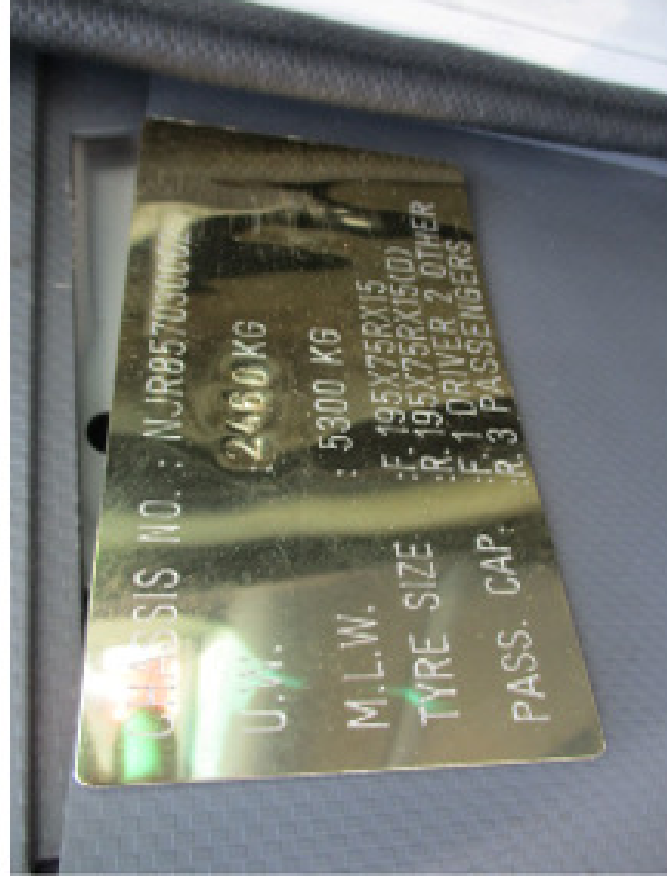
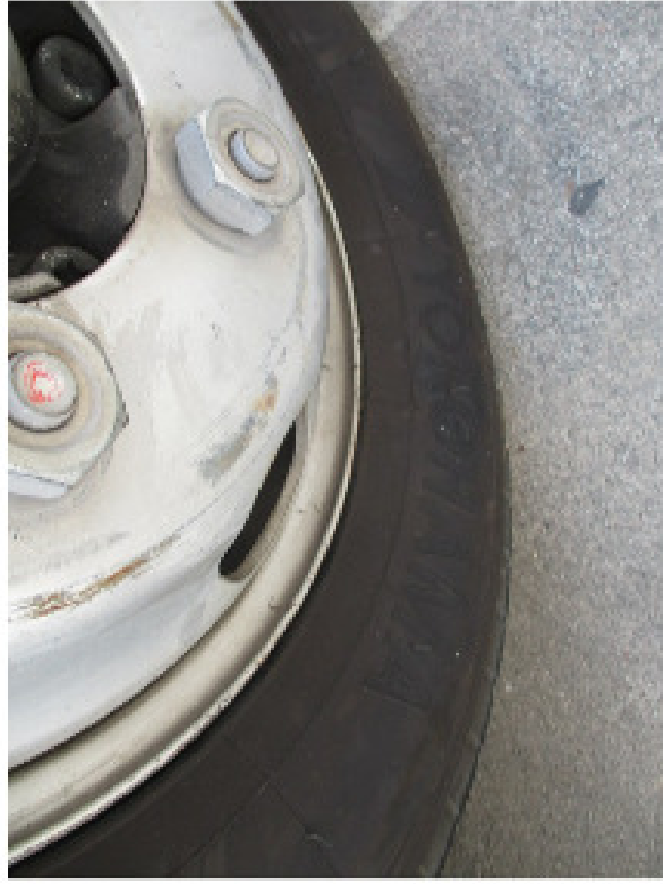
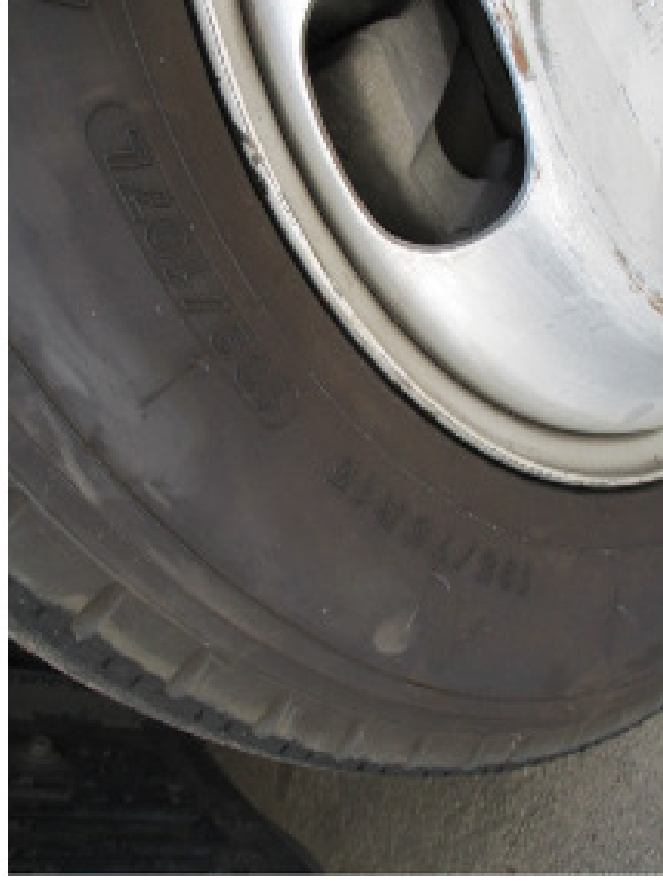
THE VEHICLE SUSTAINED DAMAGES AT THE FRONT PORTION. DAMAGES SEE DETAILS.

1.8	Front Bumper Support	1				
1.9	Front Number Plate	1				
1.10	Front Panel Sticker	1				
	LABOUR DESCRIPTION					
1	SCOPE OF REPAIRS					
1.1	Remove & replace shuttered wind screen					4

1.2	Replace wind screen moulding					1
1.3	Water seepage for wind screen					1
1.4	Remove & replace front dented panel					4
1.5	Remove & replace dislodged radiator grill					1

1.6	Remove & replace front dented bumper					2
1.7	Remove & replace front dented bumper support					2
1.8	Remove & replace front dented number plate					0.5

1.9	Replace front panel sticker					1
1.10	Putty & spray paint front panel , radiator grill & front bumper					5
