Your Ref: TP/IP/05243/2020
Our Ref: CI/TPD20005586/P

11th May 2020

MECHANICAL INSPECTION REPORT OF MOTOR LORRY GBD 8155P

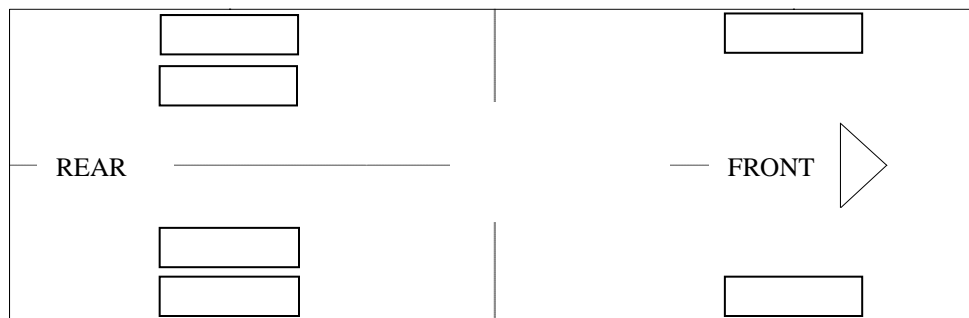
6. The front right tyre of the Motor Lorry were observed cut and deflated. However, the other tyres were observed to be in serviceable condition and sufficiently inflated for vehicular operation and we did not find any tear, cut or burst mark(s) on the outer and the inner sidewalls as well as across the tread of the 5 tyres. The tyre brand, tyre size and remaining tread depth of the 6 tyres of the Motor Lorry were recorded as follows:-

Condor 155/ R13 (1.7mm)

Rivo 195/ R15 (4.8mm) (Cut)

Rivo 195/ R15 (4.7mm)
