Our Reference : KAAS/TA/5878/7425/TP/01.20  
Date : 20 February 2020

## VEHICLE APPRAISAL REPORT

Registration No.	: SKC 7425R	Chassis Frame No.	: WAUZZZ4G8BN023912
Make / Model	: Audi A6 2.8 FSI MU	Engine No. ( Logcard )	: CHV003670
Year of Manufacture/Reg	: 2011	Odometer Reading	: 164,374 KM
Colour	: Black		
Class / Type	: Saloon

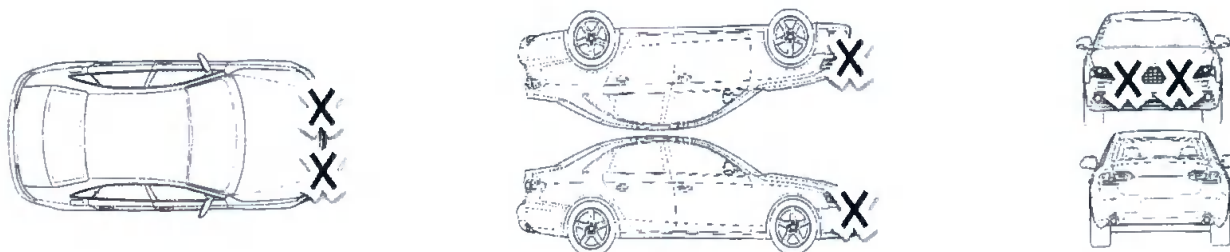
Damages sustained were consistent with the subject vehicle being involved in a collision with another vehicle and the impact was delivered to the Front portion of the vehicle.

The general area of damages is at the Front portion  
( Please refer to the parts list and photographs as attached for more information )
