LKK Auto Consultants Pte Ltd

Affiliated to Federation Internationale Des Experts En Automobile				
SOMPO INSURANCE SINGAPORE PL		Ref : CS/SMO20006066/Kqf3n2		
50 RAFFLES PLACE #05-01/06 SINGAPORE LAND TOWERSINGAPORE 048623		Date : 24-06-2020

ADJUSTMENT ON REPAIR COST FOR VEHICLE NO. SLJ 9396D

PHOTOGRAPHS FOR VEHICLE NO. SLJ 9396D

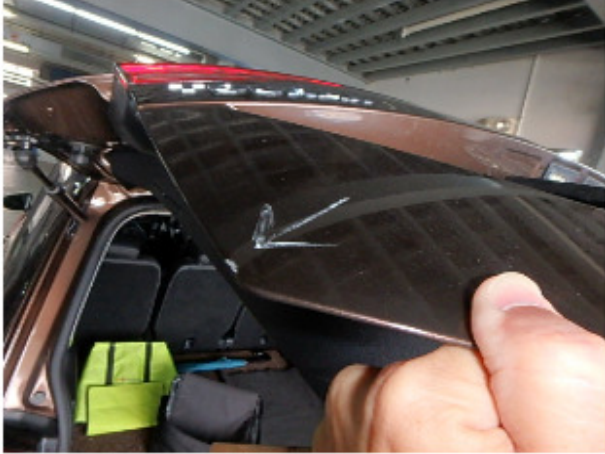
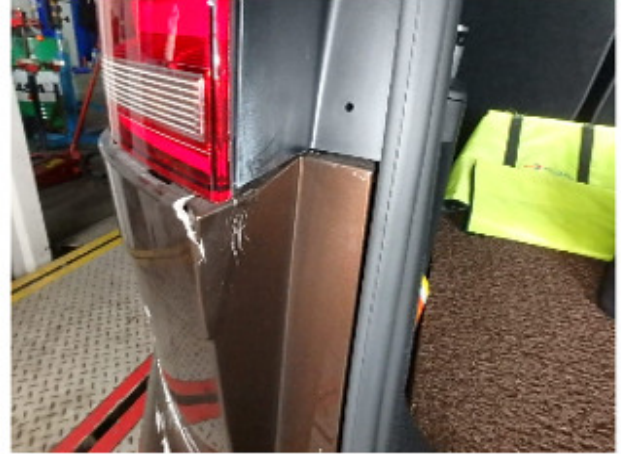
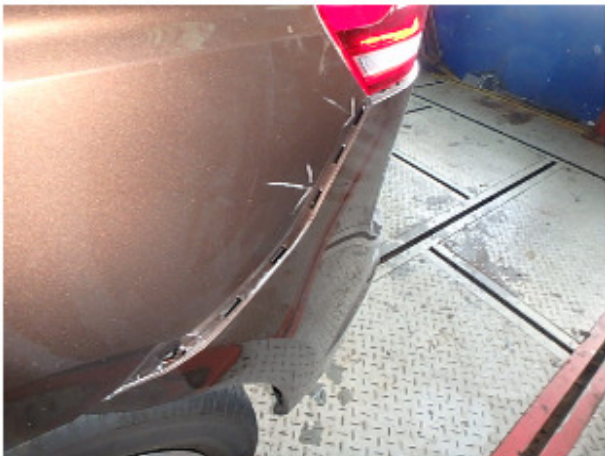
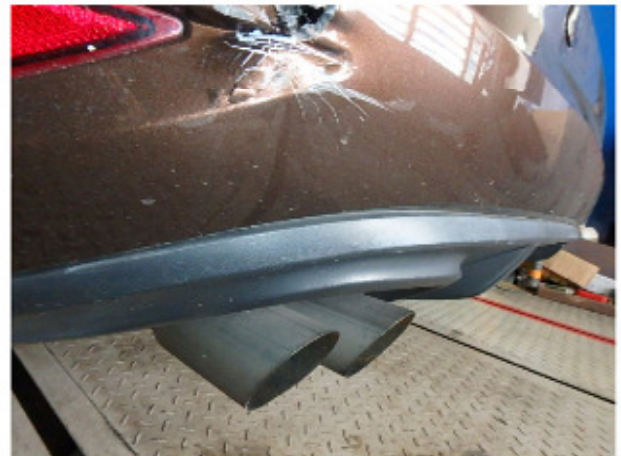
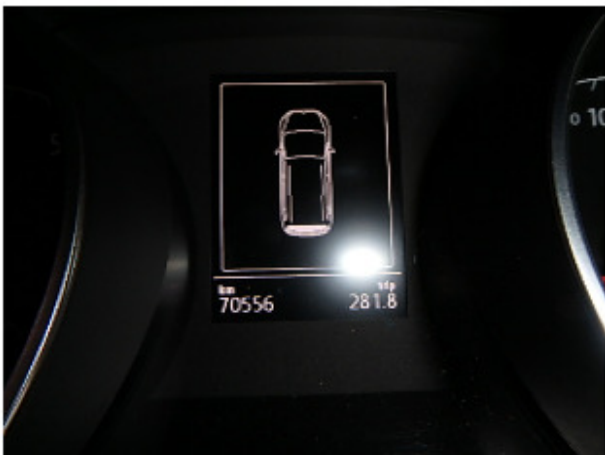
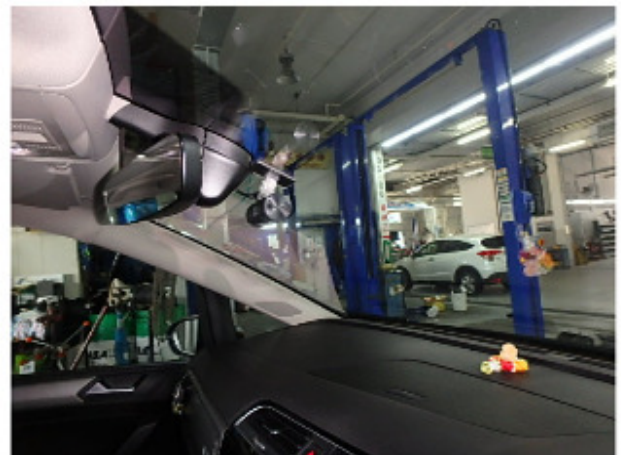
4. Description of Damages				
THE VEHICLE SUSTAINED DAMAGES AT THE REAR N/S PORTION. DAMAGES SEE DETAILS.				
5. General Information				
Accident Date	31/05/2020	Inspection Date	02/06/2020	
Survey held at	KUM CHEW MOTOR WORKSHOP 160 SIN MING DRIVE #05-08 SIN MING AUTOCITY SINGAPORE 575722			
5a. Remarks				
A)THE INSPECTION WAS CONDUCTED ON A"WITHOUT PREJUDICE" BASIS. B)IN ACCORDANCE TO YOUR INSTRUCTIONS, WE HAVE NOT AUTHORISED REPAIRS.				
5b. Estimate Days of Repair				
ESTIMATED NORMAL PERIOD FOR REPAIR:		3 Working Days

Qty	Description of Parts	Condition	Estimate By Workshop (\$)	Our Adjusted (\$)
	<u>REPLACEMENT OF PARTS</u>			
1	REAR BUMPER	CRACKED	721.50	721.50
1	REAR BUMPER REINFORCEMENT	BENT	319.20	319.20
1	REAR BUMPER SPONGE	SERVICEABLE	241.70	-
1	REAR BUMPER SIDE RETAINER-LH	DISTORTED	32.40	32.40
1	REAR BUMPER REFLECTOR-LH	SCRATCHED	63.40	63.40
1	REAR BUMPER LOWER GARNISH	SCRATCHED	381.60	381.60
	LESS 10% DISCOUNT		-175.98	-151.81
			1,583.82	1,366.29
	<u>SPECIAL NETT ITEMS</u>			
1	SET REAR REVERSE SENSOR (SN)	SERVICEABLE	280.00	-

280.00	-
	<u>LABOUR</u>			
	TO PULL,KNOCK ON REAR ACCIDENT PORTION & CHANGE THE ABOVE PARTS.		480.00	300.00
	TO SPRAY & PAINT ON REAR ACCIDENT PORTION.		580.00	450.00
	TO ANTI-RUST REAR AFFECTED AREAS.	NOT NECESSARY	60.00	-
	TO CHECK WIRING FUNCTIONS.		50.00	15.00
	TO DISMANTLE AND CHAGNE 1 SET REVERSE SENSOR.		50.00	50.00
			1,220.00	815.00
	GRAND TOTAL		3,083.82	2,181.29
	RECOMMENDED COST OF LUMP SUM REPAIRS (TO ITS PRE-ACCIDENT CONDITION)			1,750.00
