LKK Auto Consultants Pte Ltd

ADJUSTMENT ON REPAIR COST FOR VEHICLE NO. SHD 321H

PHOTOGRAPHS FOR VEHICLE NO. SHD 321H

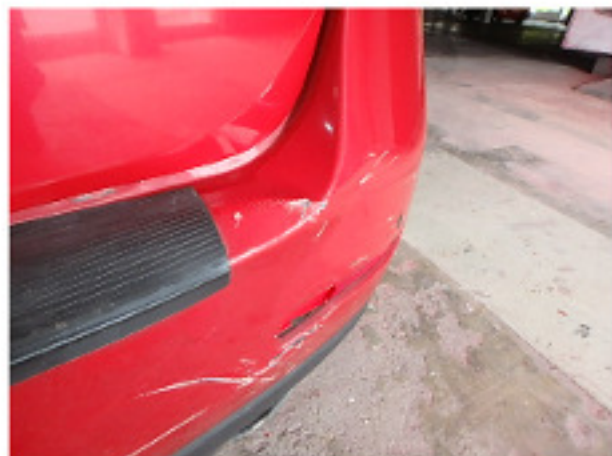
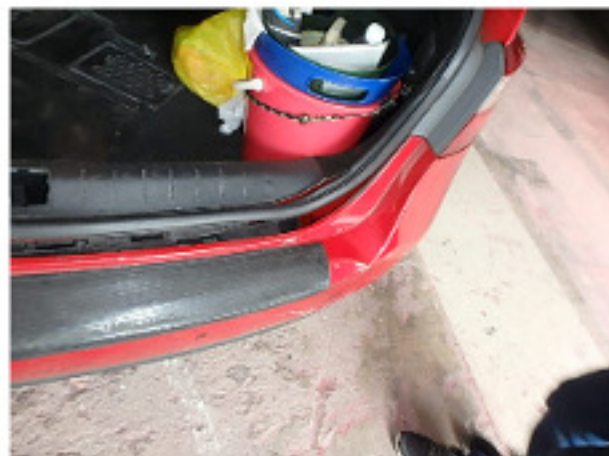
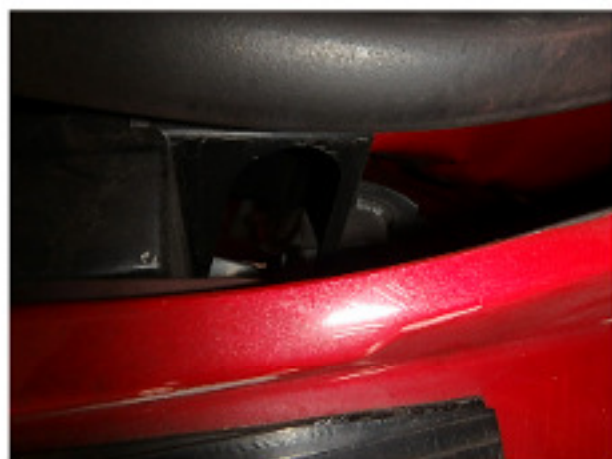
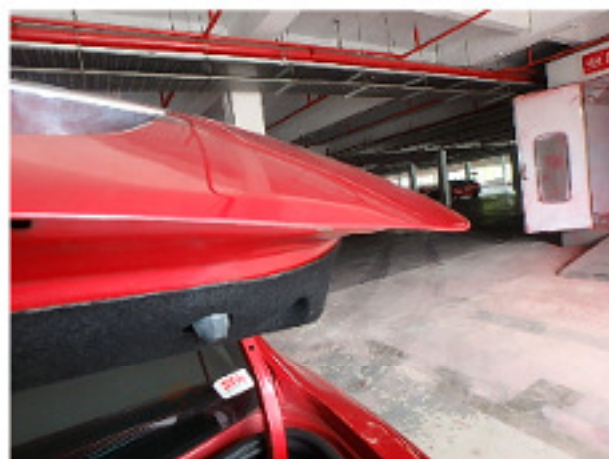
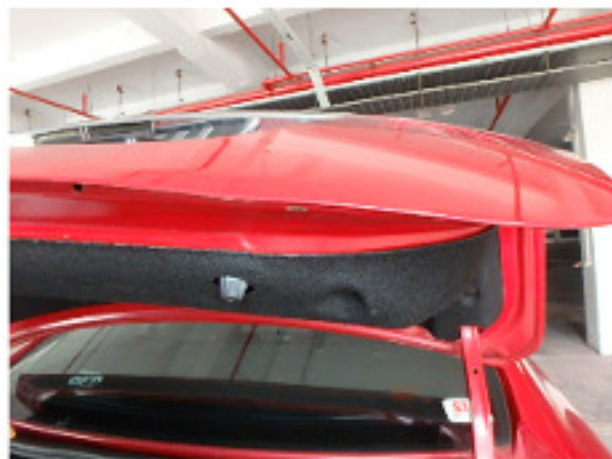
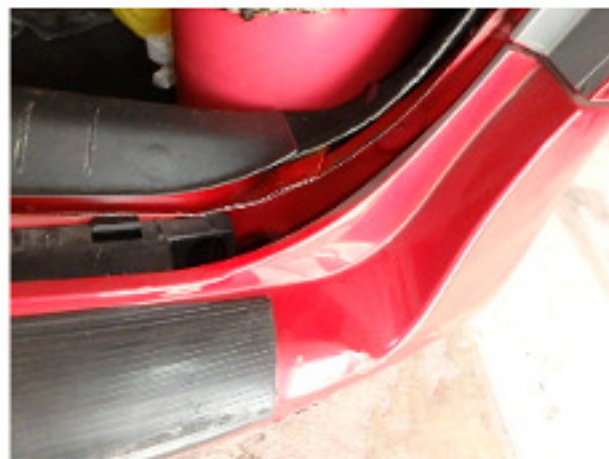
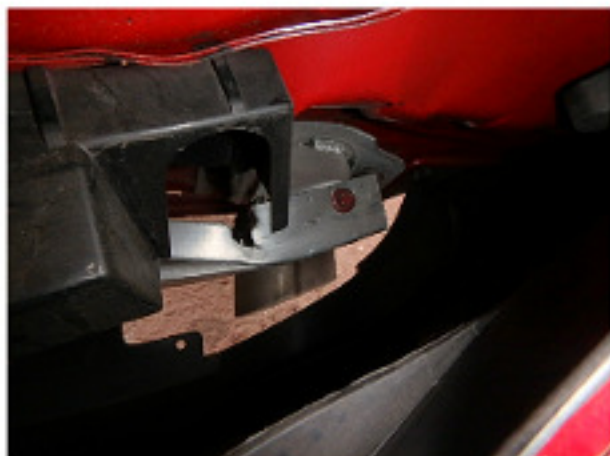
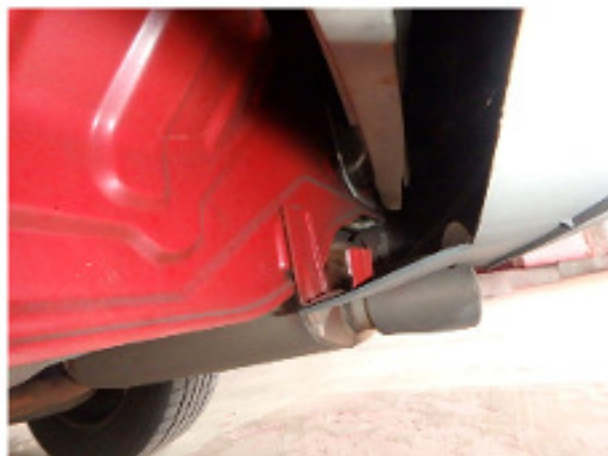
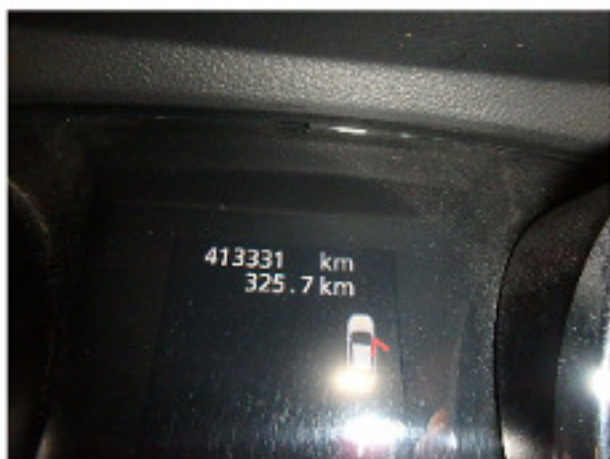
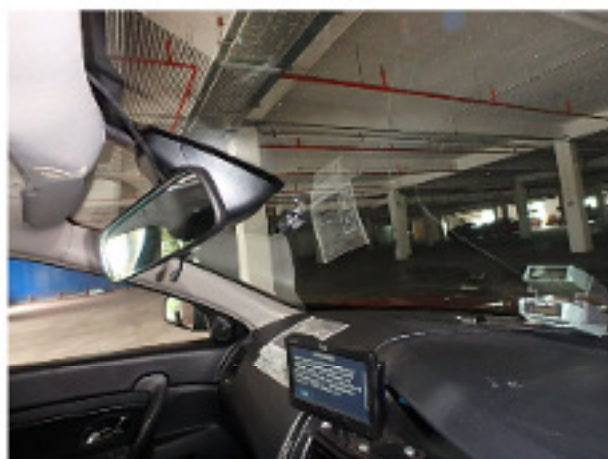
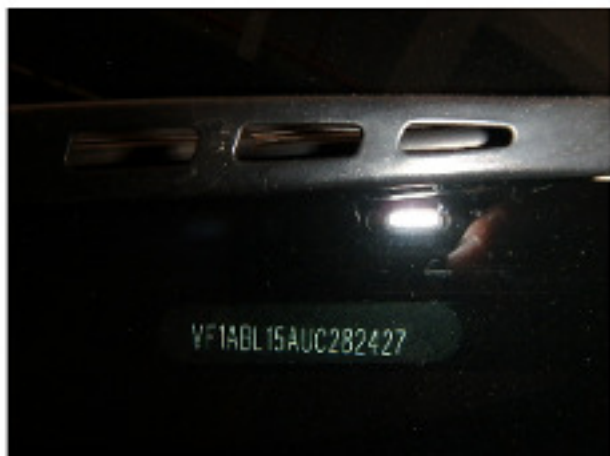
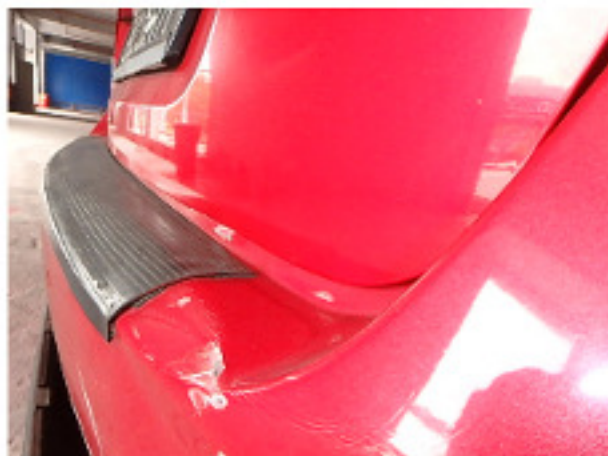
4. Description of Damages				
THE VEHICLE SUSTAINED DAMAGES AT THE REAR O/S PORTION. DAMAGES SEE DETAILS.				
5. General Information				
Accident Date	15/06/2020	Inspection Date	16/06/2020	
Survey held at	TRANS-CAB AUTO SERVICES PTE LTD NO.2 ANG MO KIO ST 63 SINGAPORE 569111			
5a. Remarks				
A)THE INSPECTION WAS CONDUCTED ON A"WITHOUT PREJUDICE" BASIS. B)IN ACCORDANCE TO YOUR INSTRUCTIONS, WE HAVE NOT AUTHORISED REPAIRS.				
5b. Estimate Days of Repair				
ESTIMATED NORMAL PERIOD FOR REPAIR:		4 Working Days
