Your Ref: TP/IP/25501/2020  
Our Ref : CI/TPD20006671/D

31 August 2020

**Fatal Accident Investigation Team**

**AUTOMOBILE TECHNICAL INSPECTION REPORT OF POLICE HEARSE YN 3128B**

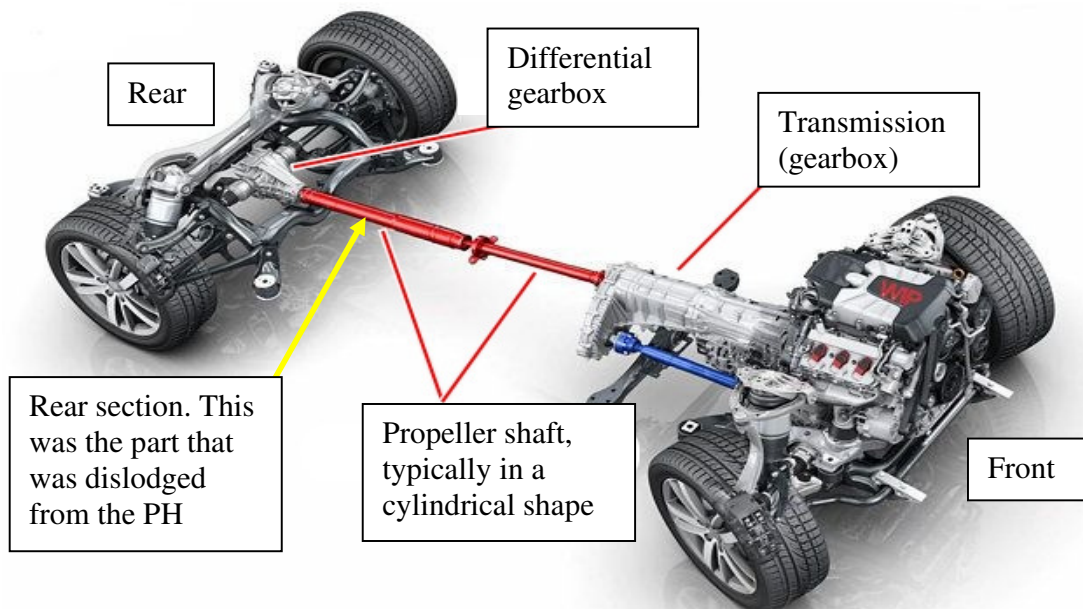
**Photo 10** shows an illustration of a typical propeller shaft. The propeller shaft (coloured in red) connects the transmission (gearbox) at the front to the differential gearbox at the rear of a vehicle. The power from the transmission, rotates the propeller shaft, which in turn rotates the gears inside the differential gearbox, giving the drive to the wheels at the rear axle of a vehicle. As seen from the illustration, the propeller shaft is typically cylindrical shaped. The part that was dislodged from the PH is the propeller shaft rear section (highlighted by the yellow arrow).

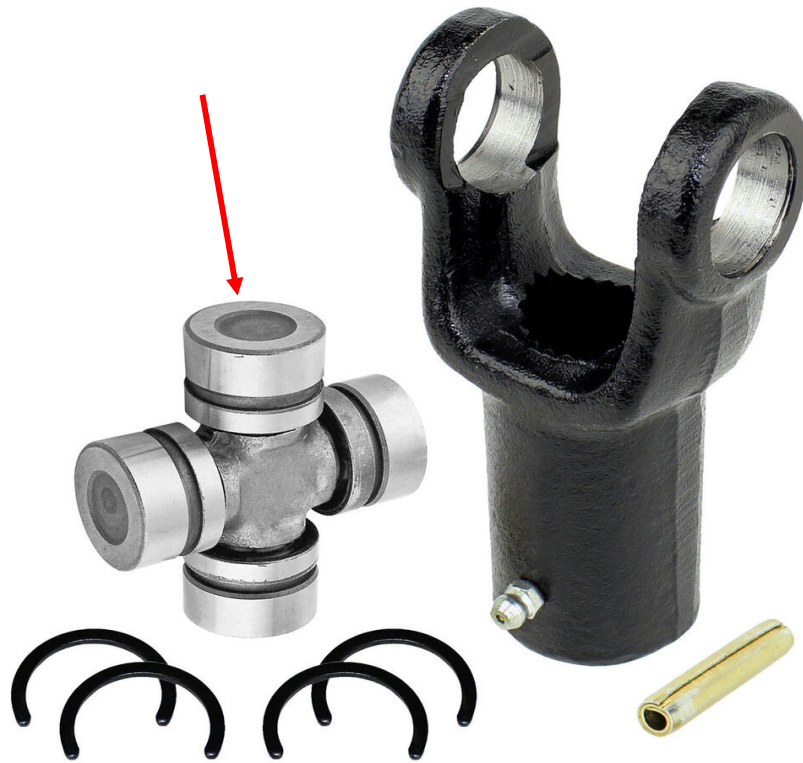
**Photo 16** shows a typical “U” joint (arrowed) that is used for propeller shafts amongst other things.
