# UNITED Appraisal And Management Pte Ltd

**Re : Third Party Claim For Vehicle Registration No. SKV7585L**

## VEHICLE INSPECTION REPORT

Registration no.	: SKV7585L	Odometer	: 176457 km
Make / Model	: Honda Vezel 1.5X CVT	Chassis no.	: RU11102032
Regn. date	: 30 Sep 2015	Engine no.	: L15B4022033
Body colour	: Black	Engine cap.	: 1496 cc

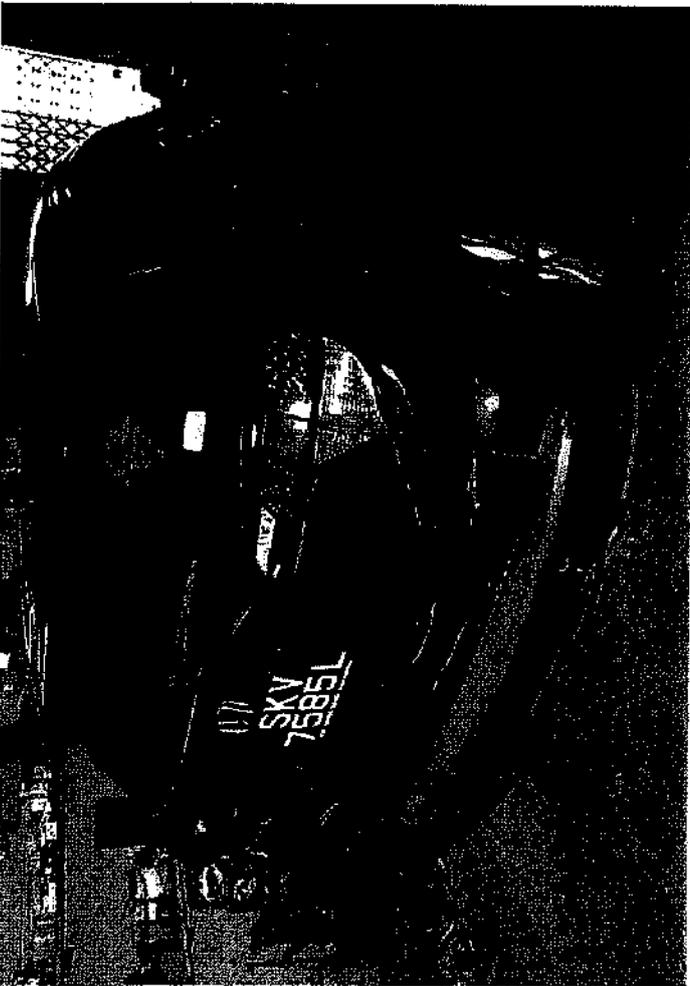
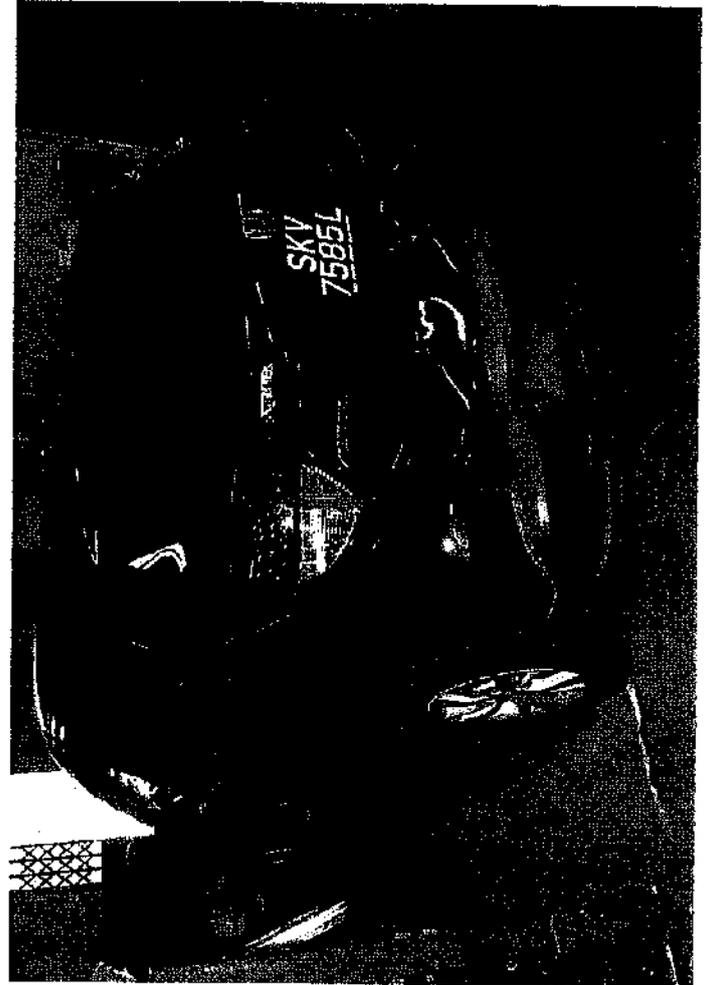
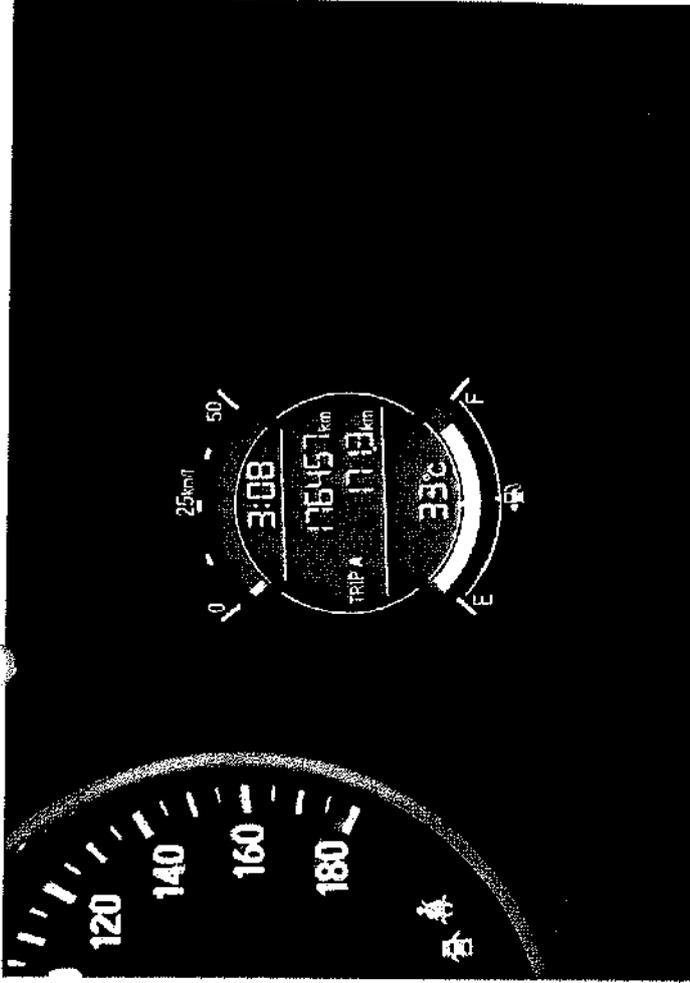
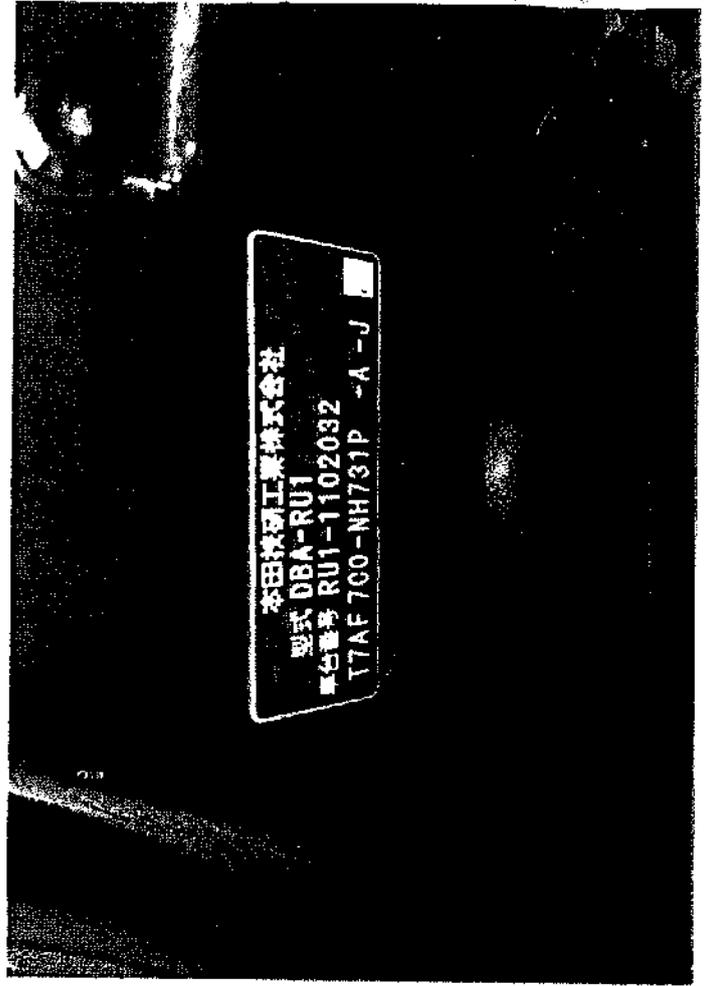
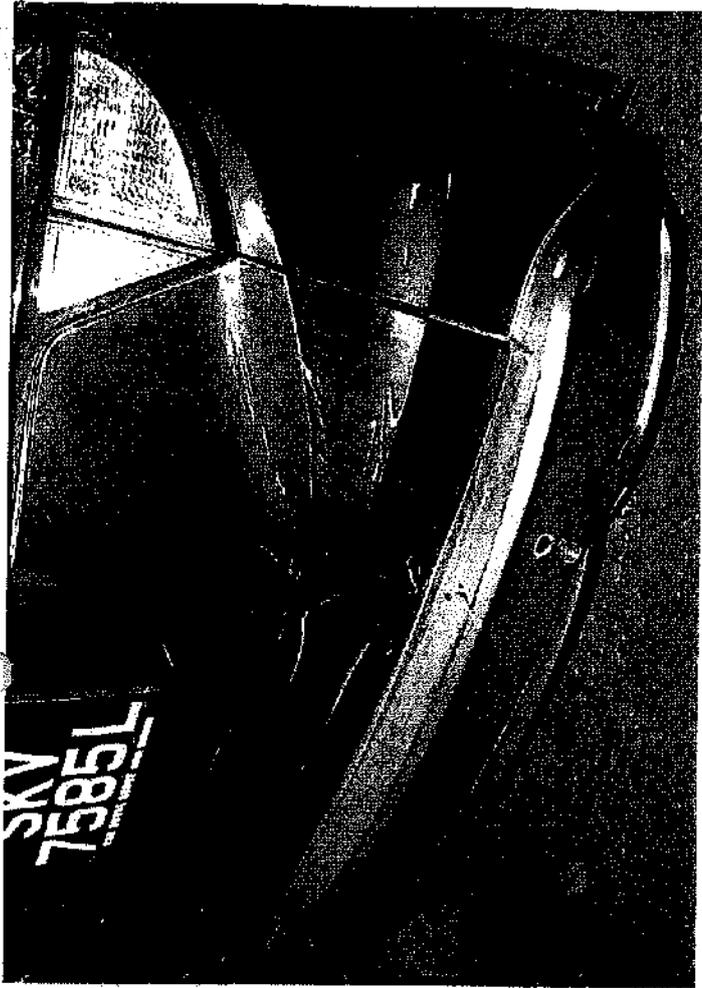
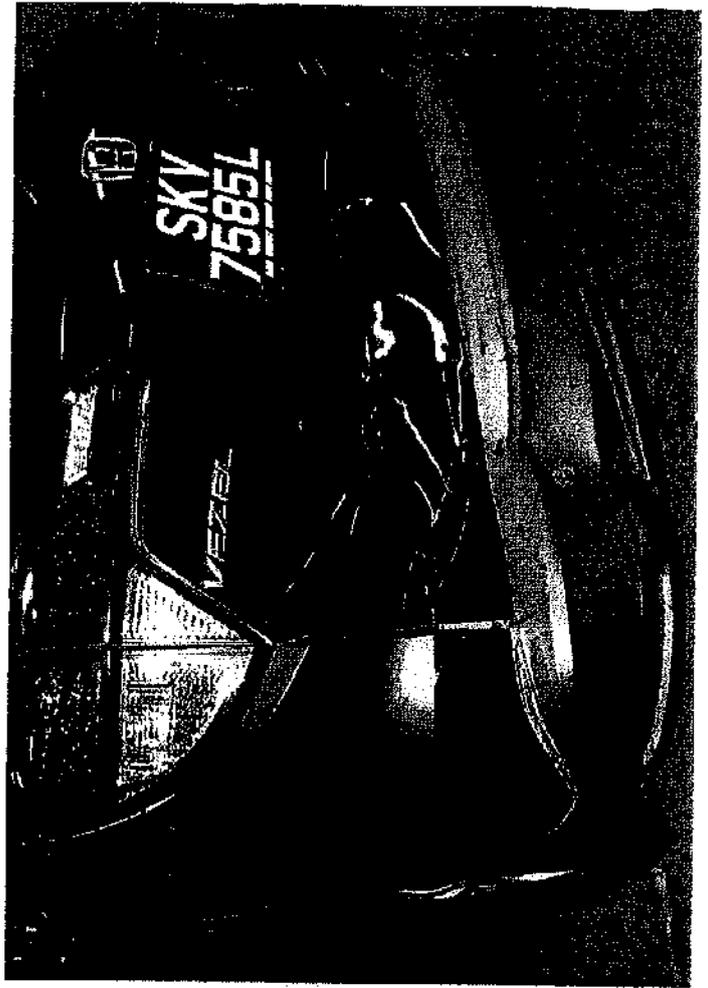
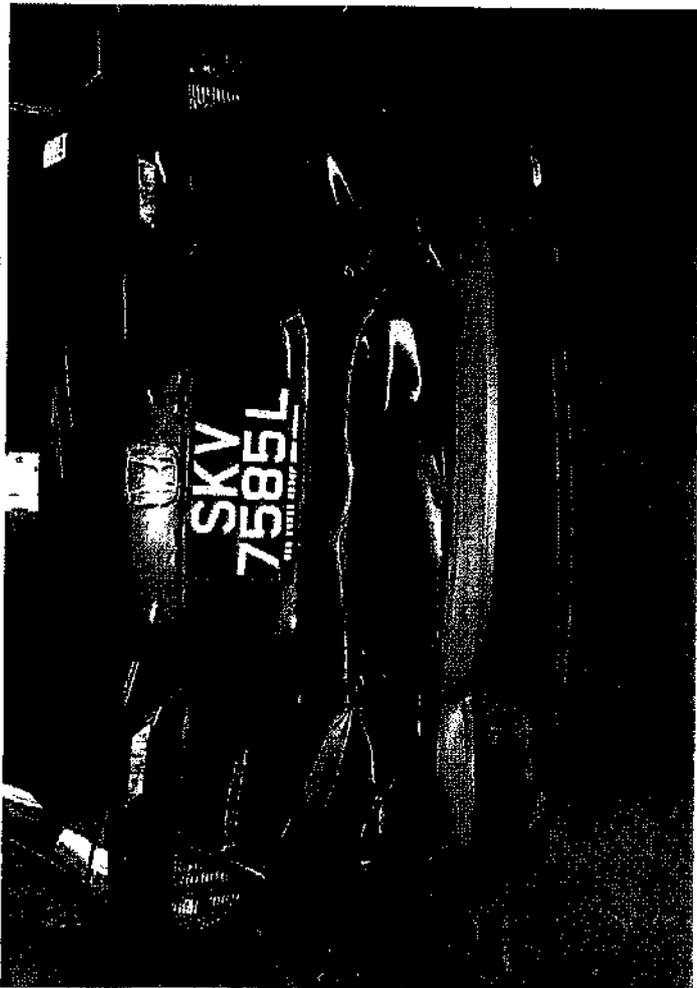
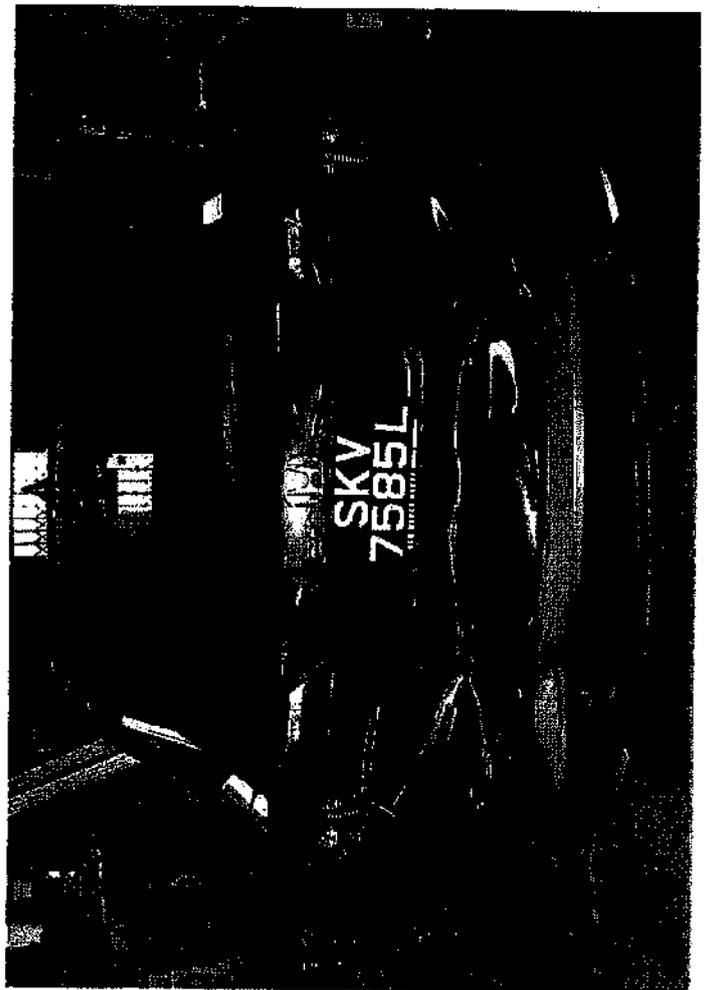
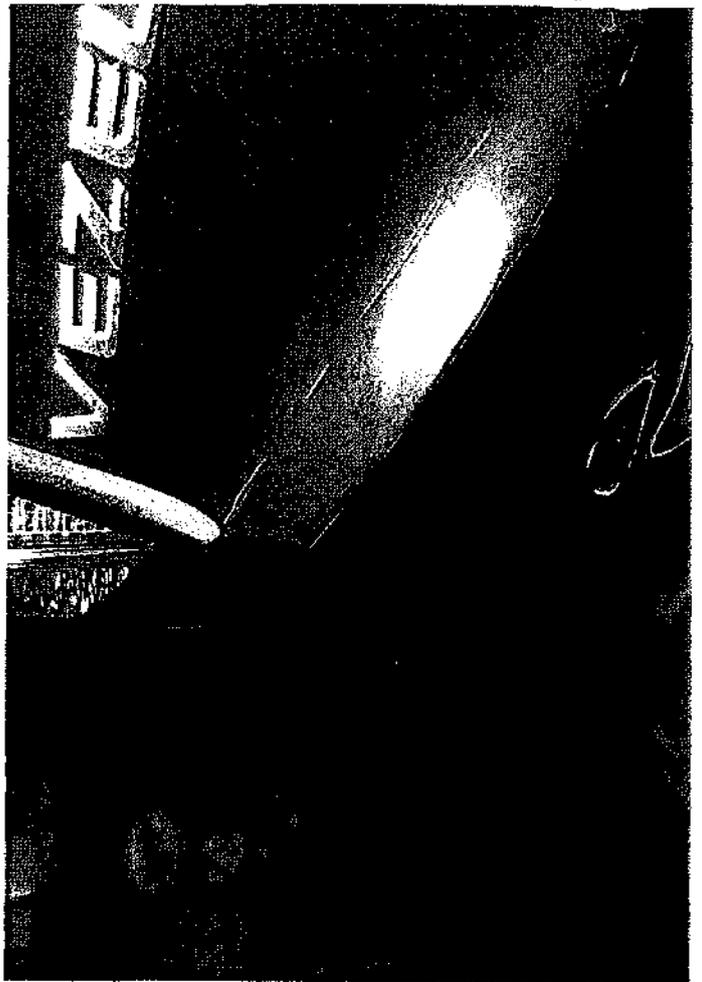
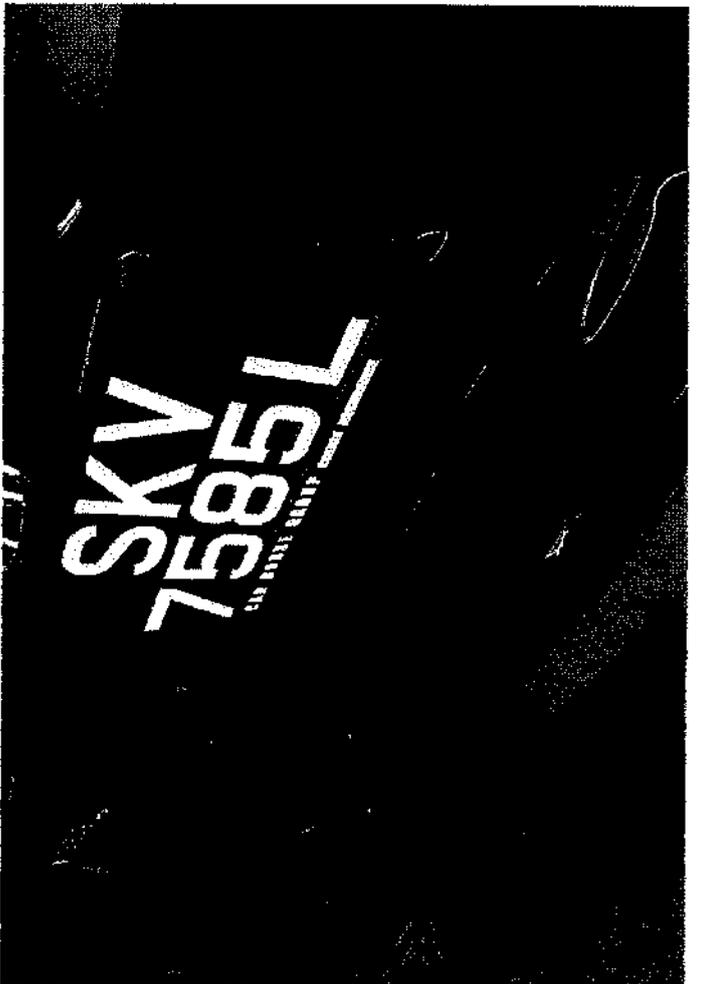
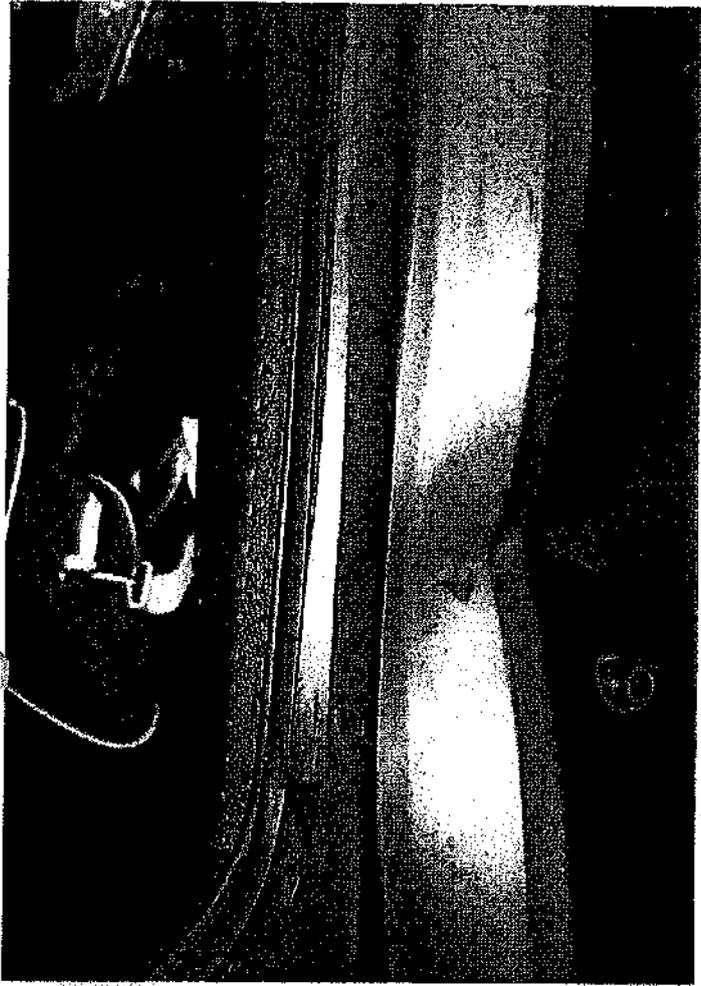
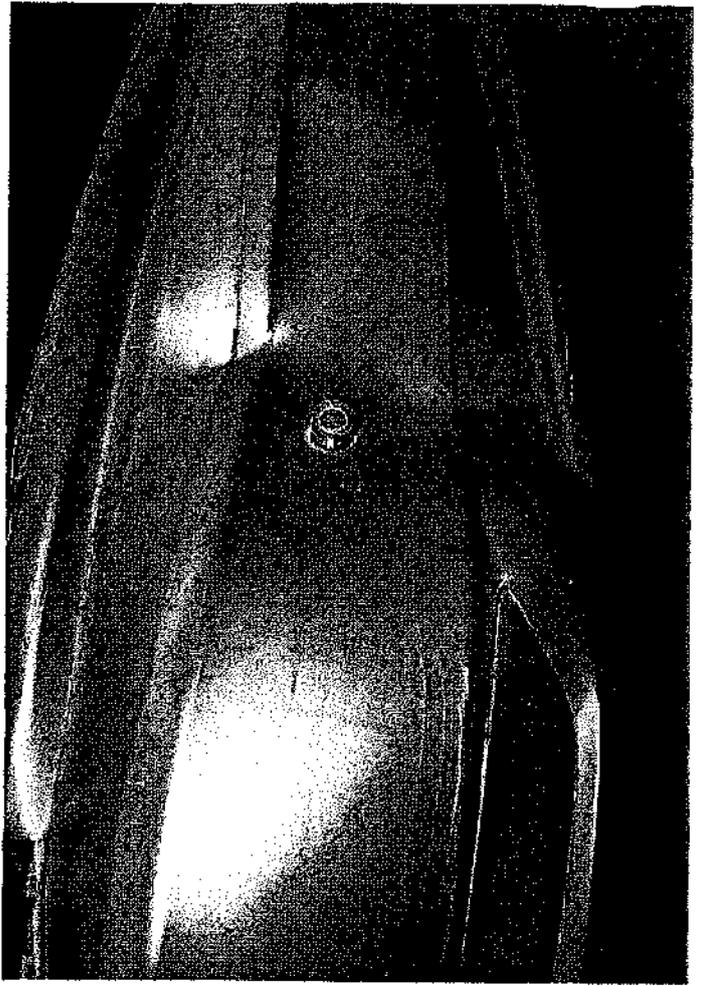
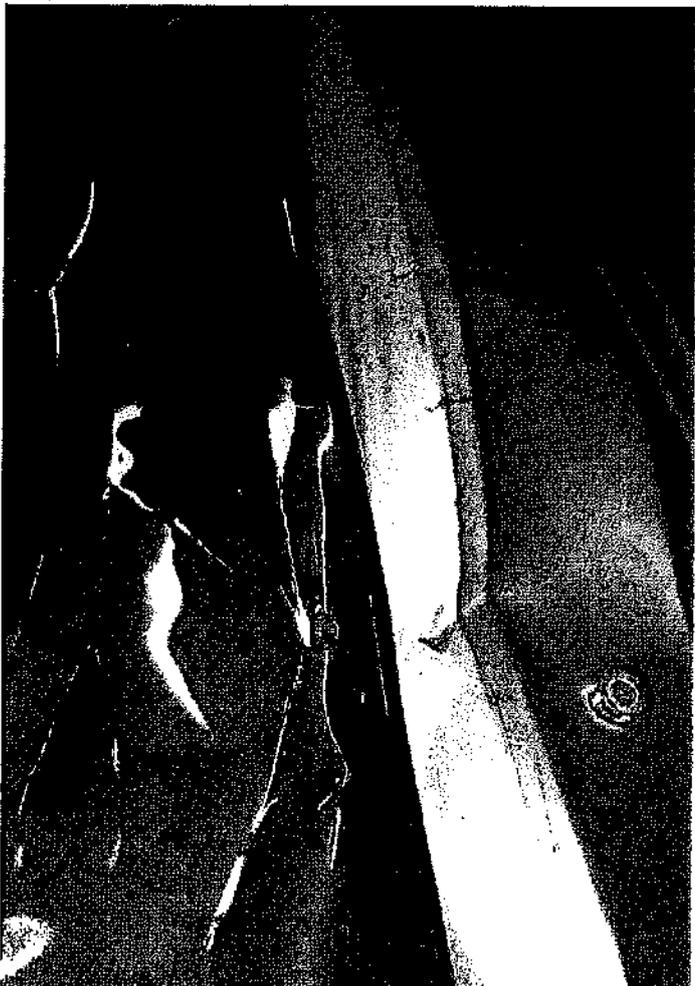
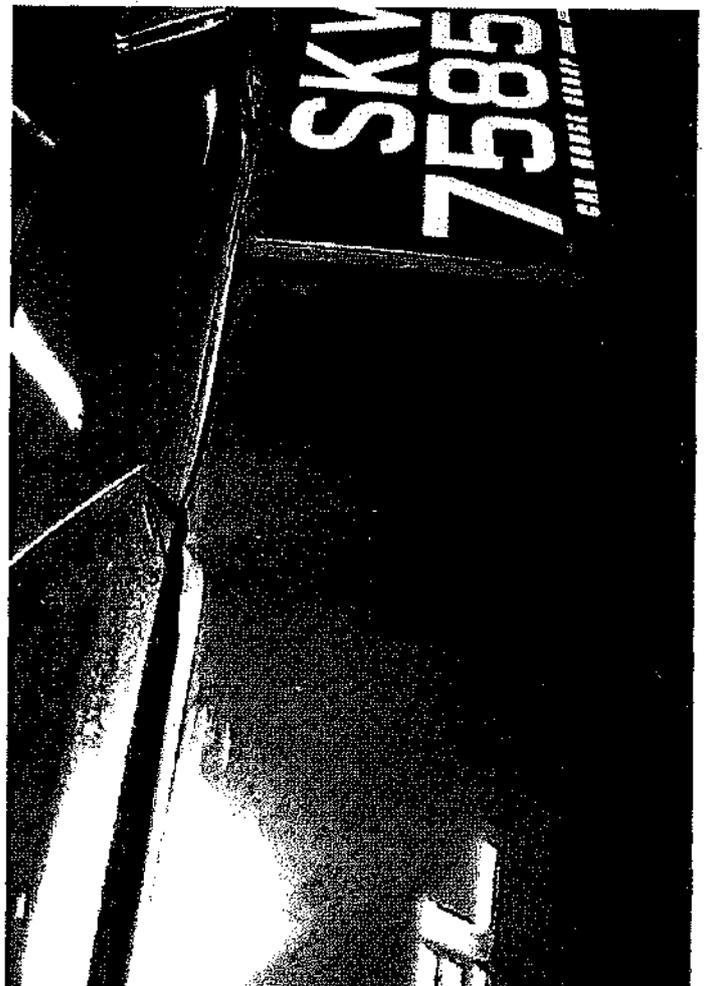
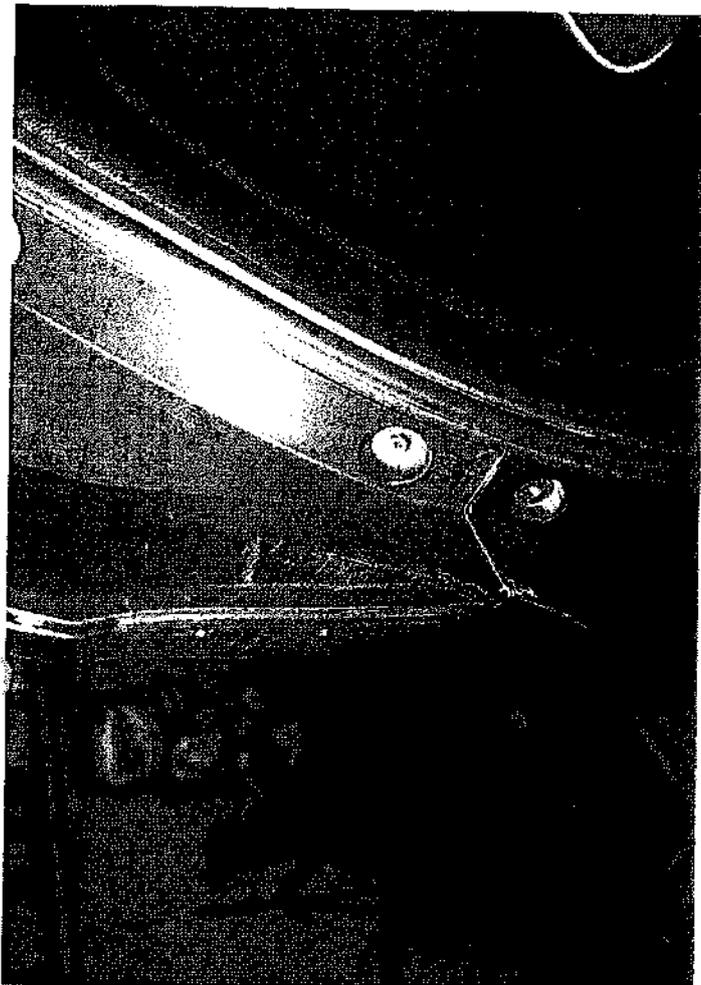
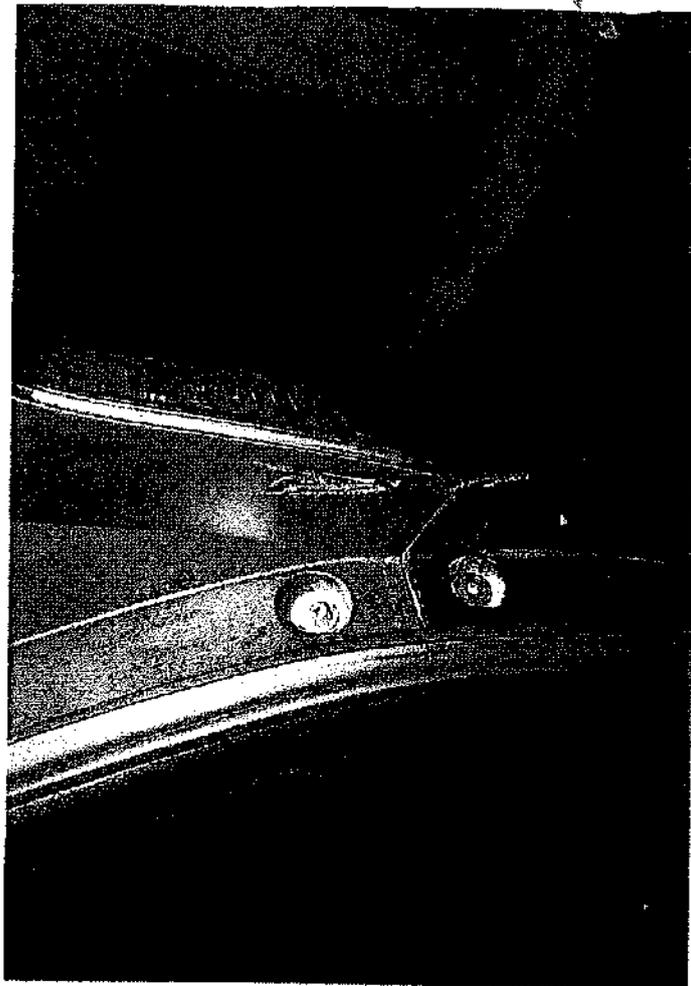
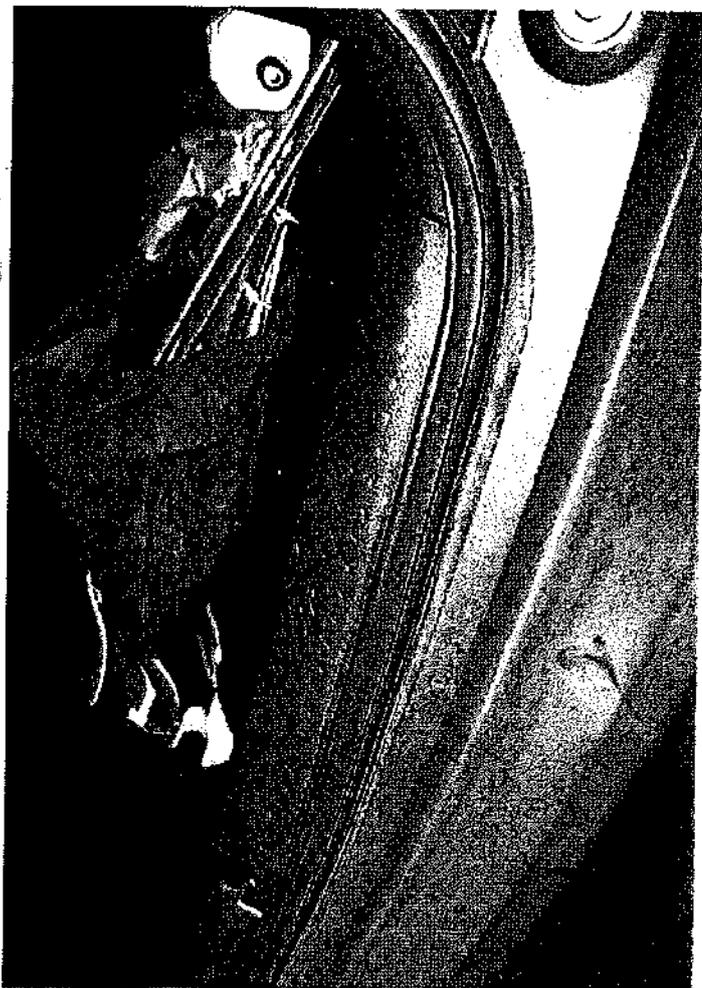
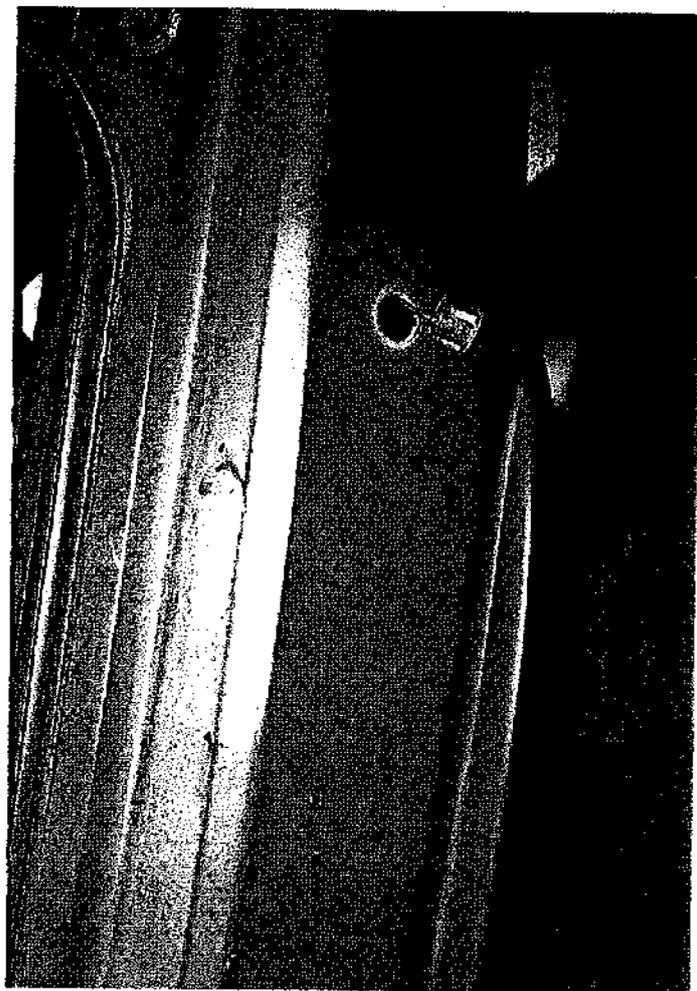
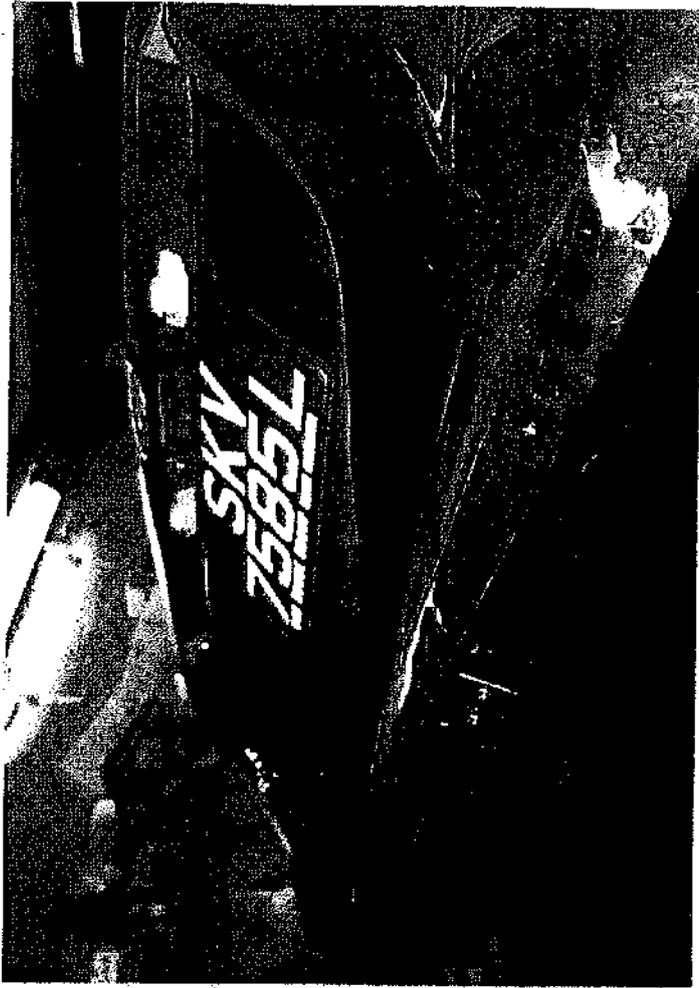
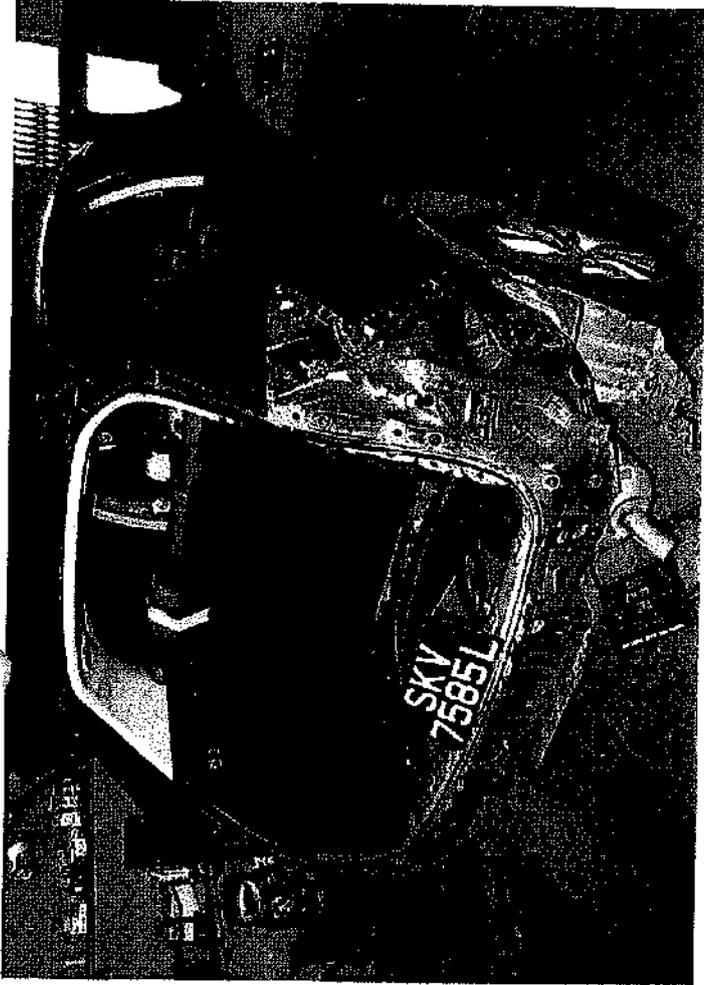
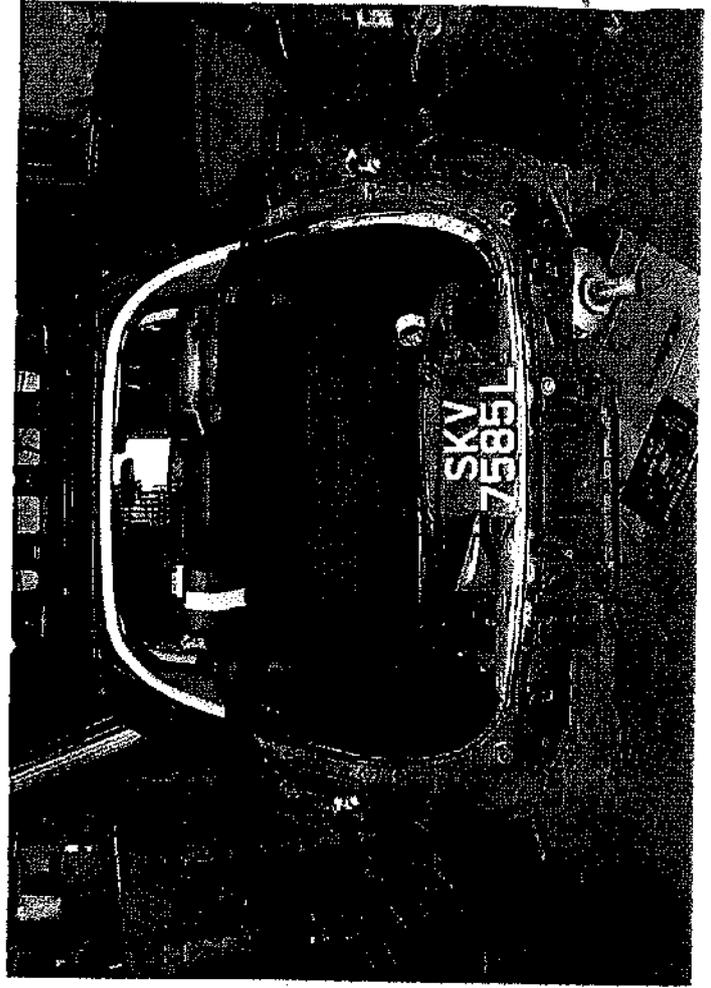
The impact of the collision has damaged / affected the tailgate, taillamp, rear bumper, rear end panel, rear fender and etc...
