Vehicle No. SHB 9800T  
Insured Veh. SHA 8810B  
Claim No. D20002710MFSH  
Policy No. D-18088937MFSH  
Accident Date 05/07/2020  
Inspection Date 07/07/2020

## LKK Auto Consultants Pte Ltd

### ADJUSTMENT ON REPAIR COST FOR VEHICLE NO. SHB 9800T

PHOTOGRAPHS FOR VEHICLE NO. SHB 9800T

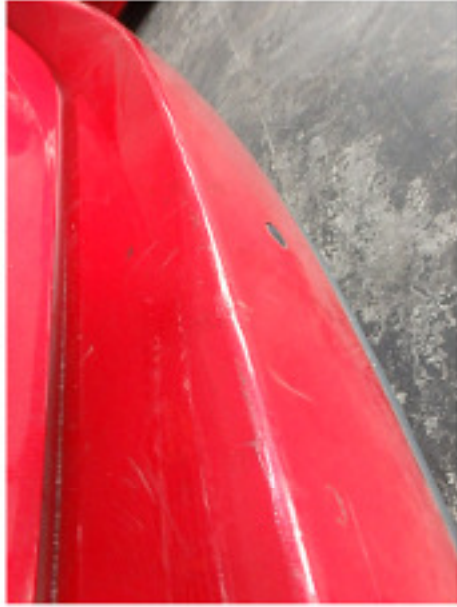
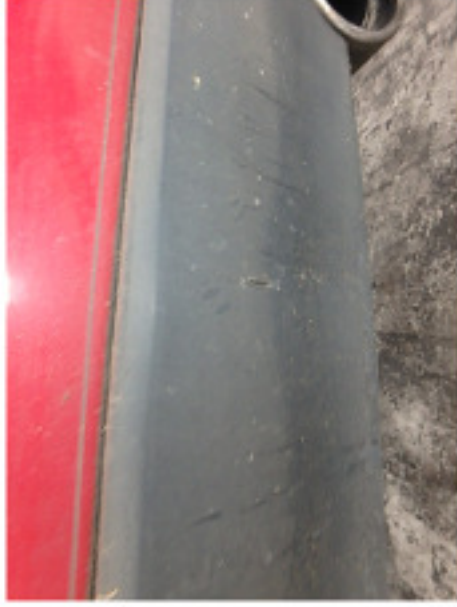
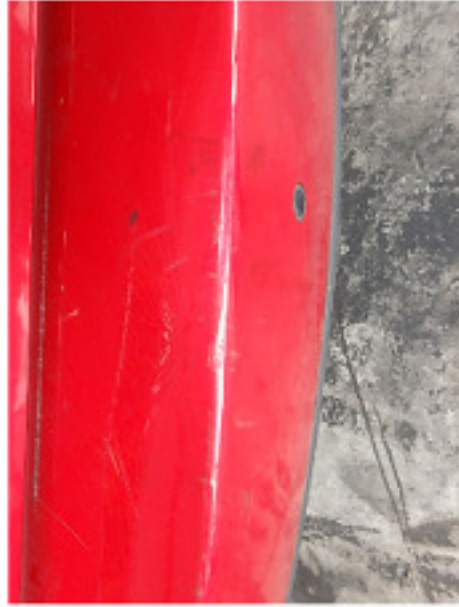
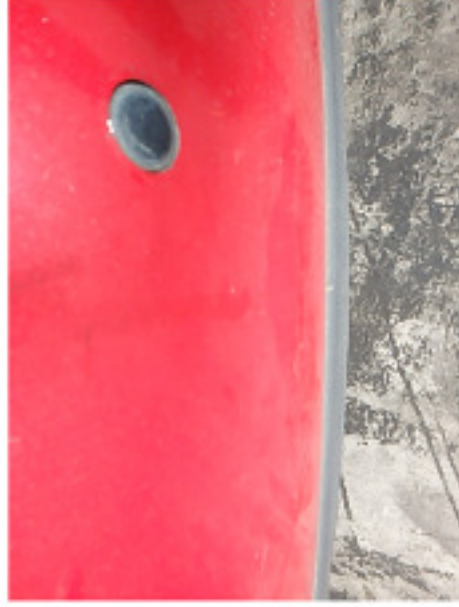
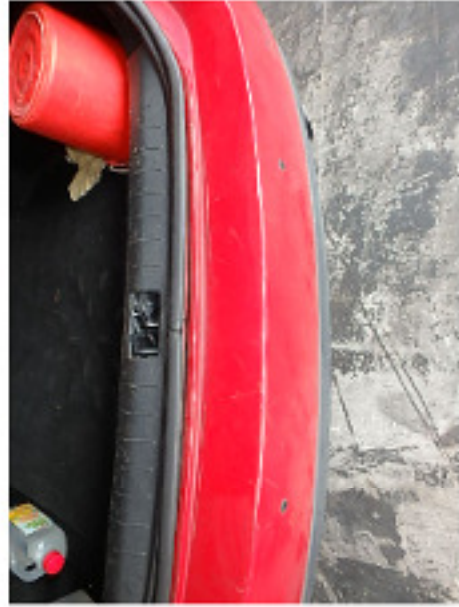
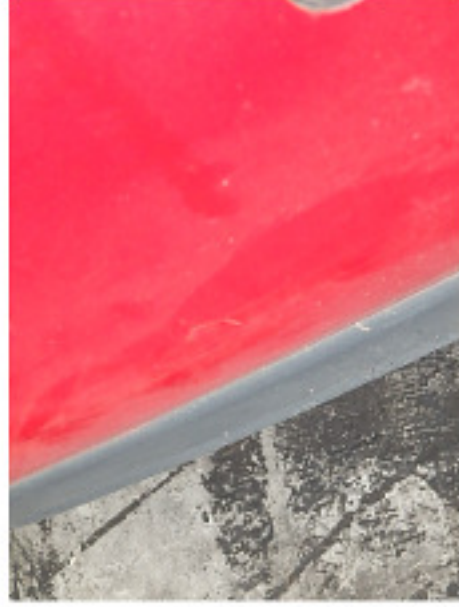
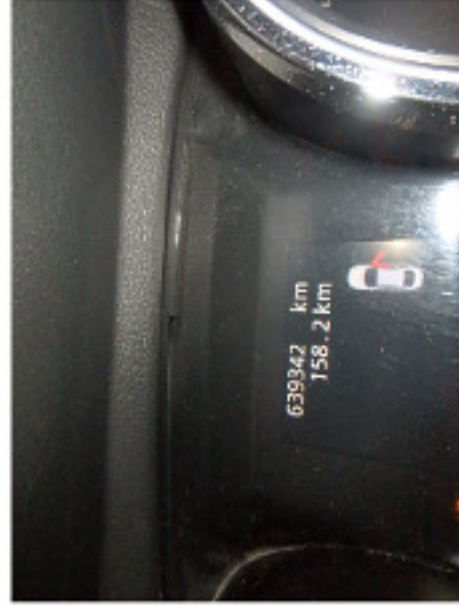
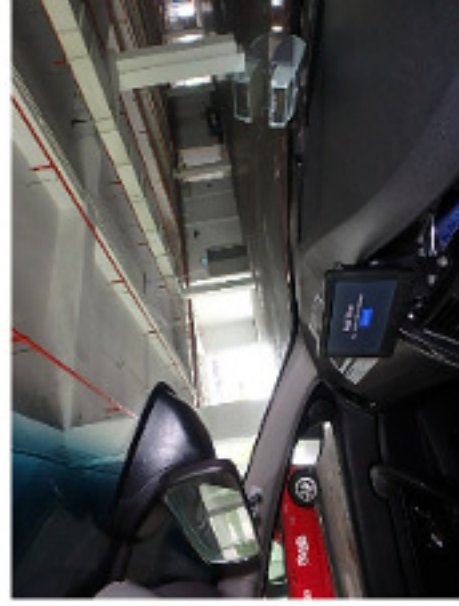
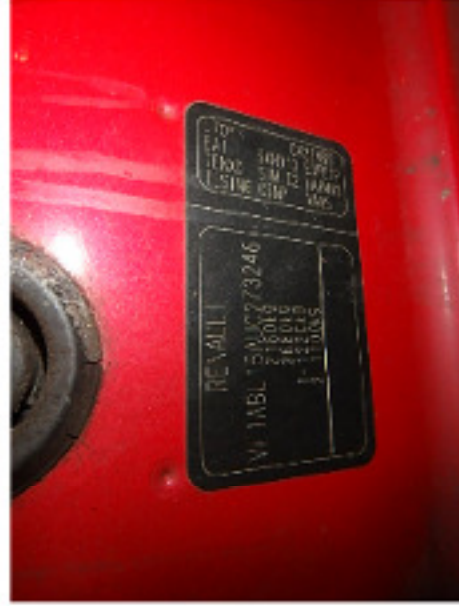
<b>4. Description of Damages</b>				
THE VEHICLE SUSTAINED DAMAGES AT THE REAR PORTION. DAMAGES SEE DETAILS.				
<b>5. General Information</b>				
Accident Date	05/07/2020	Inspection Date	07/07/2020	
Survey held at	TRANS-CAB AUTO SERVICES PTE LTD NO.2 ANG MO KIO ST 63 SINGAPORE 569111			
<b>5a. Remarks</b>				
A)THE INSPECTION WAS CONDUCTED ON A"WITHOUT PREJUDICE" BASIS. B)IN ACCORDANCE TO YOUR INSTRUCTIONS, WE HAVE NOT AUTHORISED REPAIRS.				
<b>5b. Estimate Days of Repair</b>				
ESTIMATED NORMAL PERIOD FOR REPAIR:		<b>2 Working Days</b>
