LKK Auto Consultants Pte Ltd

Vehicle No. SHD 230L
Insured Veh. SHA 9329T
Claim No. D20002875MFSH
Policy No.
Accident Date 11/07/2020
Inspection Date 14/07/2020

ADJUSTMENT ON REPAIR COST FOR VEHICLE NO. SHD 230L

PHOTOGRAPHS FOR VEHICLE NO. SHD 230L

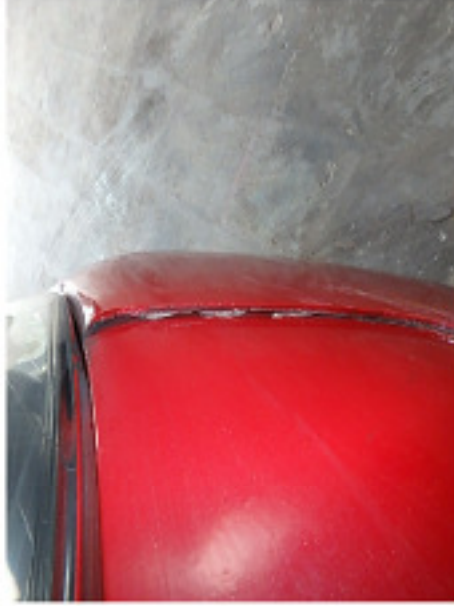
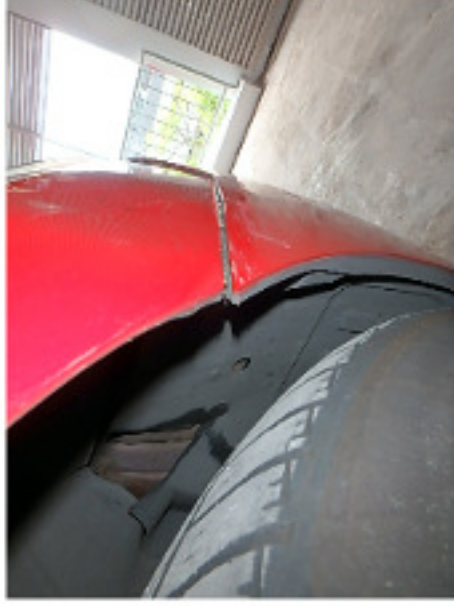
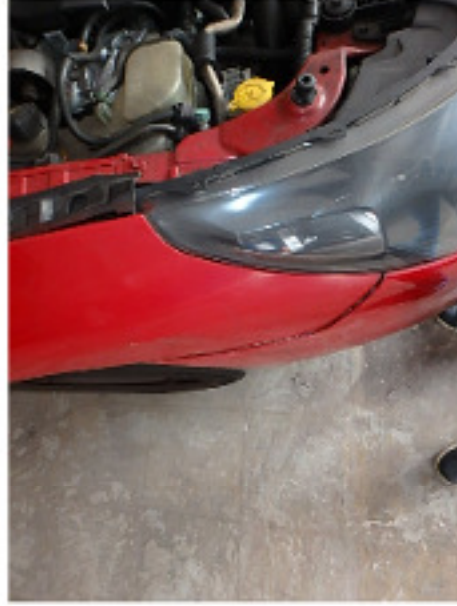
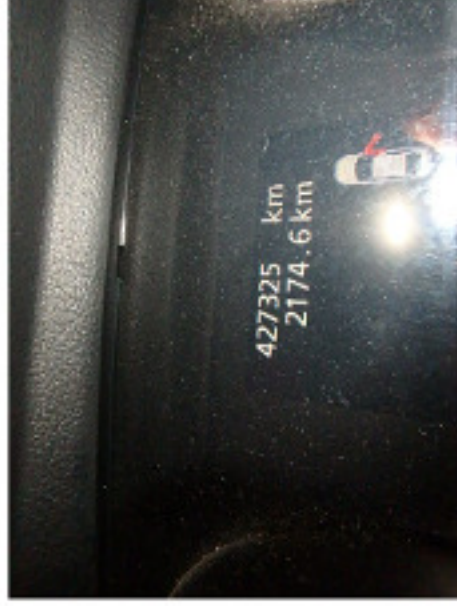
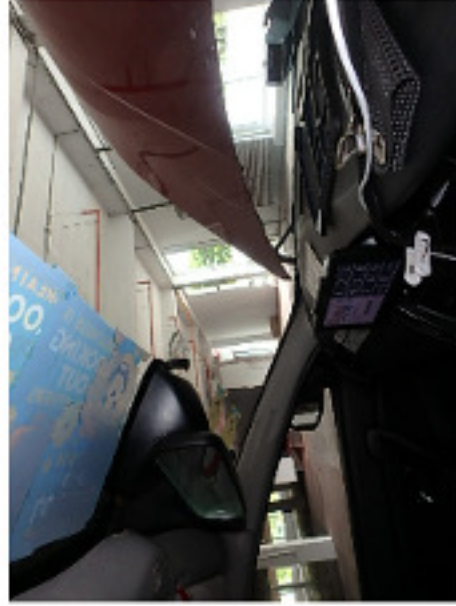
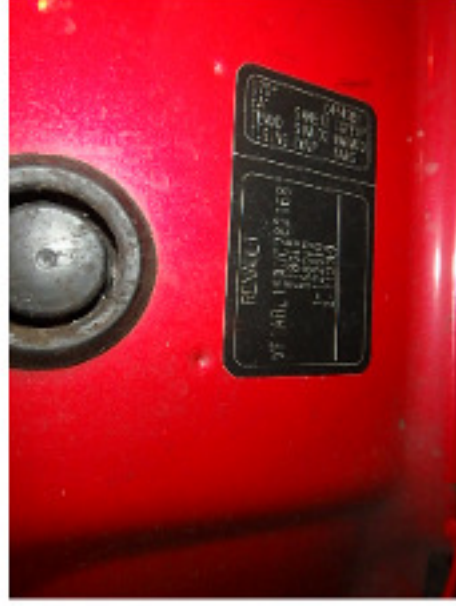
4. Description of Damages				
THE VEHICLE SUSTAINED DAMAGES AT THE O/S FRONT PORTION. DAMAGES SEE DETAILS.				
5. General Information				
Accident Date	11/07/2020	Inspection Date	14/07/2020	
Survey held at	TRANS-CAB AUTO SERVICES PTE LTD NO.2 ANG MO KIO ST 63 SINGAPORE 569111			
5a. Remarks				
A)THE INSPECTION WAS CONDUCTED ON A"WITHOUT PREJUDICE" BASIS. B)IN ACCORDANCE TO YOUR INSTRUCTIONS, WE HAVE NOT AUTHORISED REPAIRS.				
5b. Estimate Days of Repair				
ESTIMATED NORMAL PERIOD FOR REPAIR:		2 Working Days
