## LKK Auto Consultants Pte Ltd

Affiliated to Federation Internationale Des Experts En Automobile				
CHINA TAIPING INSURANCE (S) PTE LTD		Ref : CC6/CTI20007512/Kks3q2		
3 ANSON ROAD #16-00 SPRINGLEAF TOWERS SINGAPORE 079909		Date : 19-10-2020

## ADJUSTMENT ON REPAIR COST FOR VEHICLE NO. SJZ 7866S

PHOTOGRAPHS FOR VEHICLE NO. SJZ 7866S

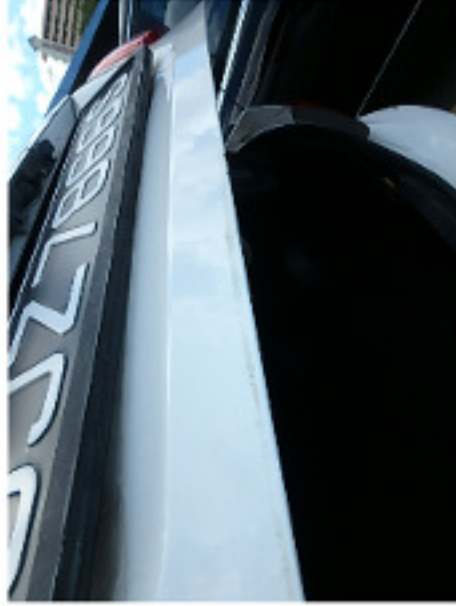
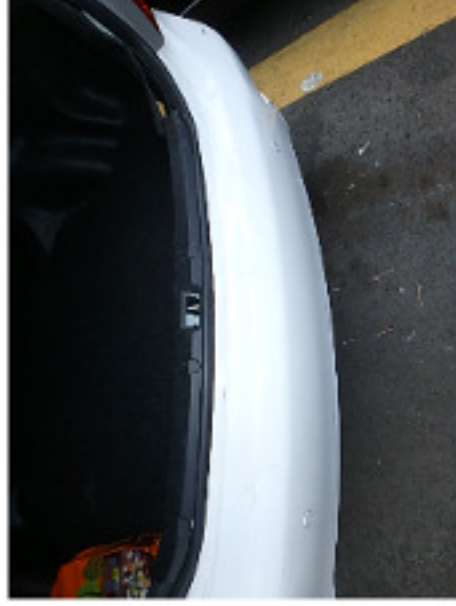
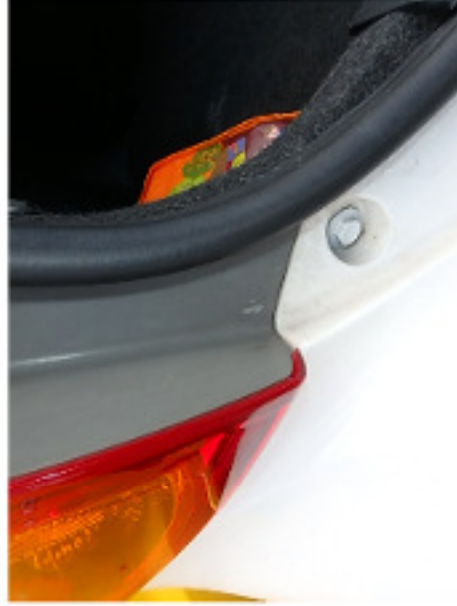
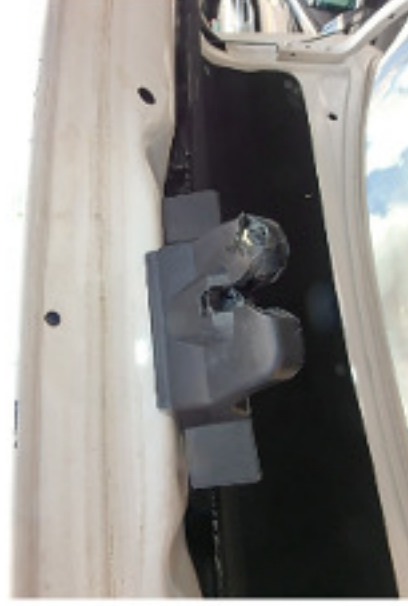
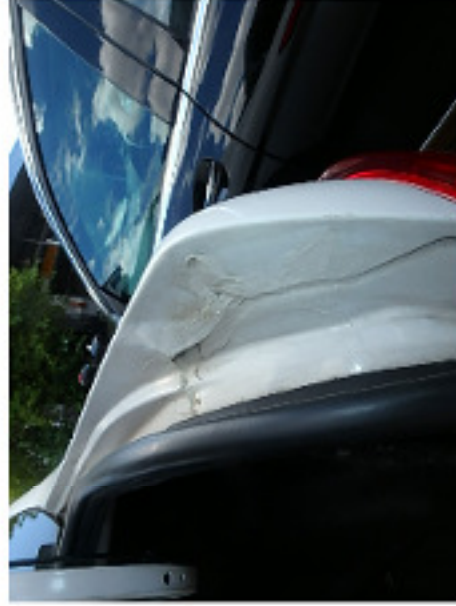
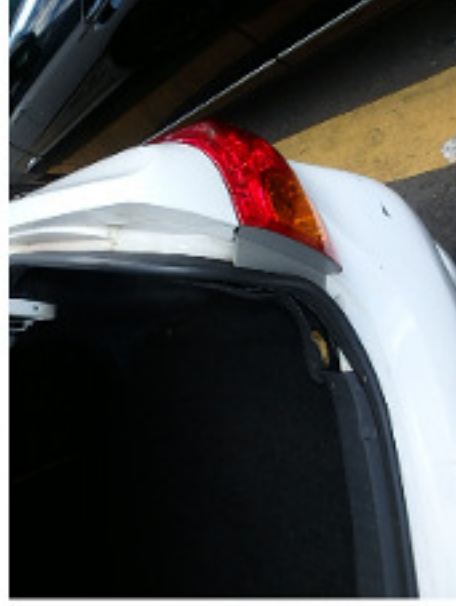
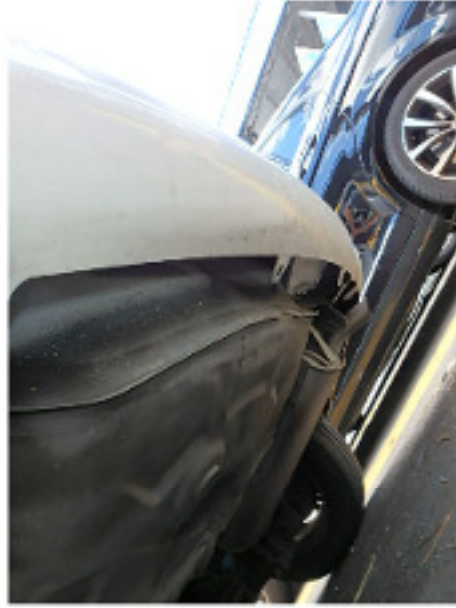
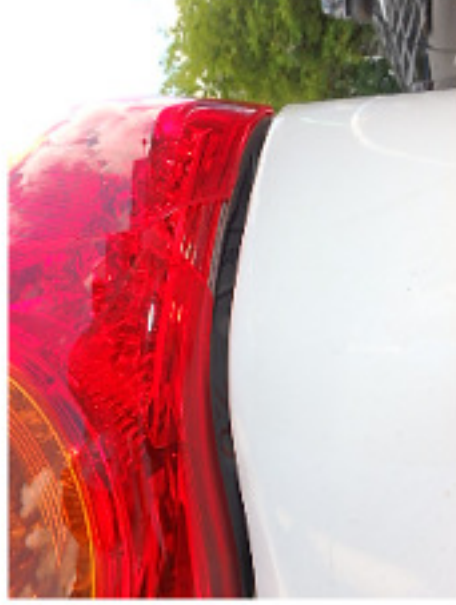
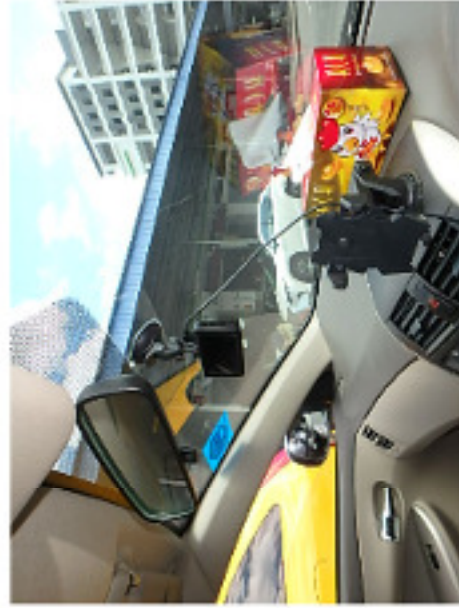
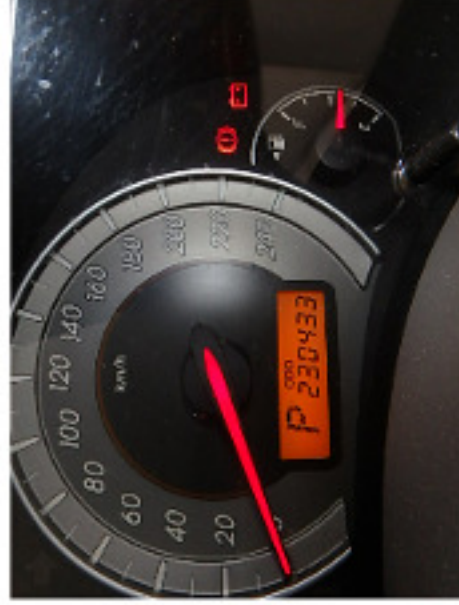
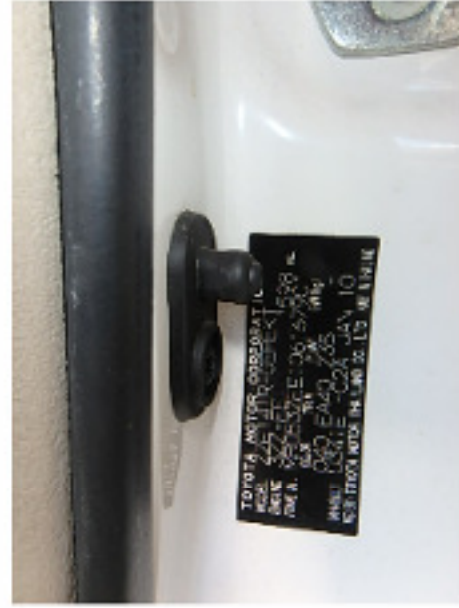
<b>4. Description of Damages</b>				
THE VEHICLE SUSTAINED DAMAGES AT THE REAR PORTION.				
DAMAGES SEE DETAILS.				
<b>5. General Information</b>				
Accident Date	20/07/2020	Inspection Date	21/07/2020	
Survey held at	WEI LEE MOTOR WORKS BLOCK 9 SIN MING INDUSTRIAL ESTATE #01-32 SINGAPORE 575644.			
<b>5a. Remarks</b>
