LKK Auto Consultants Pte Ltd

Vehicle No. SKX 8326B
Insured Veh. SH 9370E
Claim No. D20003272MFSH
Policy No. D-18088937MFSH
Accident Date 15/08/2020
Inspection Date 21/09/2020

ADJUSTMENT ON REPAIR COST FOR VEHICLE NO. SKX 8326B

PHOTOGRAPHS FOR VEHICLE NO. SKX 8326B

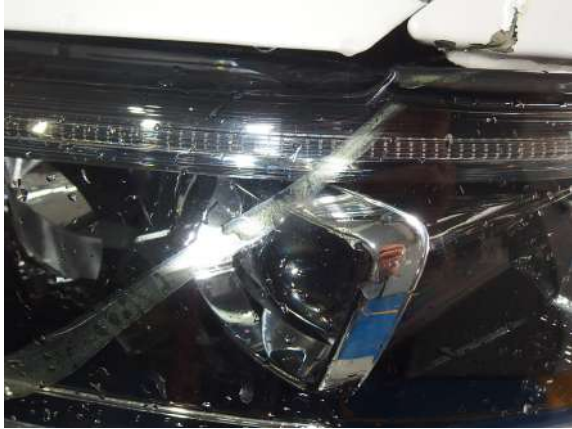
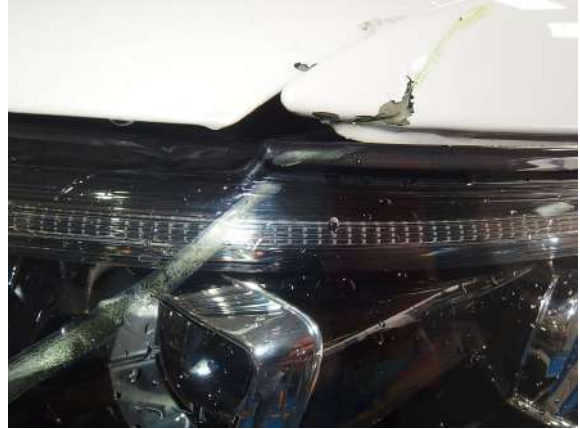
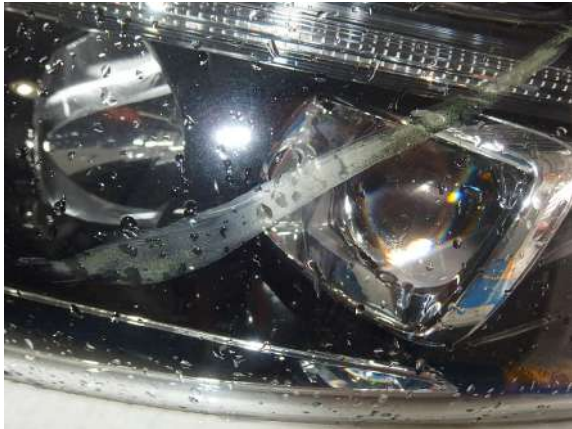
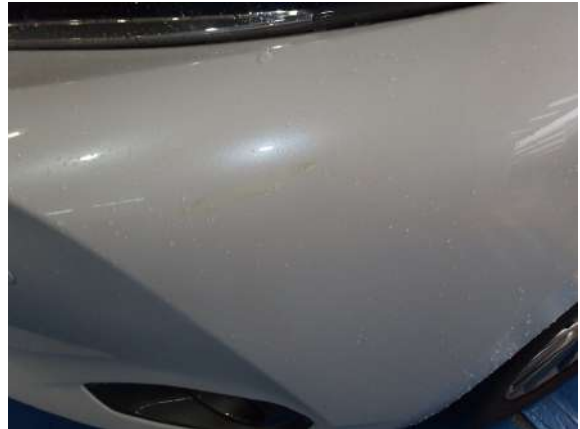
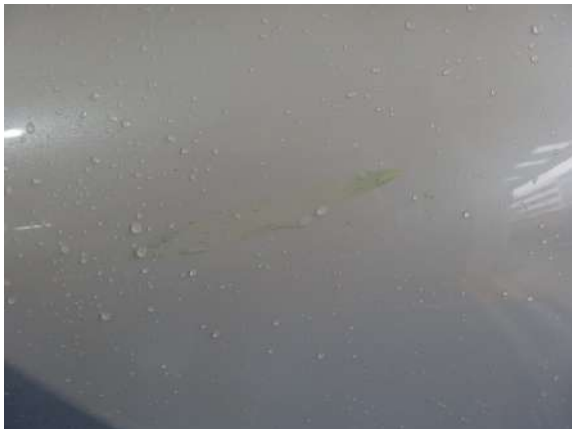
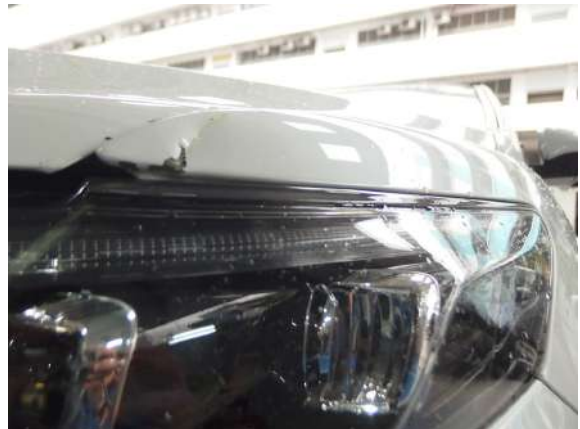
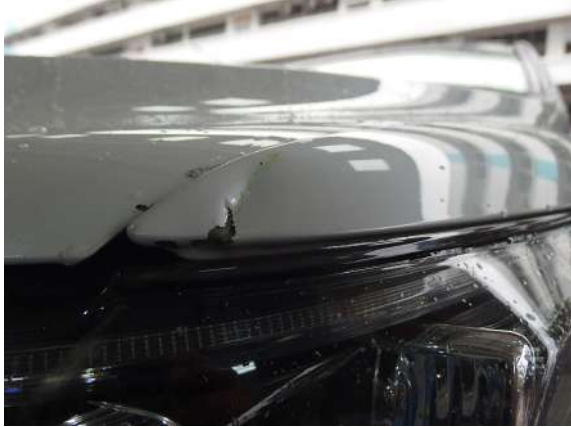
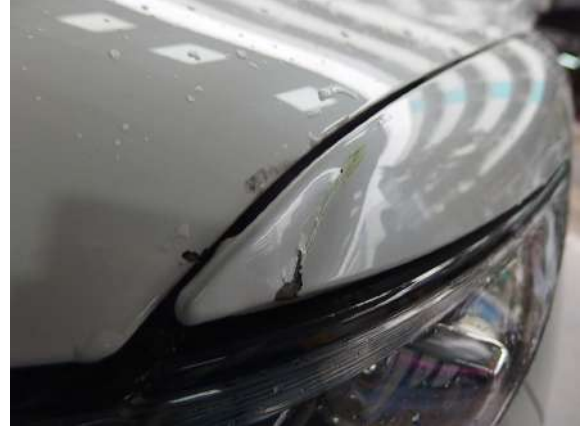
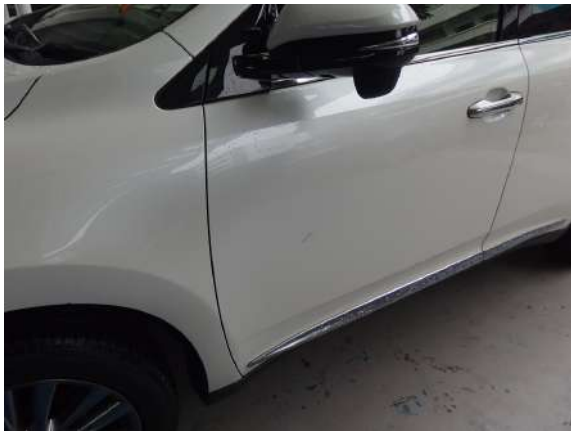
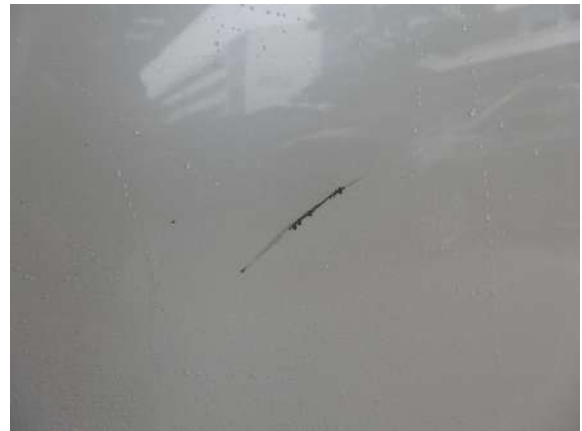
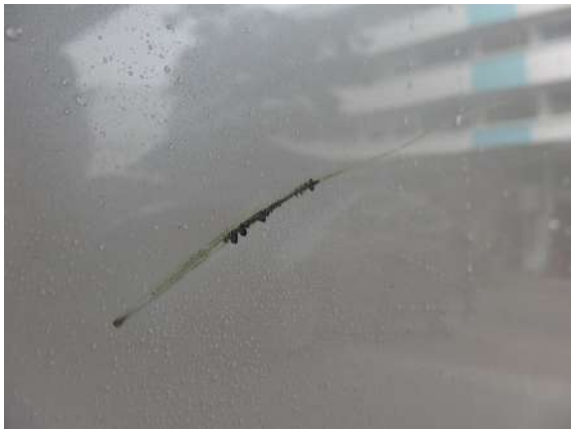
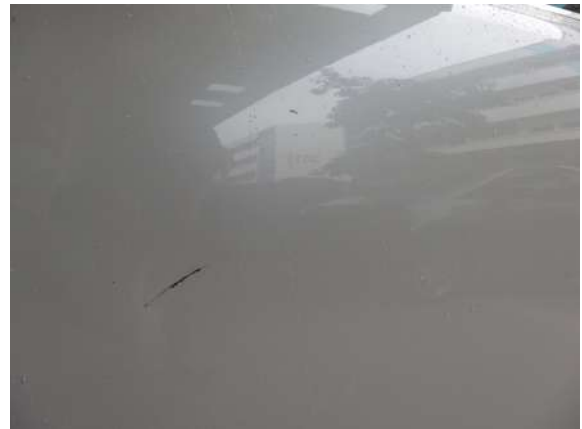
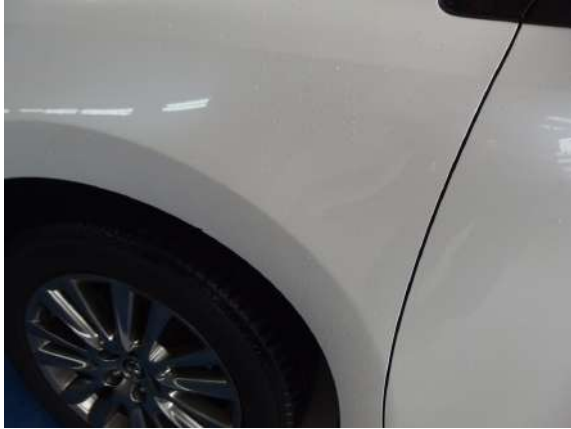
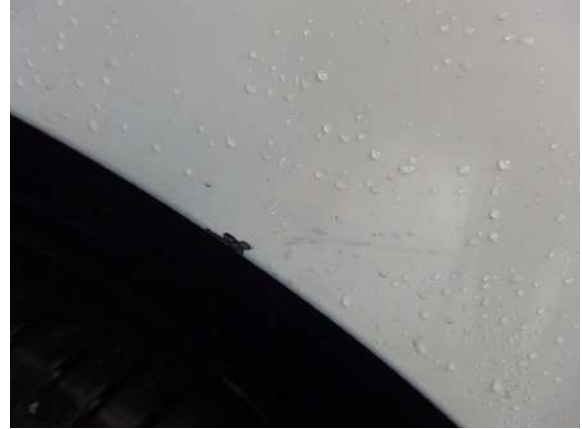
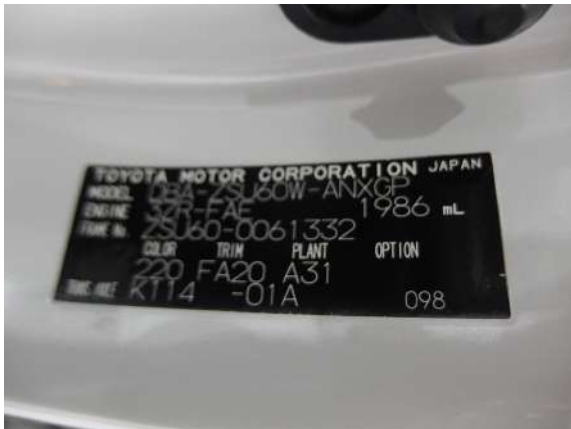
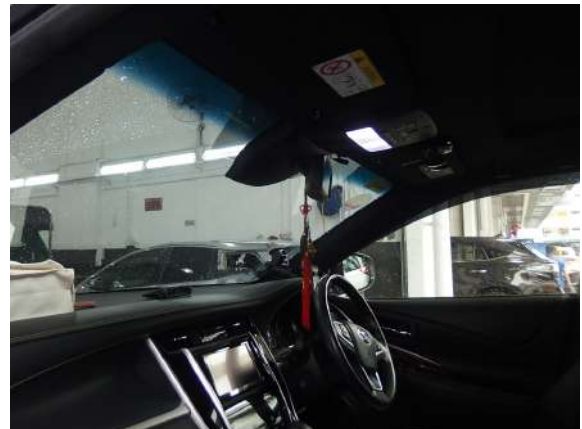
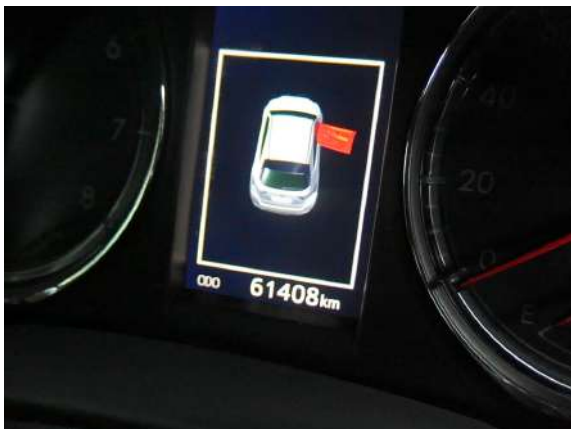
4. Description of Damages				
THE VEHICLE SUSTAINED DAMAGES AT THE N/S FRONT PORTION AND N/S BODY. DAMAGES SEE DETAILS.				
5. General Information				
Accident Date	15/08/2020	Inspection Date	21/09/2020	
Survey held at	HOCK WAH MOTOR WORKSHOP PTE LTD 3011 BEDOK INDUSTRIAL PARK E #01-2008 SINGAPORE 489977			
5a. Remarks				
A)THE INSPECTION WAS CONDUCTED ON A"WITHOUT PREJUDICE" BASIS. B)IN ACCORDANCE TO YOUR INSTRUCTIONS, WE HAVE NOT AUTHORISED REPAIRS.				
5b. Estimate Days of Repair				
ESTIMATED NORMAL PERIOD FOR REPAIR:			3 Working Days

Qty	Description of Parts	Condition	Estimate By Workshop (\$)	Our Adjusted (\$)
	<u>REPLACEMENT OF PARTS</u>			
1	HEADLAMP LH	SCRATCHED / CRACKED	3,357.30	3,357.30
1	FRONT FENDER LH	TO REPAIR SEE LABOUR	1,446.30	-
1	FRONT BUMPER	TO REPAIR SEE LABOUR	1,658.90	-
1	FRONT BUMPER RETAINER LH	NOT NECESSARY	115.20	-
1	BONNET (NPA)	TO REPAIR SEE LABOUR	-	-
1	FRONT DOOR LH (NPA)	TO REPAIR SEE LABOUR	-	-
1	REAR DOOR LH (NPA)	TO REPAIR SEE LABOUR	-	-
	LESS 25% DISCOUNT		-1,644.43	-839.33
			4,933.27	2,517.97
	<u>LABOUR</u>			
	LABOUR TO REMOVE & REFIT NECESSARY PARTS.INCLUSIVE OF THE REPAIR OF BONNET ,FRONT DOOR LH , REAR DOOR LH ,FRONT BUMPER AND FRONT FENDER LH .		700.00	300.00
	SPRAY PAINT ON THE AFFECTED AREAS.		900.00	800.00
	ANTI-RUST COATING.	NOT NECESSARY	150.00	-
	WIRING.		40.00	20.00
			1,790.00	1,120.00
	GRAND TOTAL		6,723.27	3,637.97
	RECOMMENDED COST OF REPAIR SUM			3,300.00
