Your Ref: TP/IP/33657/2020  
Our Ref : CI/TPD20008771/P

**MECHANICAL INSPECTION REPORT OF MOTOR CAR SLB 5250J**

1. I refer to your request on 19<sup>th</sup> August 2020 to conduct a physical inspection of a Motor Car bearing registration number SLB 5250J (herein referred to as "**Motor Car**"), which was involved in a road traffic accident on 10<sup>th</sup> August 2020.
2. The objective of the inspection is to determine if there was any possible mechanical failure to the Motor Car that may have contributed to the accident.
3. Following the request, I had carried out a physical inspection of the Motor Car on 2<sup>nd</sup> September 2020 at the premises of Traffic Police vehicle pound, 517 Airport Road Singapore 539942. I now set out below my observations and comments with respect to this inspection.

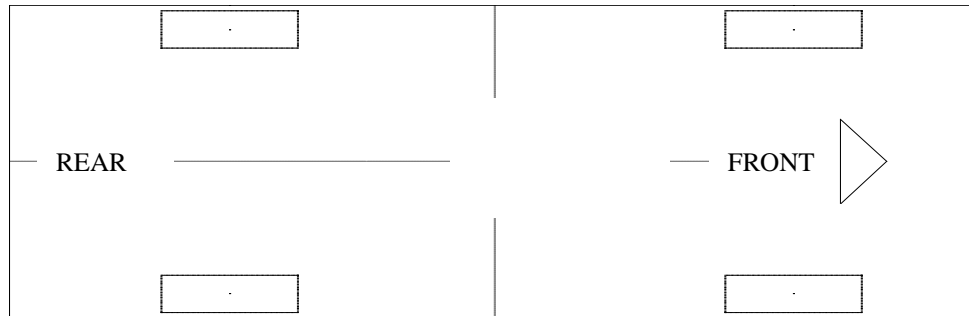
6. The front both and rear right tyres and rims was observed to be damaged. However, the condition of the Motor Car's rear left tyre was observed to be in serviceable condition. I did not find any tear, cut or burst mark(s) on the outer and the inner sidewalls as well as across the tread of the rear left tyre. The rear right tyre were observed to be sufficiently inflated for vehicular operation. The tyre brand, tyre size and remaining tread depth of the 4 tyres were recorded as follows:-

Pirelli 225/45R17 (4.4mm)

Pirelli 225/45R17 (8.2mm) (Cut)

Pirelli 225/45R17 (4.3mm) (Cut)

Pirelli 225/45R17 (8.1mm) (Cut)
