Our Ref : 19/0019/TP
Your Ref : Not Advised

ACCIDENT DAMAGED VEHICLE INSPECTION REPORT (WITHOUT PREJUDICE)

Registration Number	: SKA 7103 E	Mileage	: 164,980 km
Make & Model	: Toyota Wish 1.8X A	Chassis Number	: ZGE200008634
Date of Registration	: 25 March 2011	Engine Number	: 2ZR0428472
Colour	: Black	Engine Capacity	: 1,797 cc

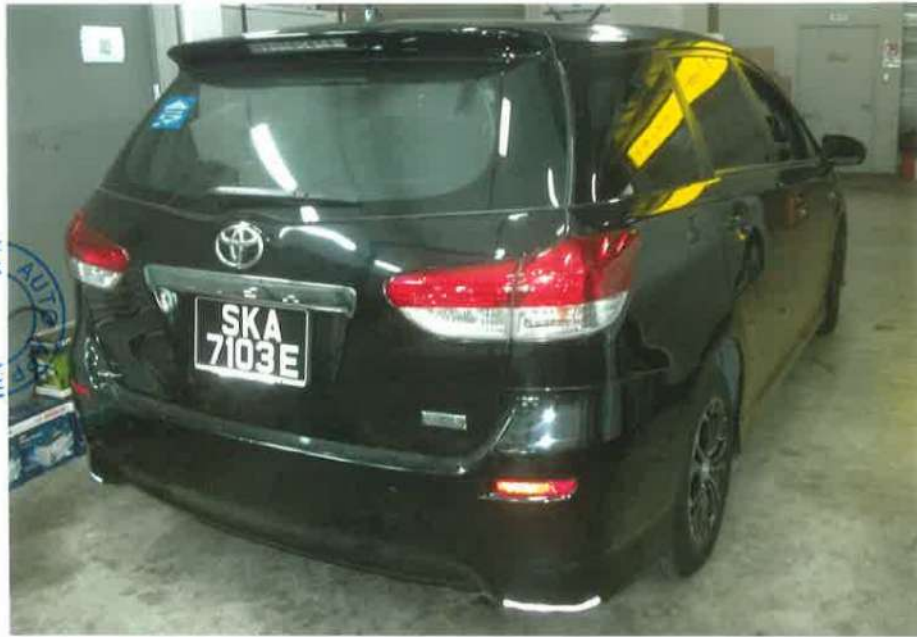
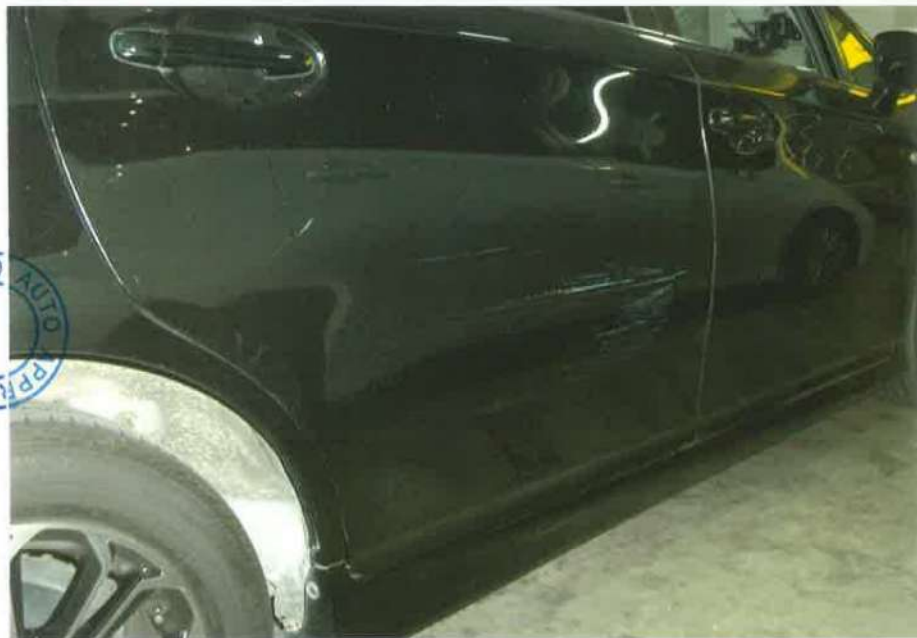
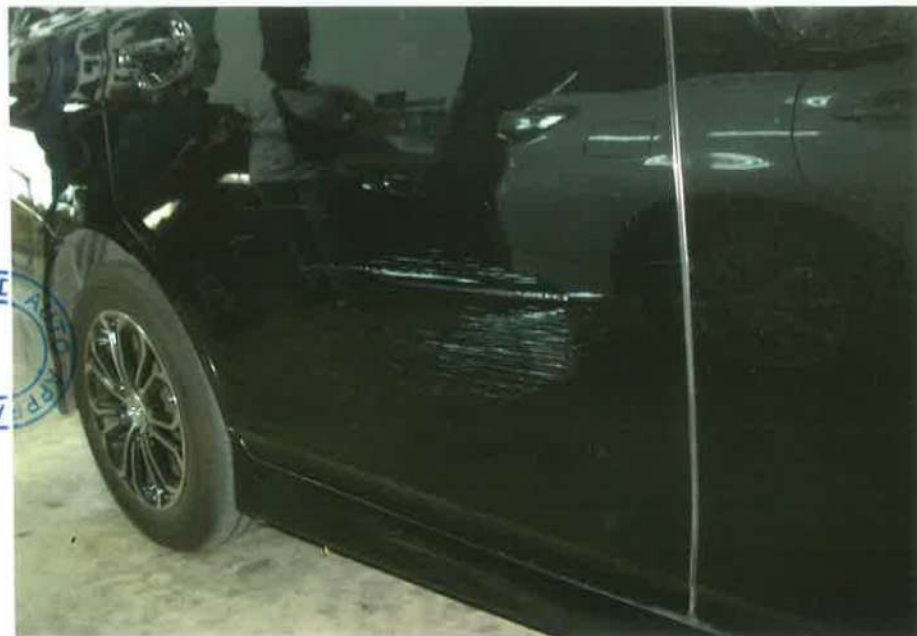
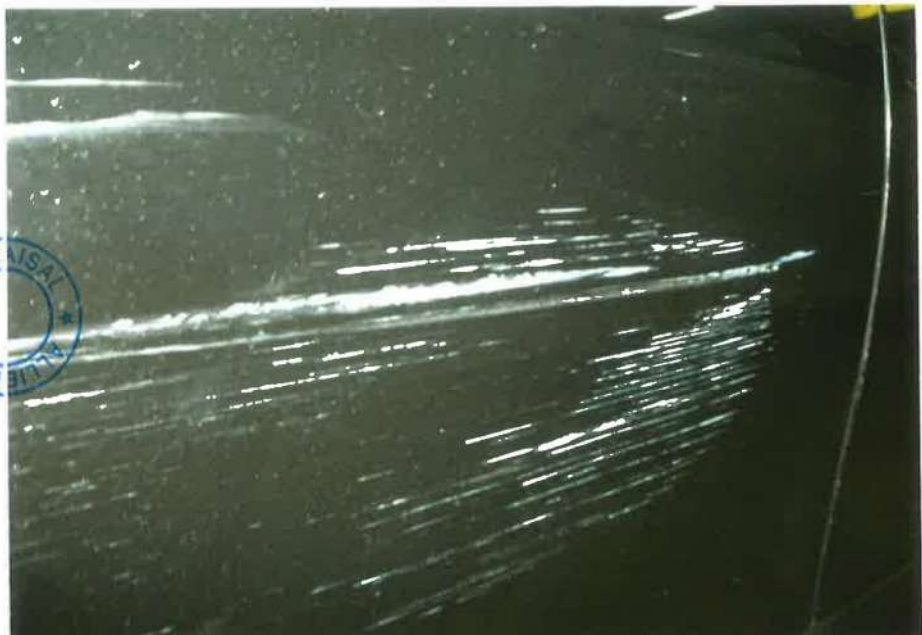
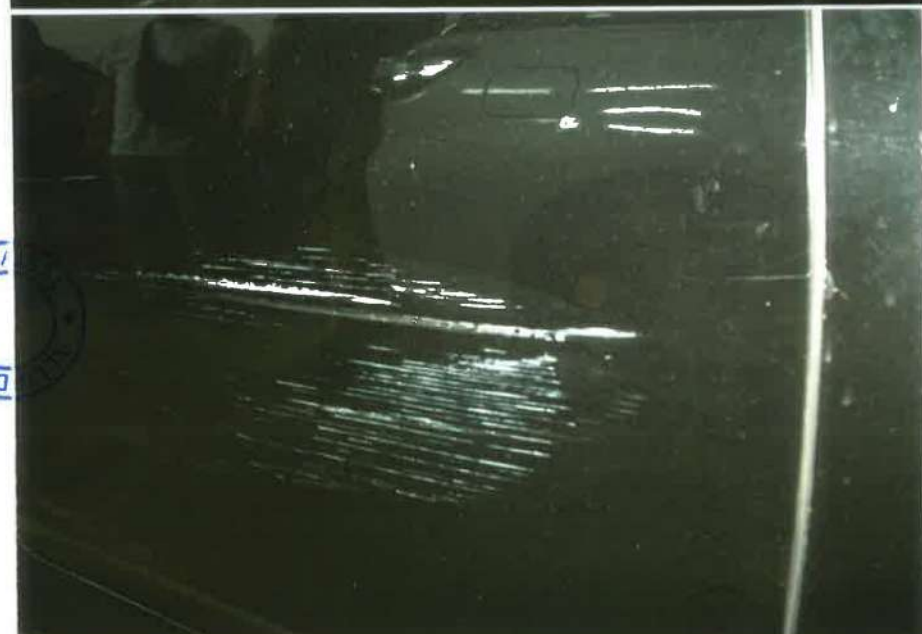
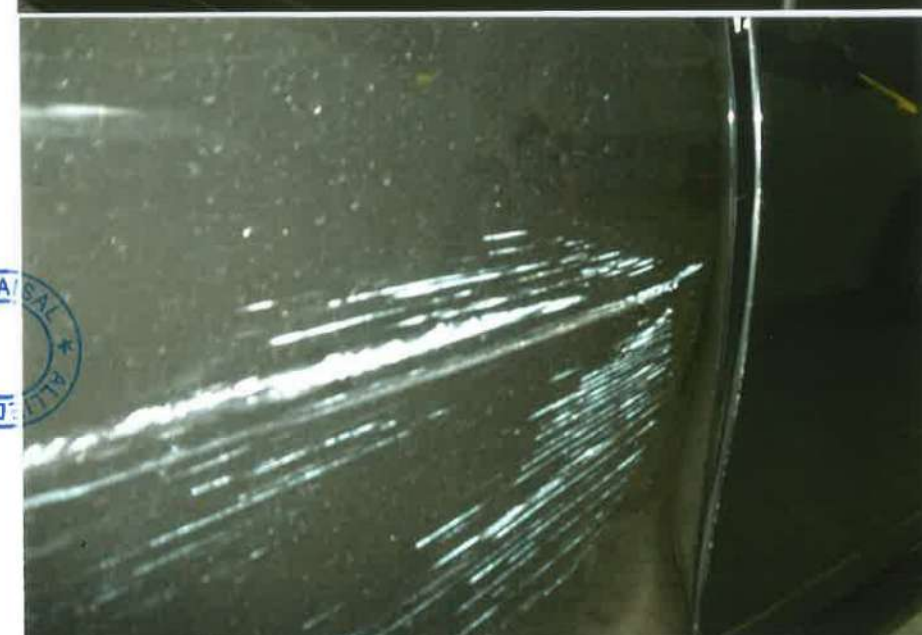
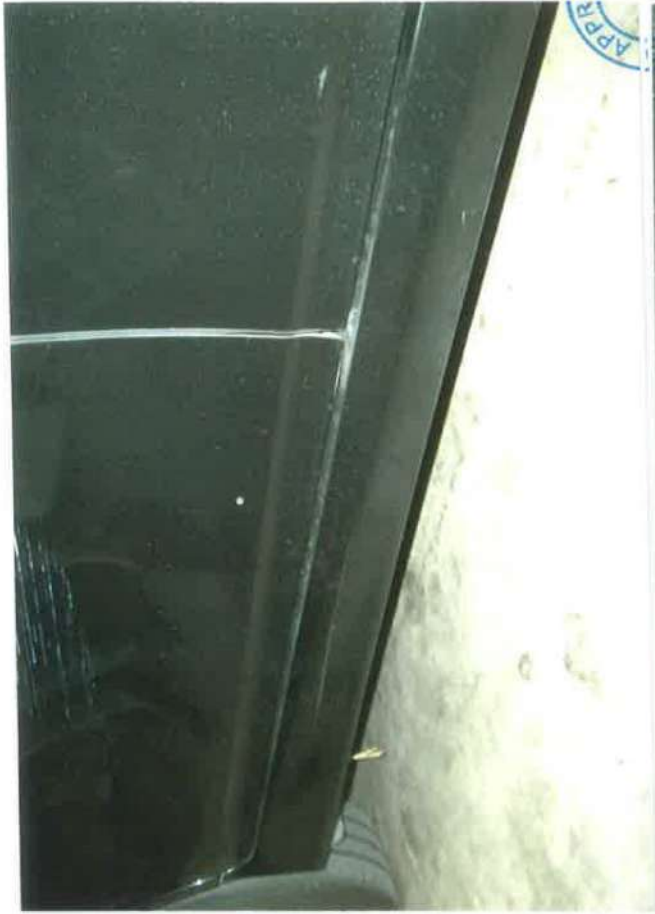
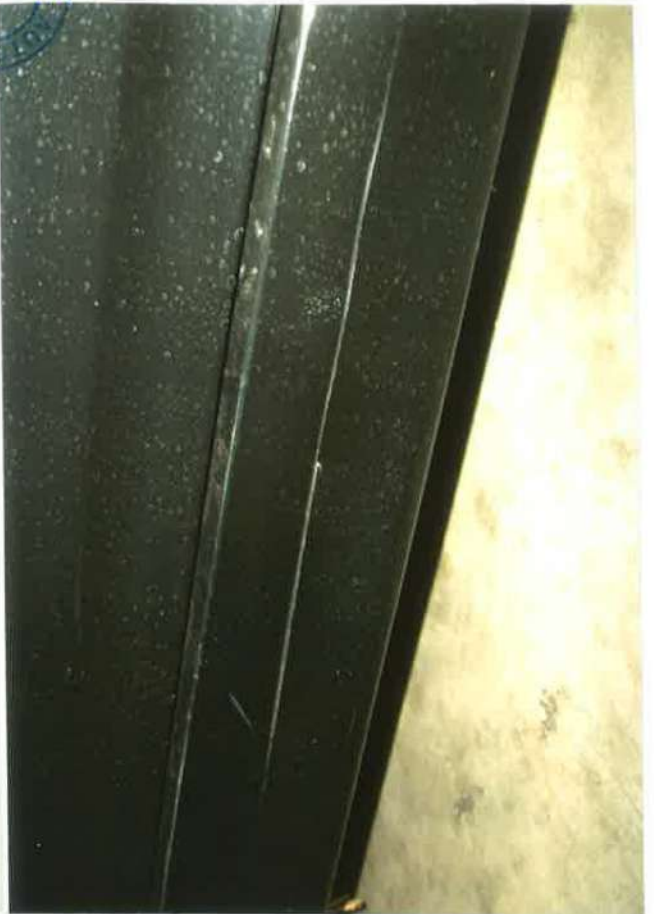
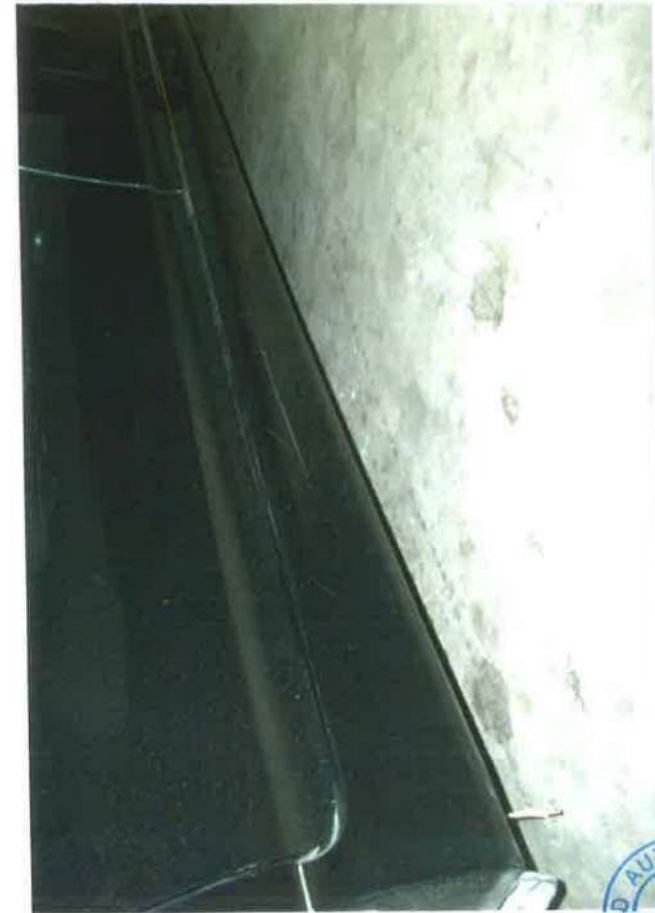
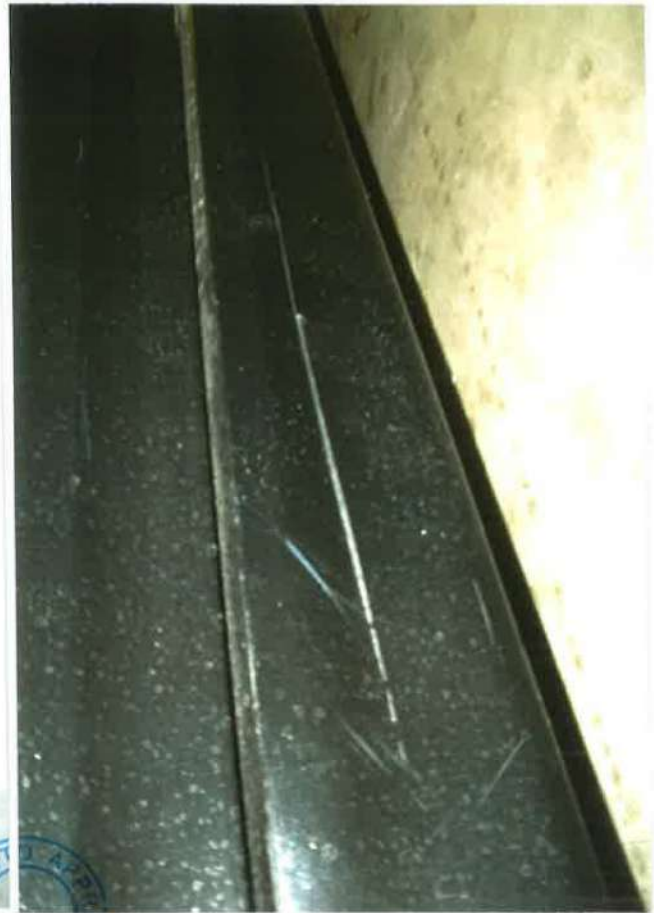
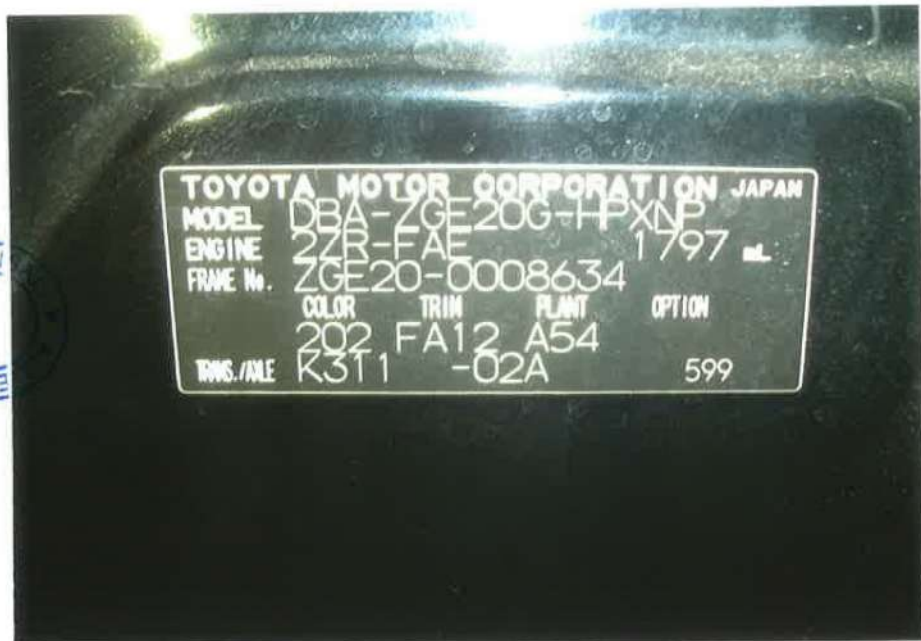
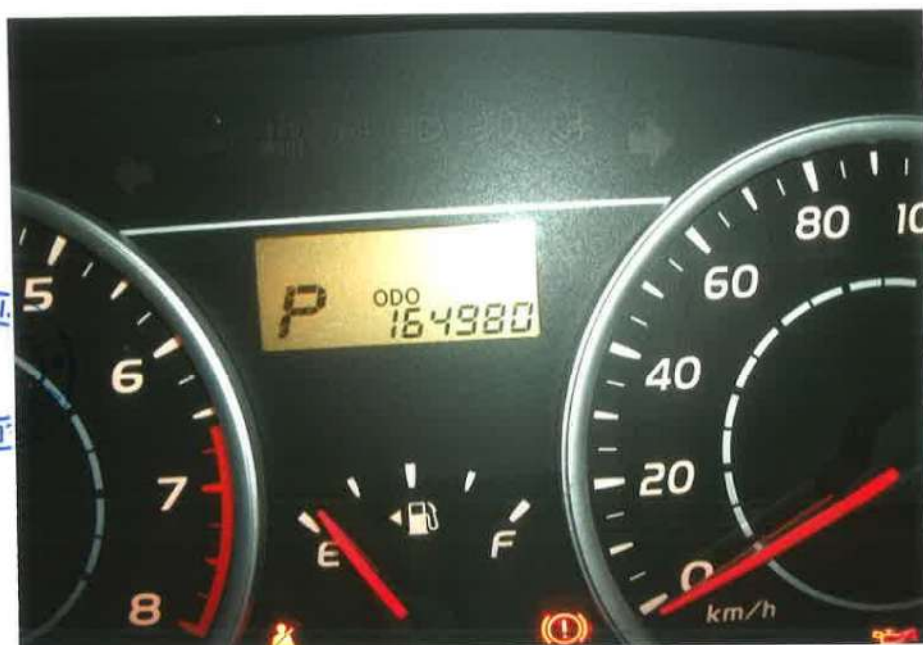
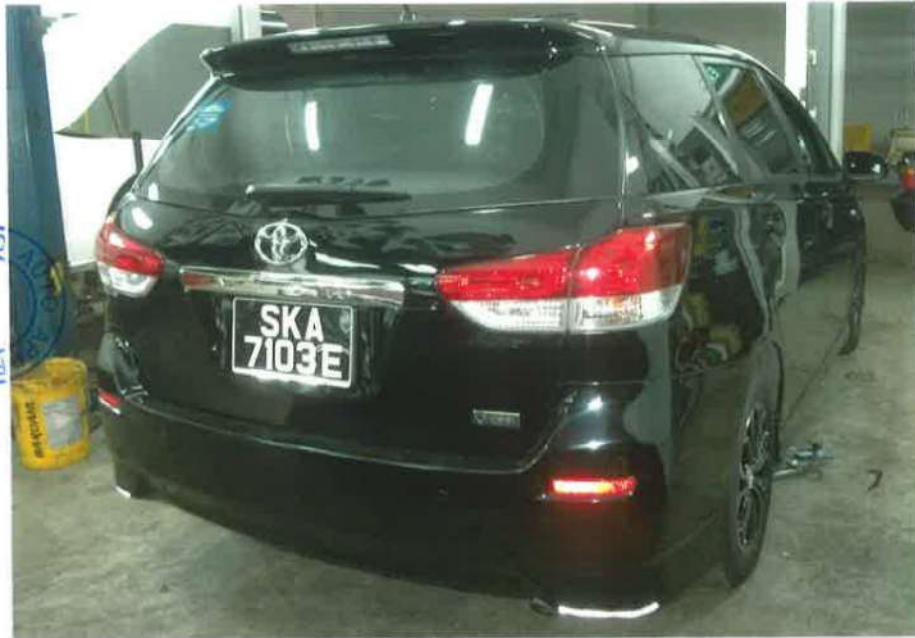
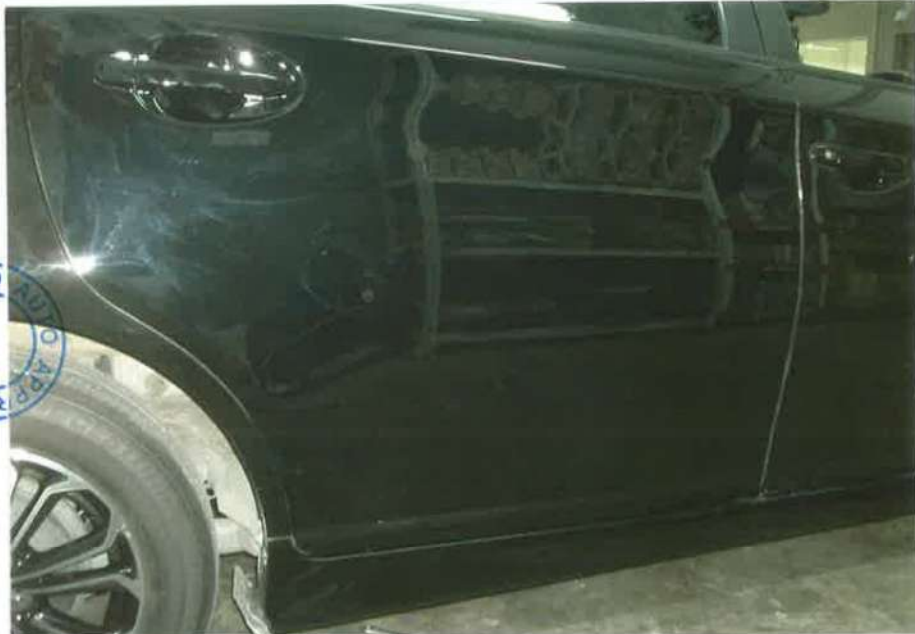
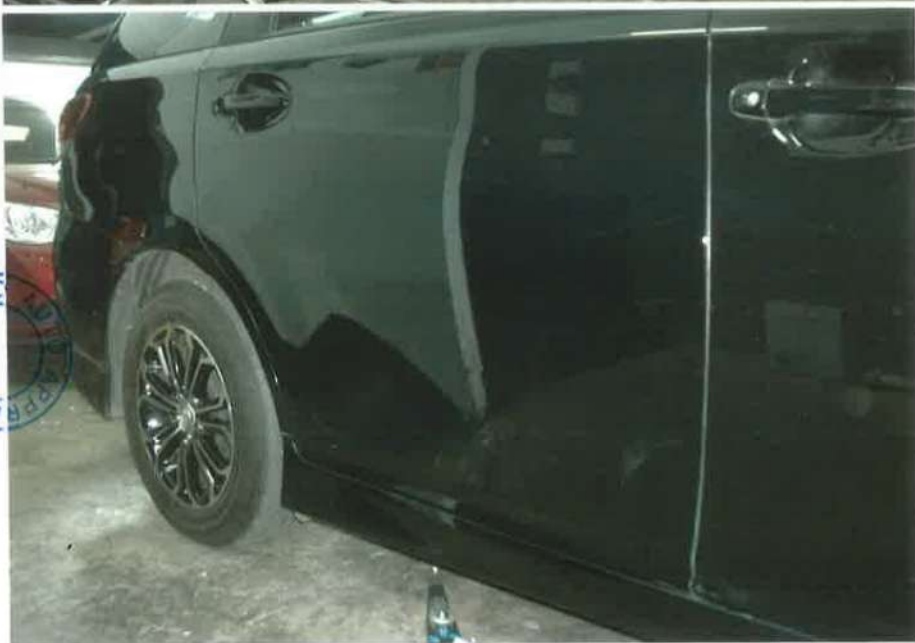
The impact of the collision has damaged/affected the right rear door, right rocker garnish and etc.

No	Qty	Particulars	Condition	Repairer's Amount	Adjuster's Amount
1	1	Rear Door Assembly - O/s	Dented/Grazed	1,663.20	1,663.20
2	1	Rear Door Black Tape - O/s	Necessary	47.30	47.30
3	1	Rear Door Weather-strip - O/s	Clip Snapped	196.90	196.90
4	1	Rocker Panel Garnish - O/s	Deep Grazed	1,244.10	1,244.10
				3,151.50	3,151.50
			Less 25%	787.88	787.88
			Sub-Total	2,363.62	2,363.62
		<u>Special Nett Item</u>			
5	1	Rear Door Inner Sealer - O/s	Necessary	80.00	60.00
		Total Parts (S\$)		2,443.62	2,423.62

We have inspected thoroughly the actual damages found on the vehicle before we conclude as to whether the parts needed replacement or repairs. The estimated cost of repair submitted by the repairer is **\$3,873.62**. We have adjusted the cost to **\$3,593.62** and recommend that the repairs to be taken on a lump sum basis of **\$3,050.00**. In our opinion, the damaged parts are consistent with that caused by the accident.

S\$3,050.00
