Your Ref: TP/IP/35401/2020  
Our Ref : CI/TPD20009190/P

12<sup>th</sup> October 2020

**MECHANICAL INSPECTION REPORT OF MOTOR VAN GBB 236C**

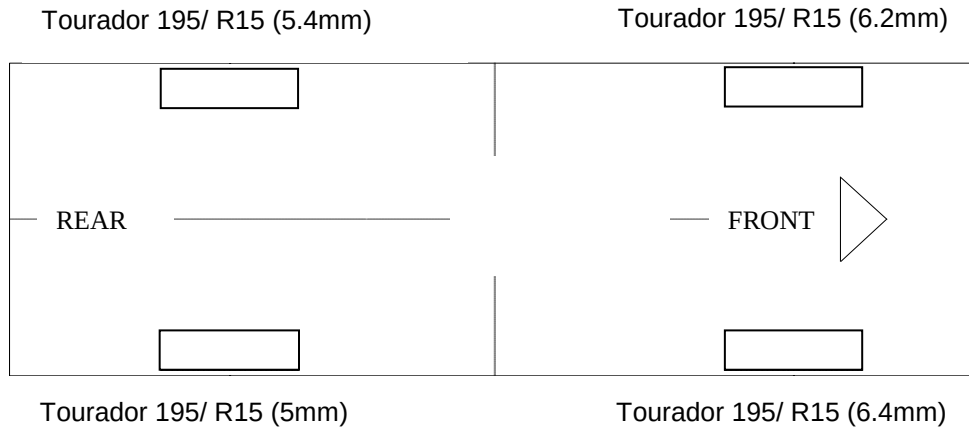
6. The 4 tyres of the Motor Van were observed to be in serviceable condition and sufficiently inflated for vehicular operation. I did not find any tear, cut or burst mark(s) on the outer and the inner sidewalls as well as across the tread of the 4 tyres. The tyre brand, tyre size and remaining tread depth of the 4 tyres of the Motor Van were recorded as follows:-
