Your Ref: TP/IP/35397/2020
Our Ref: CI/TPD20009195/P

Fatal Accident Investigation Team

MECHANICAL INSPECTION REPORT OF MOTOR LORRY GU 5156H

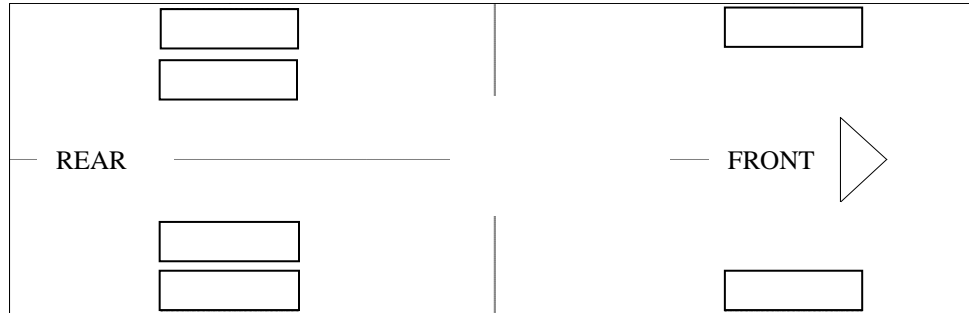
6. The condition of the Motor Lorry's 6 tyres was observed to be in serviceable condition. I did not find any tear, cut or burst mark(s) on the outer and the inner sidewalls as well as across the tread of the 6 tyres. The 6 tyres were also observed to be sufficiently inflated for vehicular operation. The tyre brand, tyre size and remaining tread depth of the 6 tyres were recorded as follows:-

Westlake 155/ R12 (4.6mm)

Greenmax 185/ R14 (7.6mm)

Westlake 155/ R12 (5.3mm)

Greenmax 185/ R14 (7.9mm)
