Your Ref: TP/IP/13095/2019  
Our Ref : CS/ASM20010979/N

5 April 2021

### **MECHANICAL INSPECTION REPORT OF MOTOR CAR SJQ 5827R**

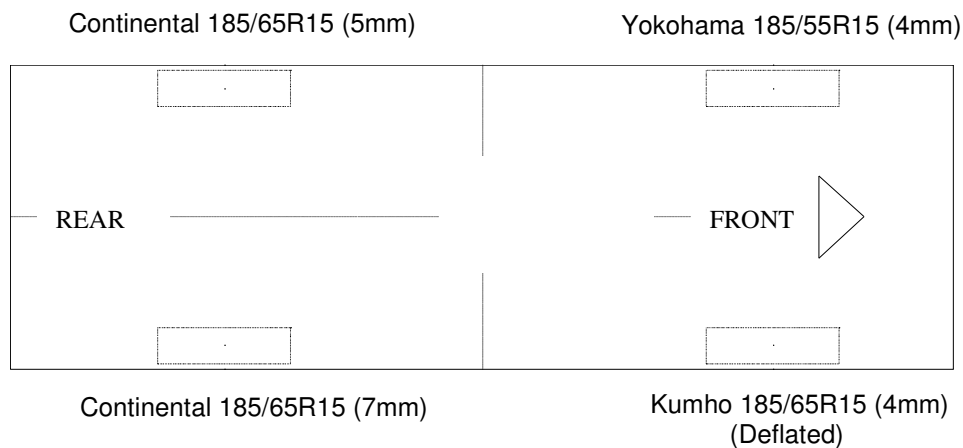
7. The condition of the Motor car's 4 tyres was observed to be in serviceable condition. We did not find any tear, cut or burst mark(s) on the outer and the inner sidewalls as well as across the tread of the 4 tyres. The front right tyre was found to be deflated. However the other 3 tyres were also observed to be sufficiently inflated for vehicular operation. The tyre brand, tyre size and remaining tread depth of the 4 tyres were recorded as follows:-
