Your Ref: TP/IP/42901/2020
Our Ref : CI/TPD20011022/P

9th December 2020

MECHANICAL INSPECTION REPORT OF MOTOR CAR SJH 2723Z

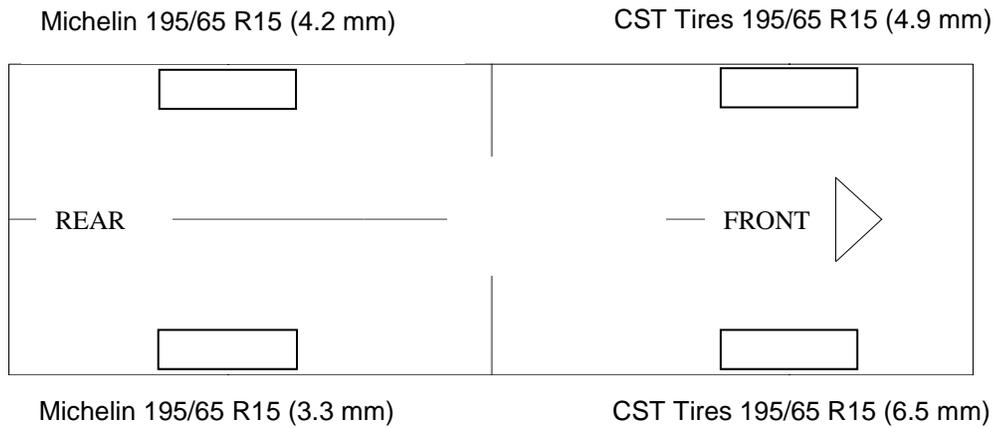
6. The 4 tyres of the Motor Car were observed to be in serviceable condition and sufficiently inflated for vehicular operation. I did not find any tear, cut or burst mark(s) on the outer and the inner sidewalls as well as across the tread of the 4 tyres. The tyre brand, tyre size and remaining tread depth of the 4 tyres of the Motor Car were recorded as follows:-
