Your Ref: TP/IP/25271/2020  
Our Ref : CI/TPD20011140/P

**Fatal Accident Investigation Team**

**MECHANICAL INSPECTION REPORT OF MOTOR VAN GBE 1000T**

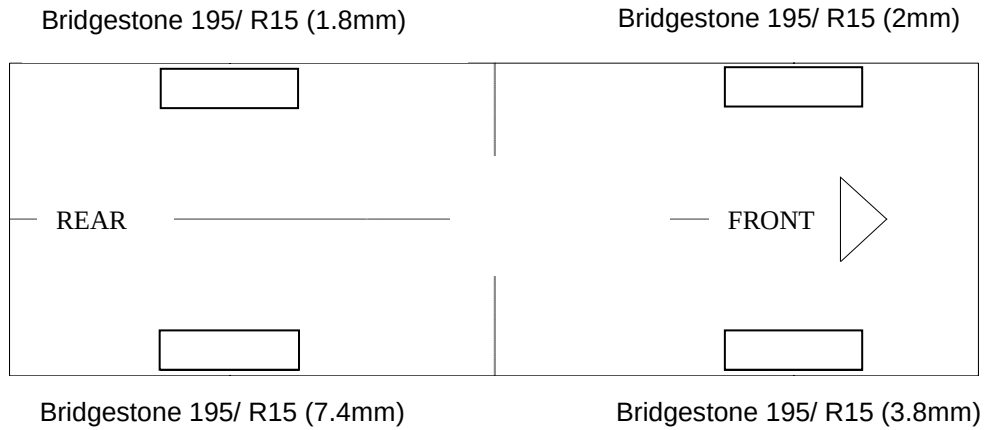
6. The 4 tyres of the Motor Van were observed to be in serviceable condition and sufficiently inflated for vehicular operation. I did not find any tear, cut or burst mark(s) on the outer and the inner sidewalls as well as across the tread of the 4 tyres. The tyre brand, tyre size and remaining tread depth of the 4 tyres of the Motor Van were recorded as follows:-
