## LKK Auto Consultants Pte Ltd

Vehicle No. GBF 4764Y  
Insured Veh. GBC 4426P  
Claim No. SNM20D203935/C02  
Policy No. DMCVSN3084771900  
Accident Date 28/09/2020  
Inspection Date 15/10/2020

## ADJUSTMENT ON REPAIR COST FOR VEHICLE NO. GBF 4764Y

PHOTOGRAPHS FOR VEHICLE NO. GBF 4764Y

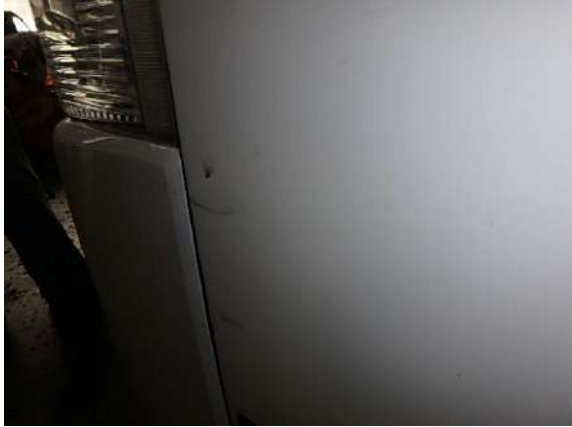
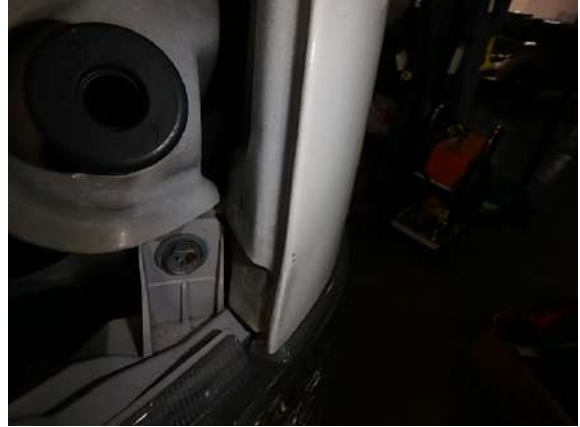
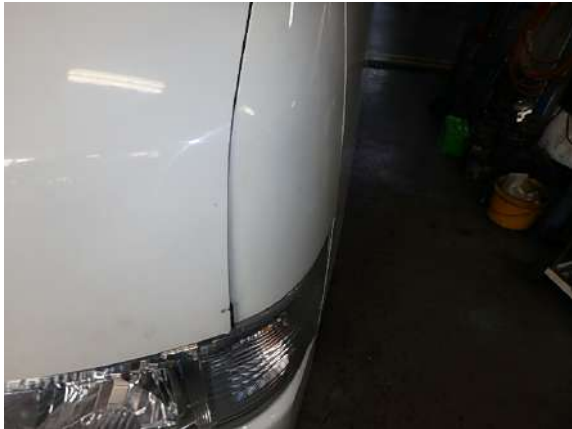
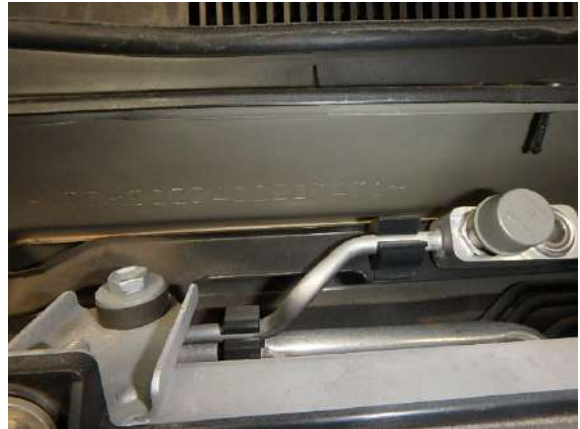
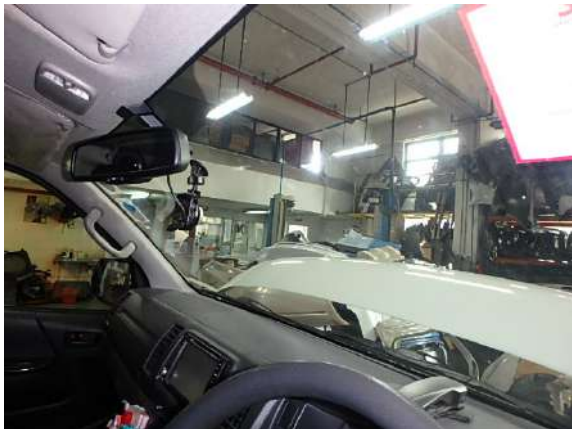
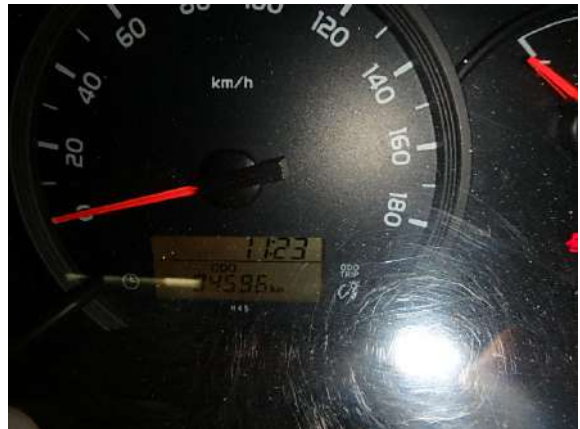
<b>R/H Front Tyre</b>	195 R15X8	BEARWAY	9 mm
	<b>L/H Front Tyre</b>	195 R15X8	BEARWAY	9 mm
	<b>R/H Rear Tyre</b>	195 R15X8	BEARWAY	9 mm
	<b>L/H Rear Tyre</b>	195 R15X8	BEARWAY	9 mm
<b>4. Description of Damages</b>				
	THE VEHICLE SUSTAINED DAMAGES AT THE N/S FRONT PORTION.  DAMAGES SEE DETAILS.			
<b>5. General Information</b>				
	<b>Accident Date</b>	28/09/2020	<b>Inspection Date</b>	15/10/2020
	<b>Survey held at</b>	GUAN MOTOR WORKS 176 SIN MING DRIVE #02-03 SIN MING AUTOCARE SINGAPORE 575721		
<b>5a. Remarks</b>				
	A)THE INSPECTION WAS CONDUCTED ON A"WITHOUT PREJUDICE" BASIS. B)IN ACCORDANCE TO YOUR INSTRUCTIONS, WE HAVE NOT AUTHORISED REPAIRS.			
<b>5b. Estimate Days of Repair</b>				
	ESTIMATED NORMAL PERIOD FOR REPAIR:		<b>3 Working Days</b>

Qty	Description of Parts	Condition	Estimate By Workshop (\$)	Our Adjusted (\$)
	<b><u>REPLACEMENT OF PARTS</u></b>			
1	FRONT BUMPER	TO REPAIR SEE LABOUR	452.10	-
1	FRONT BUMPER LH SIDE RETAINER	SERVICEABLE	191.30	-
1	FRONT BUMPER INNER REINFORCEMENT	TO REPAIR SEE LABOUR	364.40	-
1	SET FRONT BUMPER CLIPS	NOT NECESSARY	40.00	-
1	LH HEADLAMP	CRACKED	748.10	748.10
1	FRONT LH CORNER PANEL	BENT/ BUCKLED	258.10	258.10
1	FRONT GRILLE ASSY	SERVICEABLE	580.80	-
1	FRONT BONNET	TO REPAIR SEE LABOUR	756.60	-
1	FRONT BONNET CENTRE 'TOYOTA' LOGO	NECESSARY	66.09	66.09
	LESS 25% DISCOUNT		-864.37	-268.07
			2,593.12	804.22
	<b><u>LABOUR</u></b>			
	LABOUR CHARGES FOR REMOVE /REFIT ,CUTTING/WELDING AND REPLACEMENT OF DAMAGES.INCLUSIVE OF THE REPAIR OF FRONT BUMPER INNER REINFORCEMENT ,FRONT BUMPER AND FRONT BONNET .		700.00	350.00
	TO PUTTY AND SPRAY PAINTINGS CHARGES.		1,000.00	600.00
	TO CHECK WIRING & LIGHTINGS.		40.00	20.00

TO REMOVE,REFIT A/C CONDENSER ,RADIATOR AND ETC.	NOT NECESSARY	150.00	-
	TO SUPPLY AND APPLY ANTI RUST TREATMENT.	NOT NECESSARY	80.00	-
			1,970.00	970.00
	<b>GRAND TOTAL</b>		<b>4,563.12</b>	<b>1,774.22</b>
	<b>RECOMMENDED COST OF REPAIRS</b>			<b>1,774.22</b>
