Your Ref: TP/IP/39835/2020
Our Ref : CI/TPD20011392/P

23rd November 2020

MECHANICAL INSPECTION REPORT OF MOTOR CAR SLD 8602Y

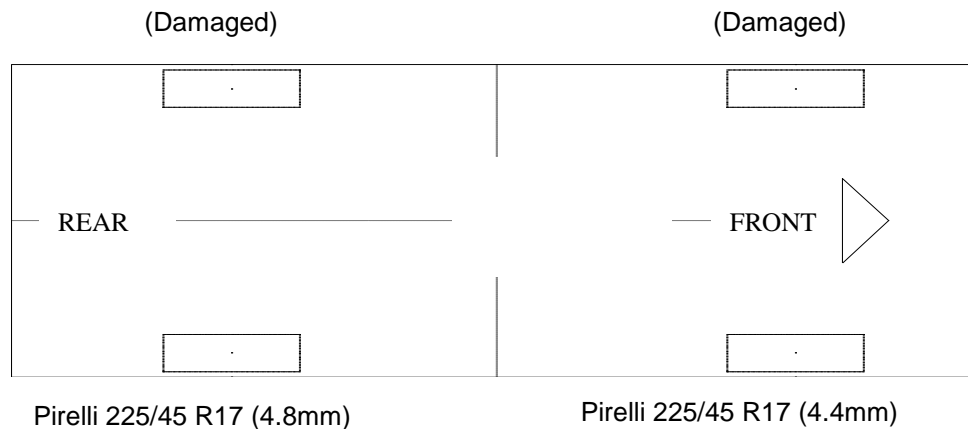
6. The condition of the Motor Car's front left and rear left tyre was observed to be damaged. However, the front right and rear right tyres was observed to be in serviceable condition. I did not find any tear, cut or burst mark(s) on the outer and the inner sidewalls as well as across the tread of the 2 tyres. The 2 tyres were also observed to be sufficiently inflated for vehicular operation. The tyre brand, tyre size and remaining tread depth of the 2 tyres were recorded as follows:-
