Your Ref: TP/IP/43633/2020
Our Ref: CI/TPD20011429/P

3rd November 2020

MECHANICAL INSPECTION REPORT OF MOTOR LORRY GBJ 5550U

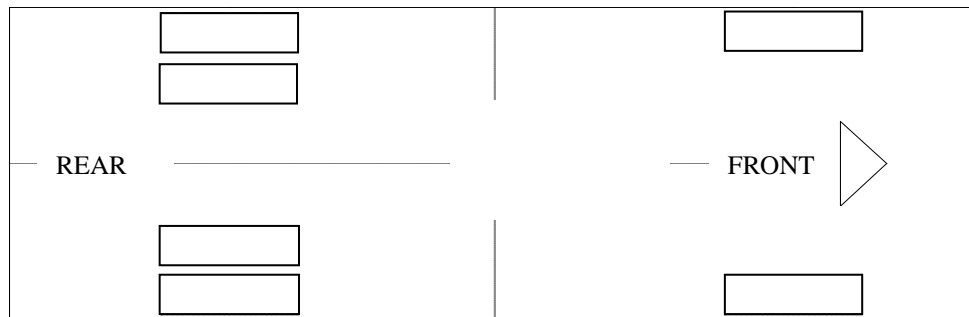
6. We observed that the front left was deflated and its rear left tyres were observed to be cut by its rims and deflated as a result of the accident.
7. However, the condition of the Motor Lorry' front right and rear right 3 tyres was observed to be in serviceable condition. I did not find any tear, cut or burst mark(s) on the outer and the inner sidewalls as well as across the tread of the tyres. The 3 tyres were also observed to be sufficiently inflated for vehicular operation. The tyre brand, tyre size and remaining tread depth of the 6 tyres were recorded as follows:-

Bridgestone 155/R12 (2.2mm) (Deflated)

Yokohama 195/R15 (2.1mm) (Deflated)

Bridgestone 155/R12 (2mm)

Yokohama 195/R15 (2.3mm)
