Vehicle No. GBE 9189E  
Insured Veh. GBG 7015B  
Claim No. SNM20D203971  
Policy No. DMCVSNA00088882003  
Accident Date 19/10/2020  
Inspection Date 20/10/2020

# LKK Auto Consultants Pte Ltd

## ADJUSTMENT ON REPAIR COST FOR VEHICLE NO. GBE 9189E

### PHOTOGRAPHS FOR VEHICLE NO. GBE 9189E

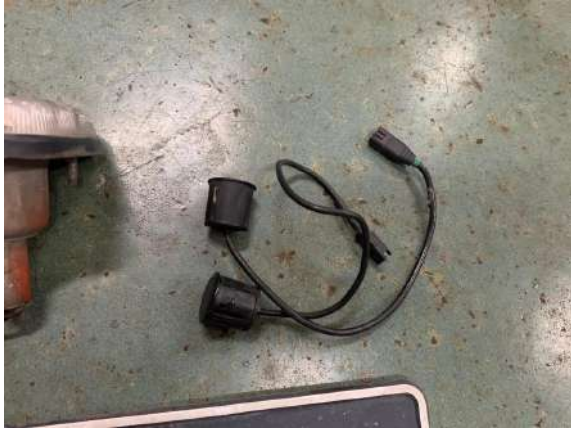
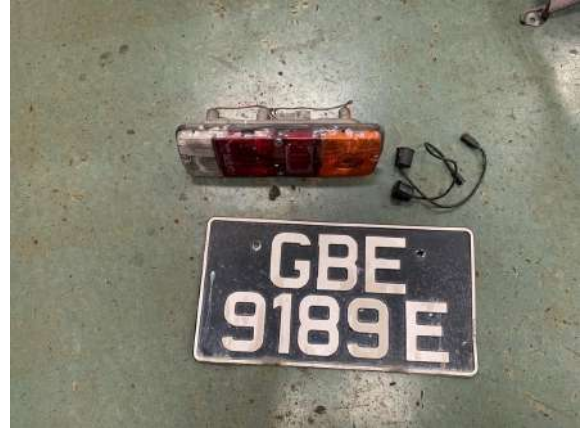
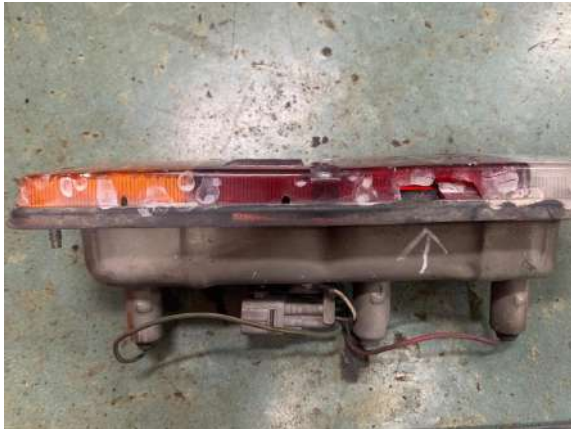
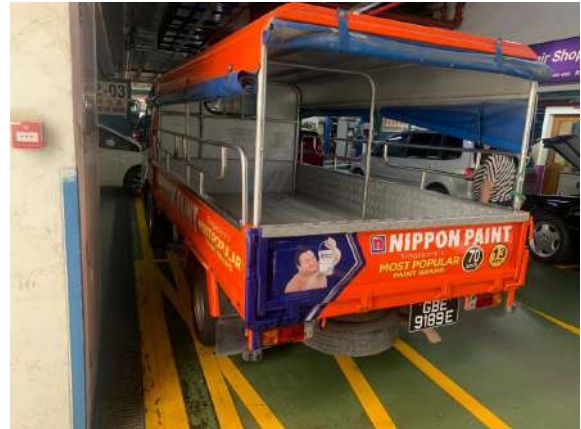
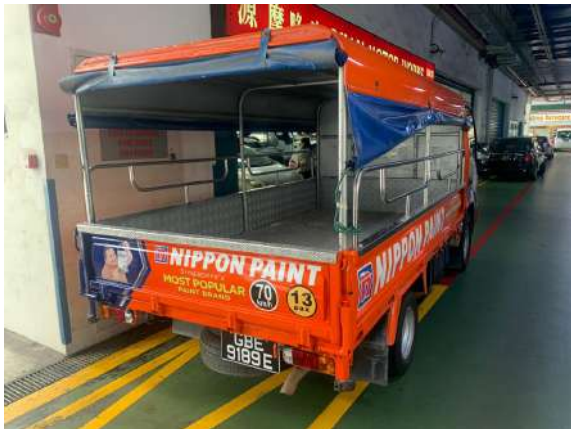
### RE-INSPECTION

| Affiliated to Federation Internationale Des Experts En Automobile | | | | |
|---|---|---|---|--|
| THE VEHICLE SUSTAINED DAMAGES AT THE REAR N/S PORTION.<br><br>DAMAGES SEE DETAILS. | | | | |

| Qty | Description of Parts | Condition | Estimate By Workshop (\$) | Our Adjusted (\$) |
|---|---|---|---|---|
| 2 | TAILLAMP | O/S SERVICEABLE / N/S CRACKED | 528.40 | 264.20 |

| Qty | Description of Parts | Condition | Estimate By Workshop (\$) | Our Adjusted (\$) |
|---|---|---|---|---|
| | LABOUR CHARGES FOR REMOVE /REFIT ,CUTTING/WELDING AND REPLACEMENT OF DAMAGES .INCLUSIVE OF THE REPAIR OF REAR NUMBER PLATE BRACKET AND REAR LOWER SPARE TYRE CARRIER CHAIN . | | 1,100.00 | 800.00 |
