### VEHICLE DAMAGE INSPECTION REPORT

Our Ref: 677/TP/2019

Date of loss: 5/12/2019  
Claimant: Rigging and Marine Services Pte Ltd

| Reg No: | YN2935U | Make & | Mitsubishi |

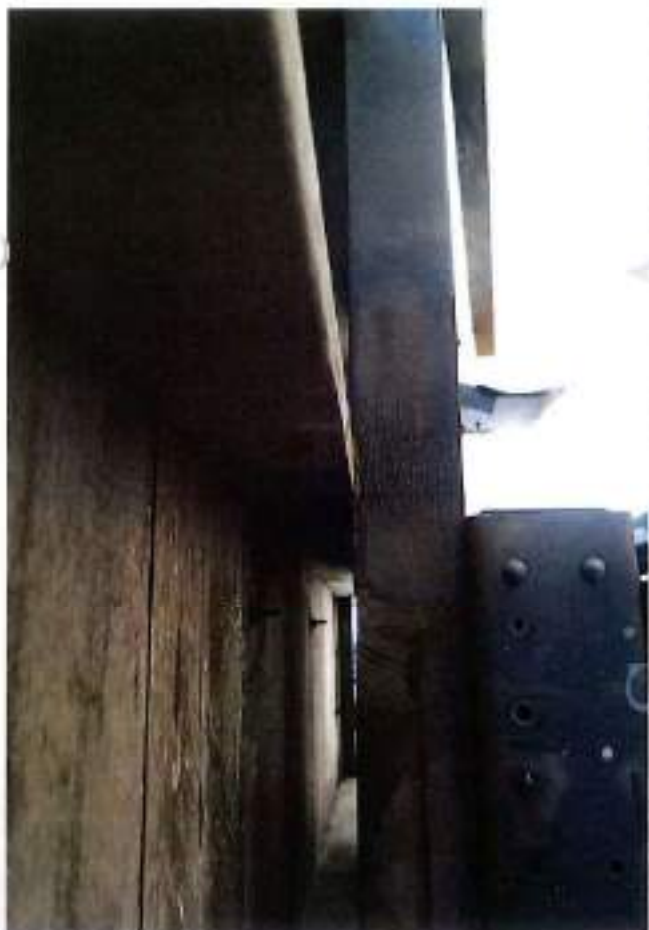
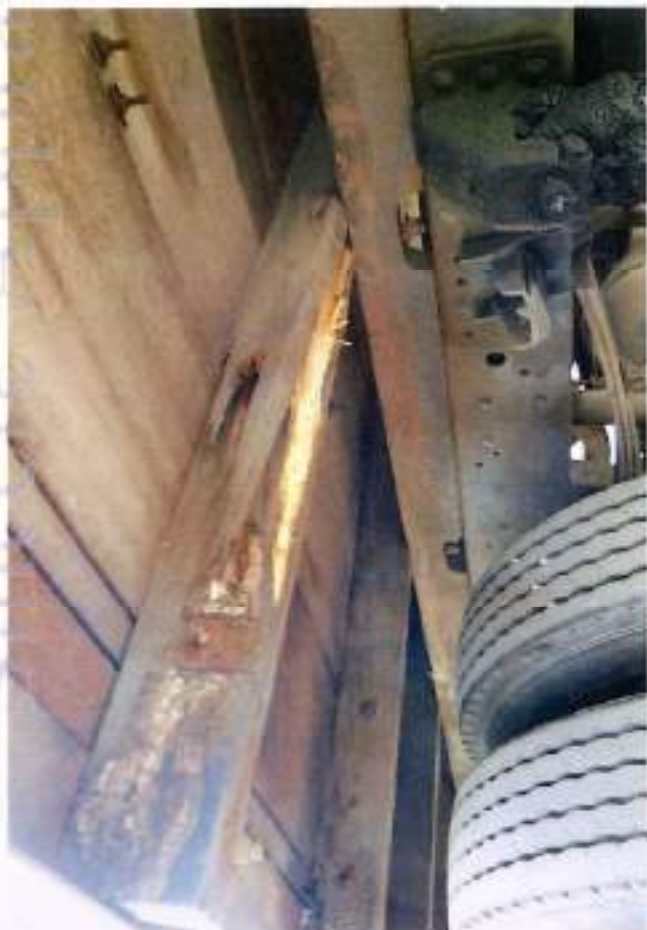
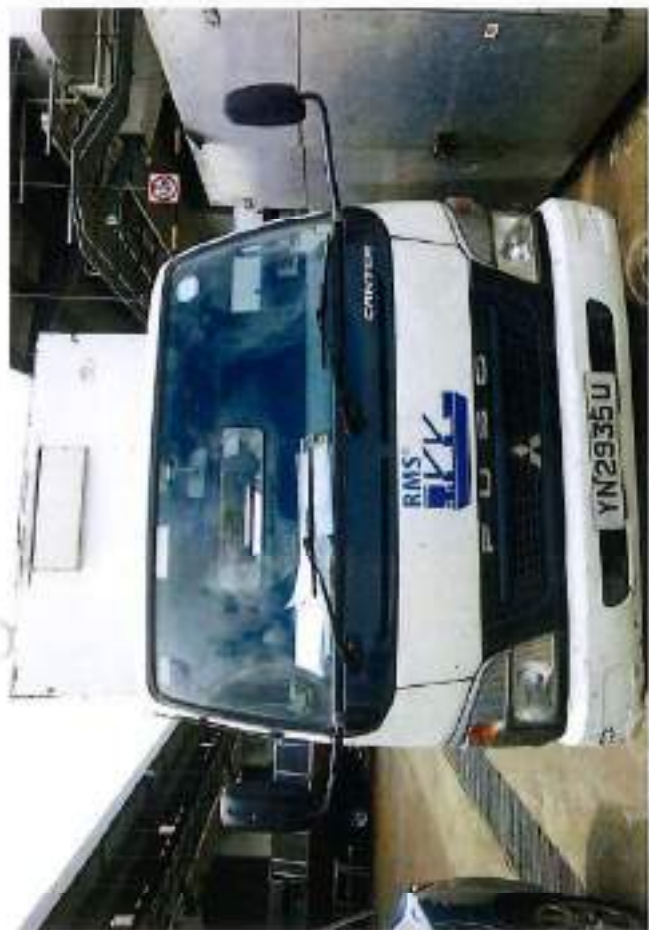
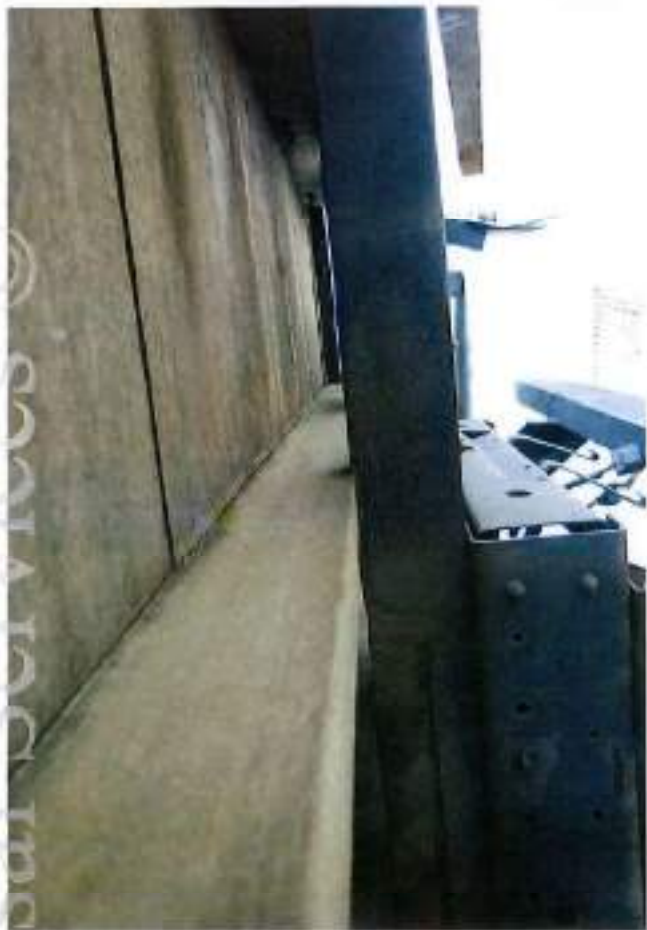
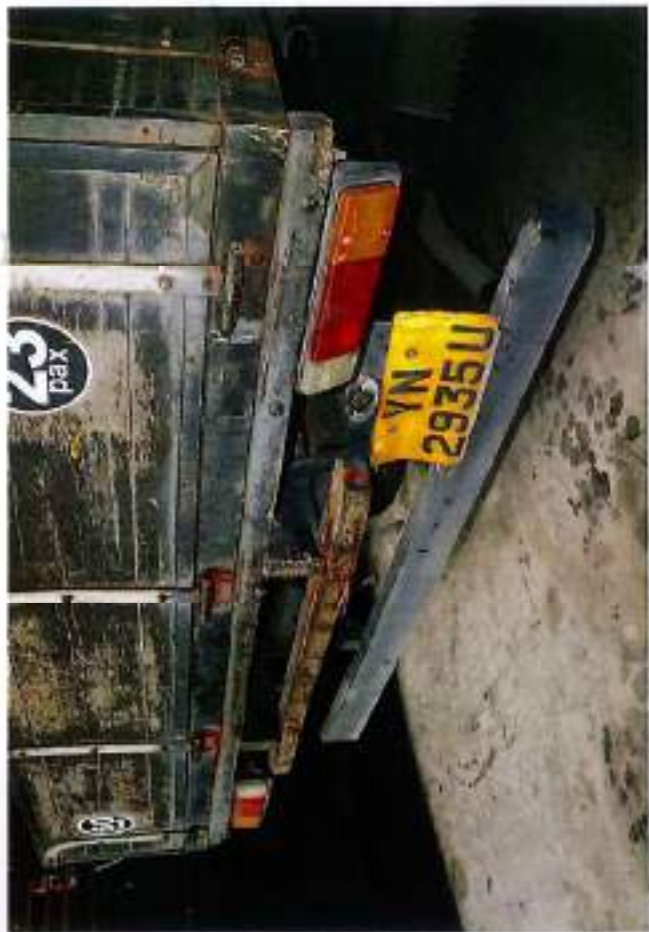
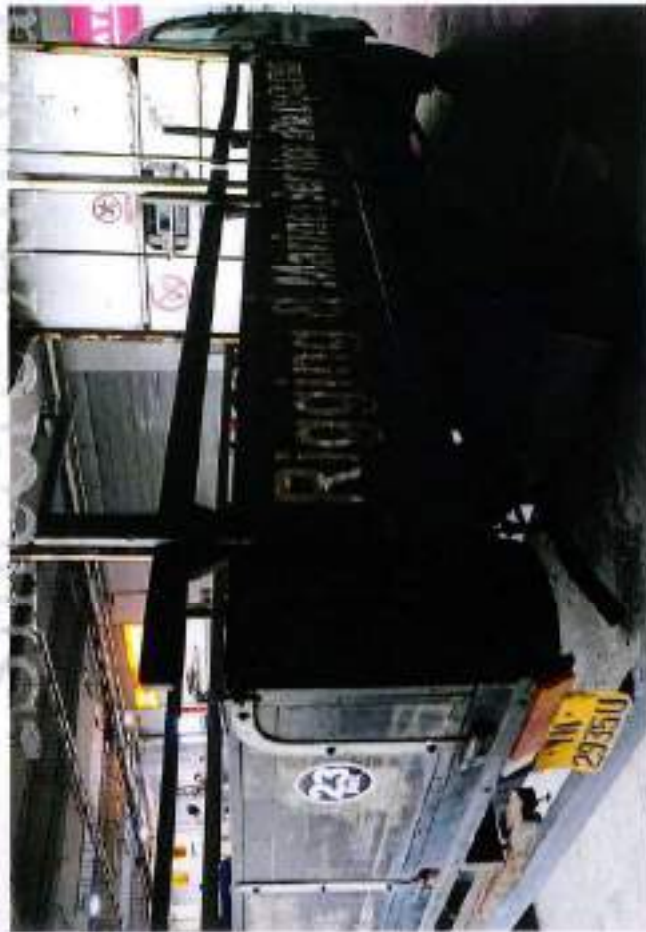
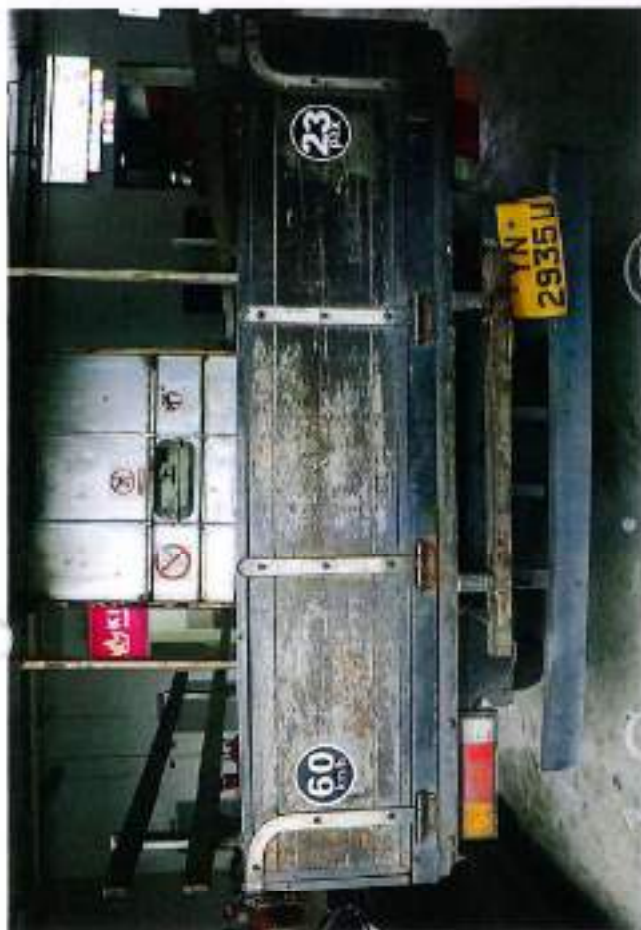
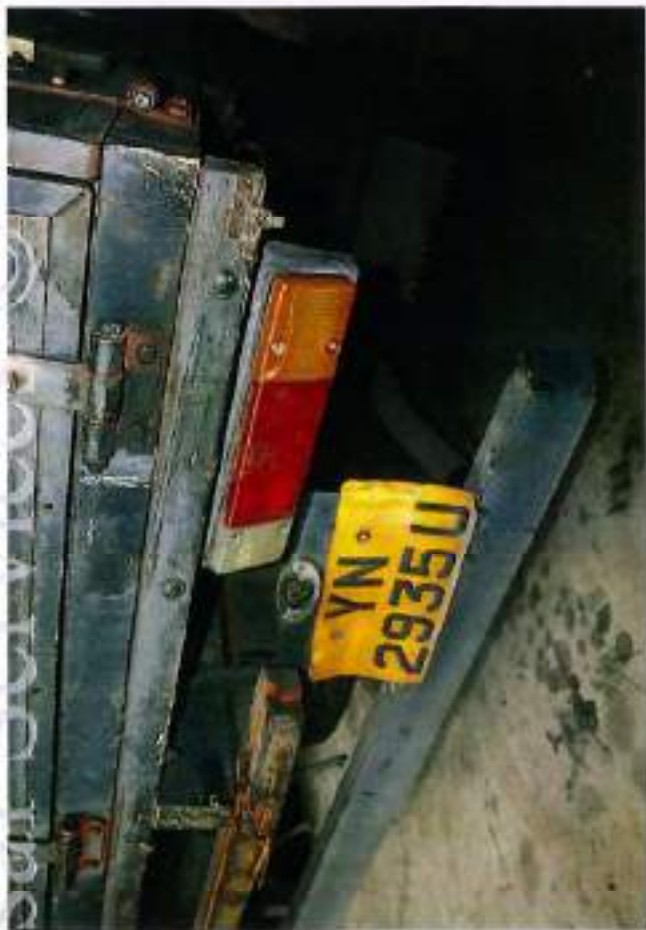
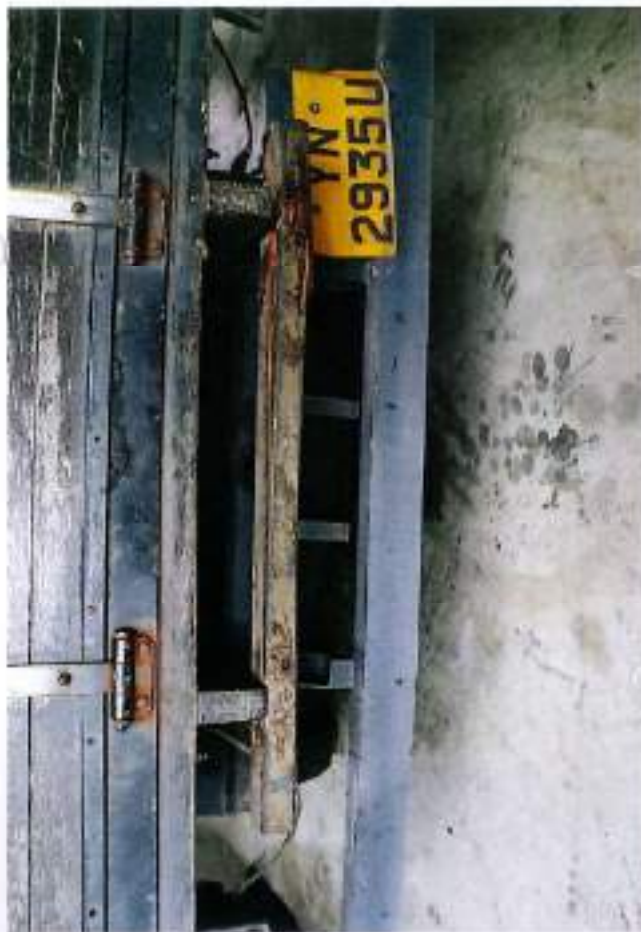
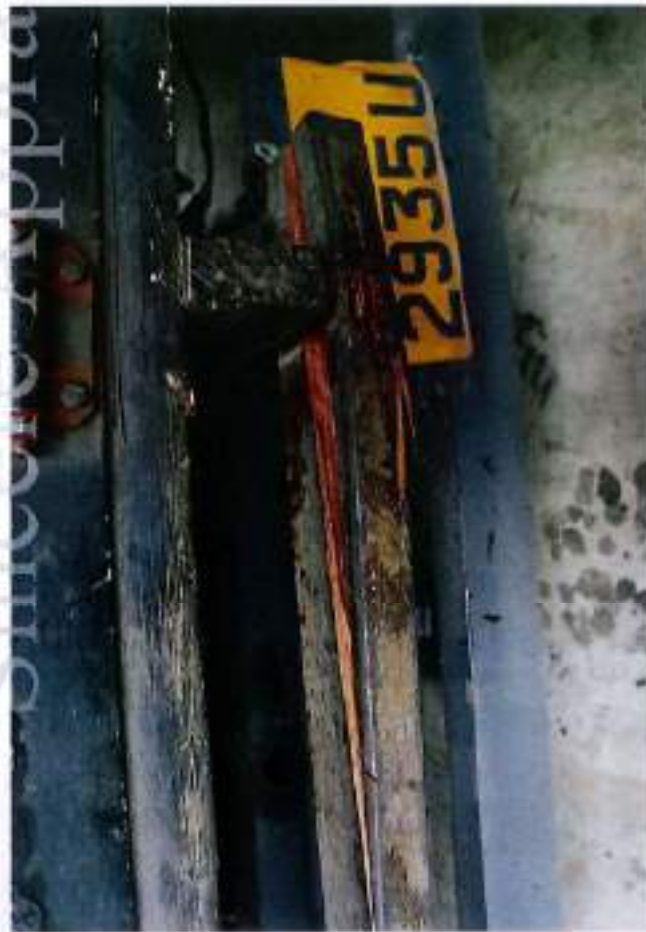
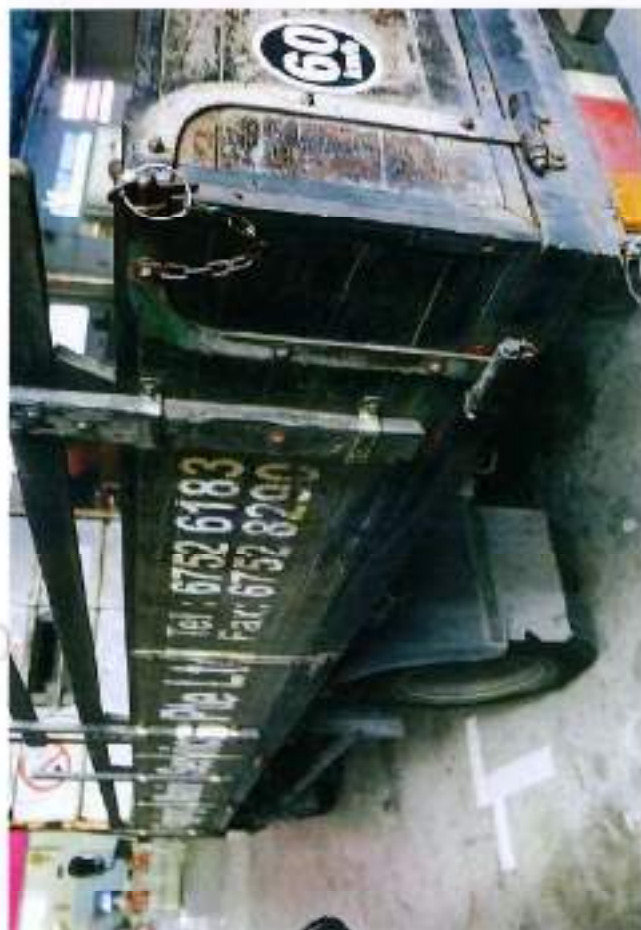
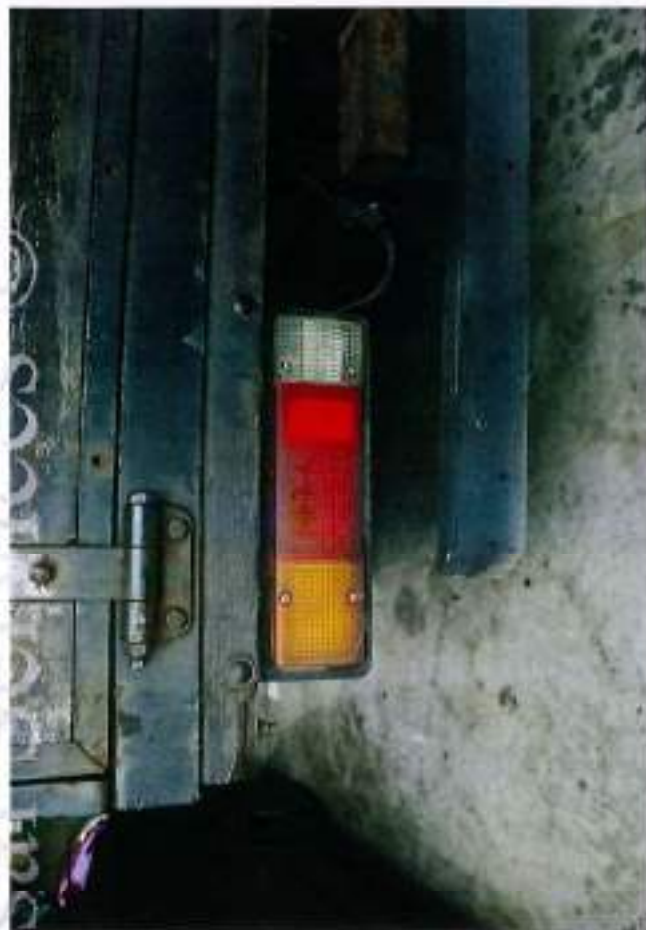
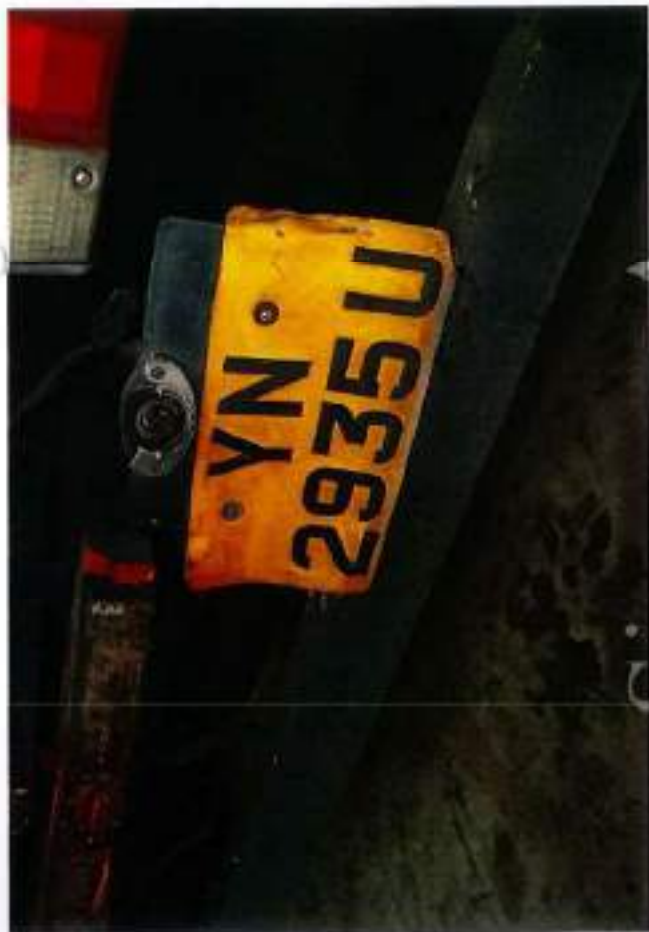
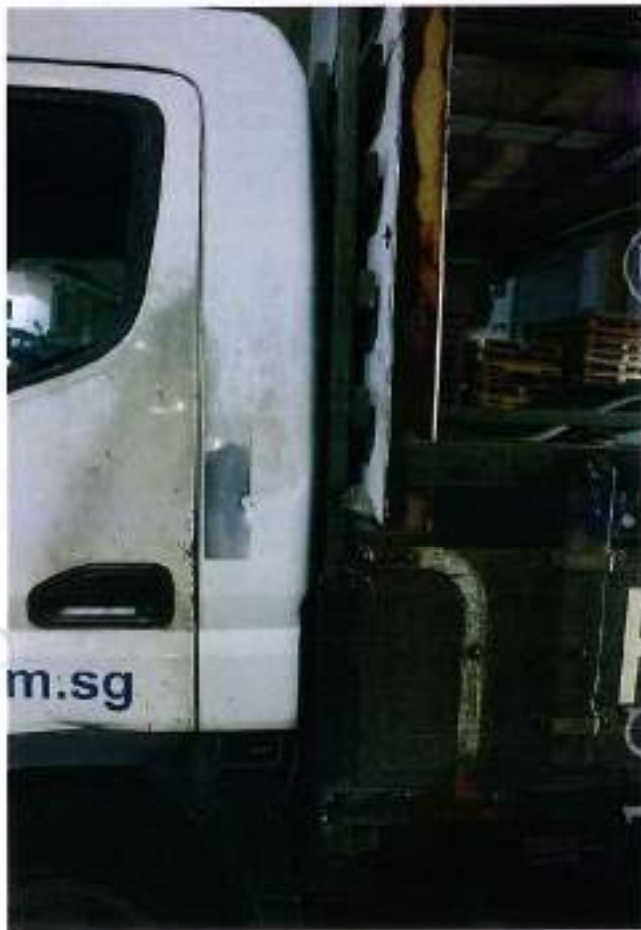
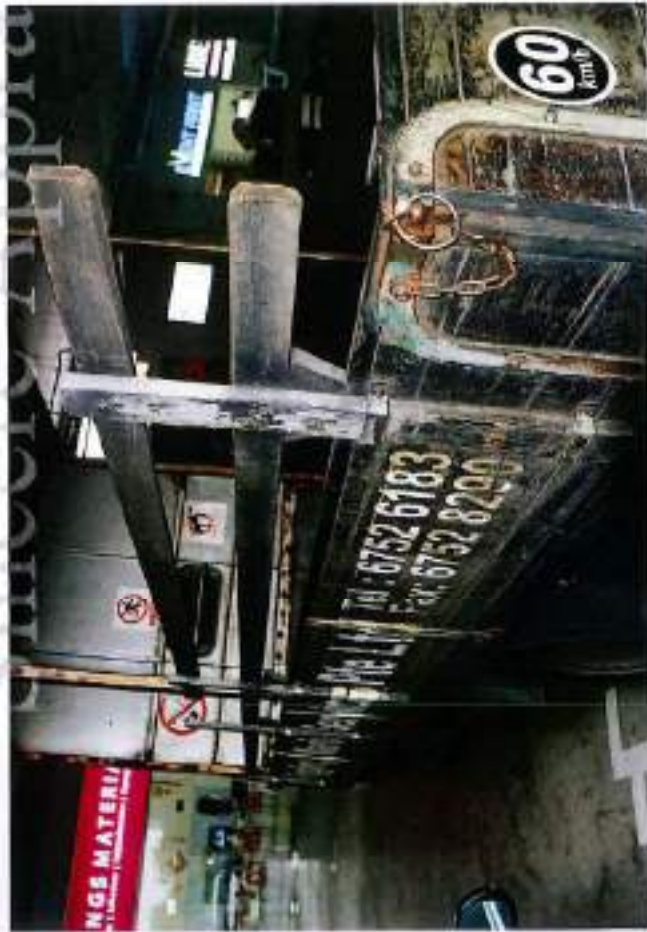
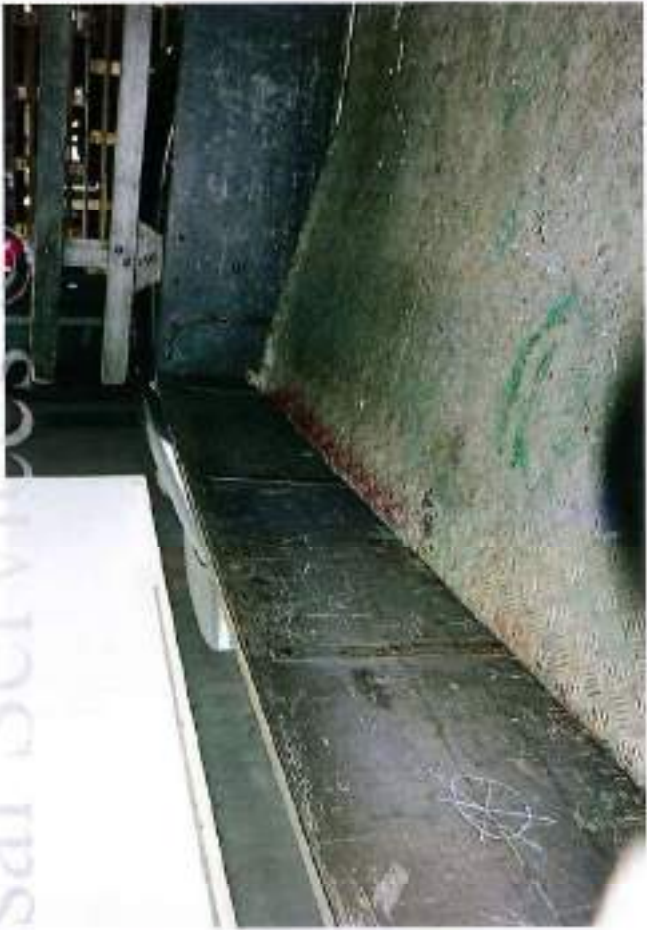
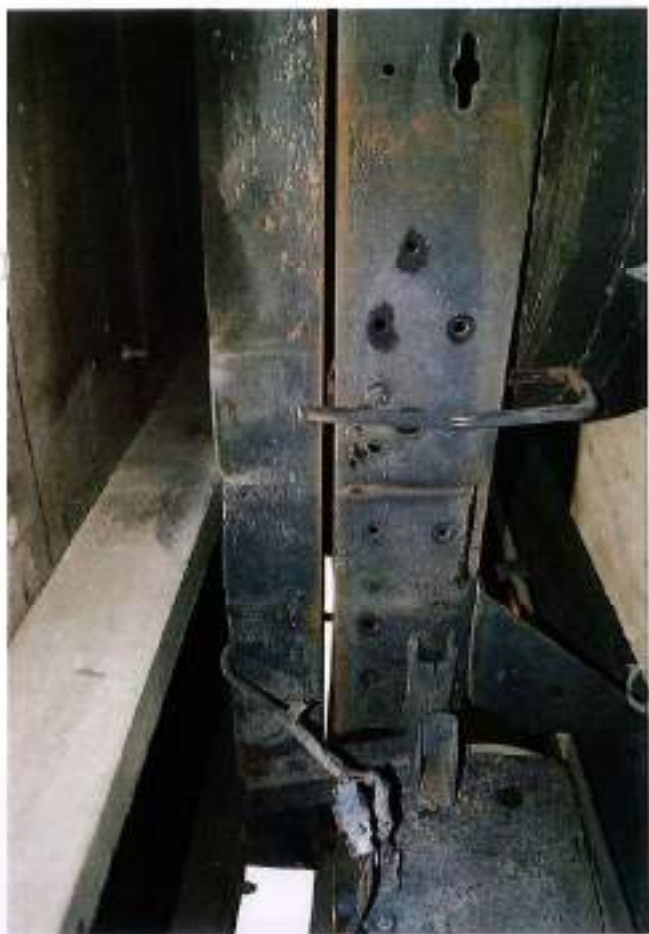
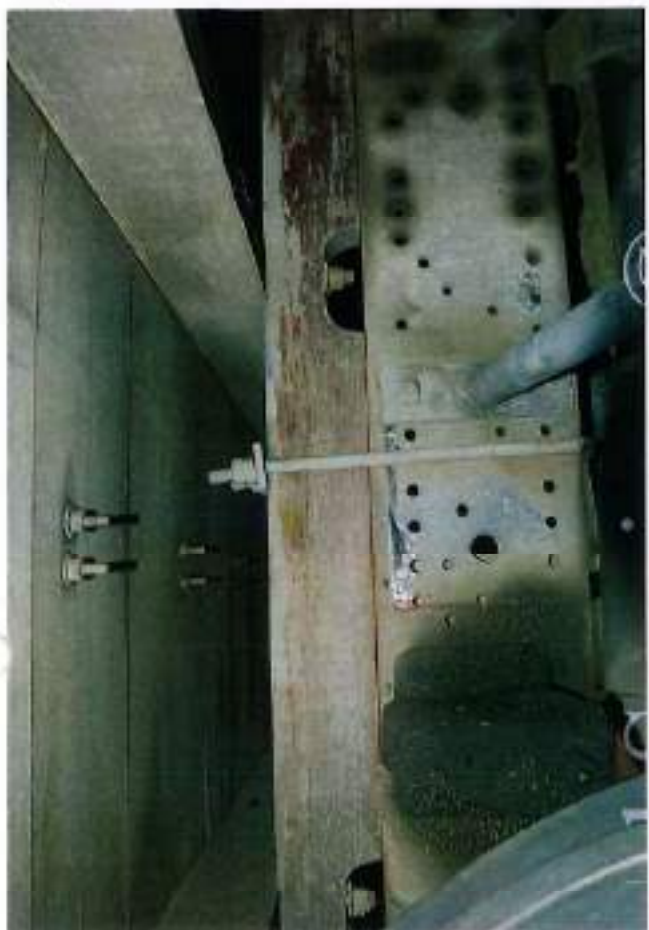
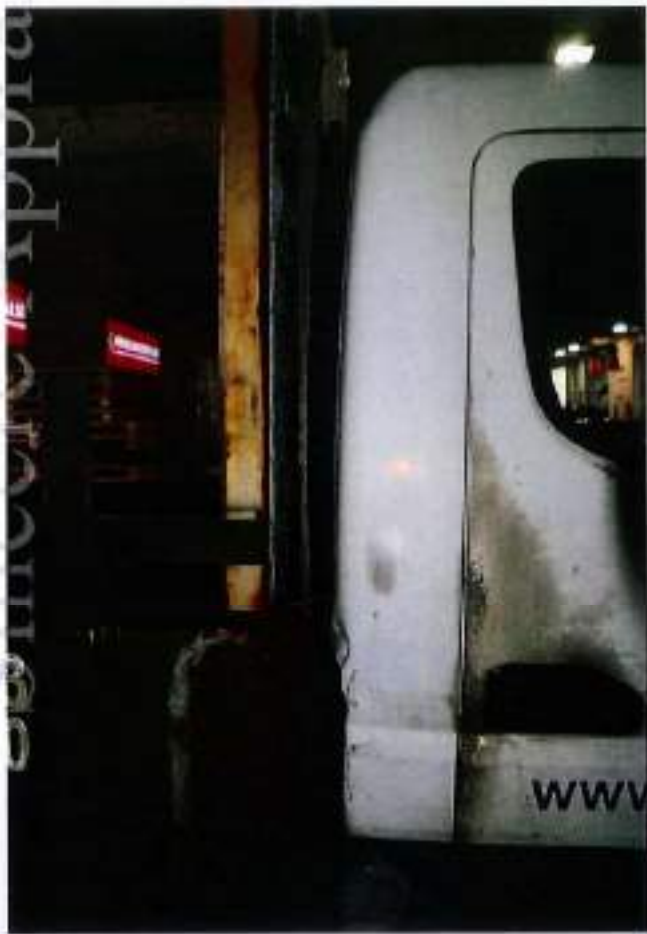
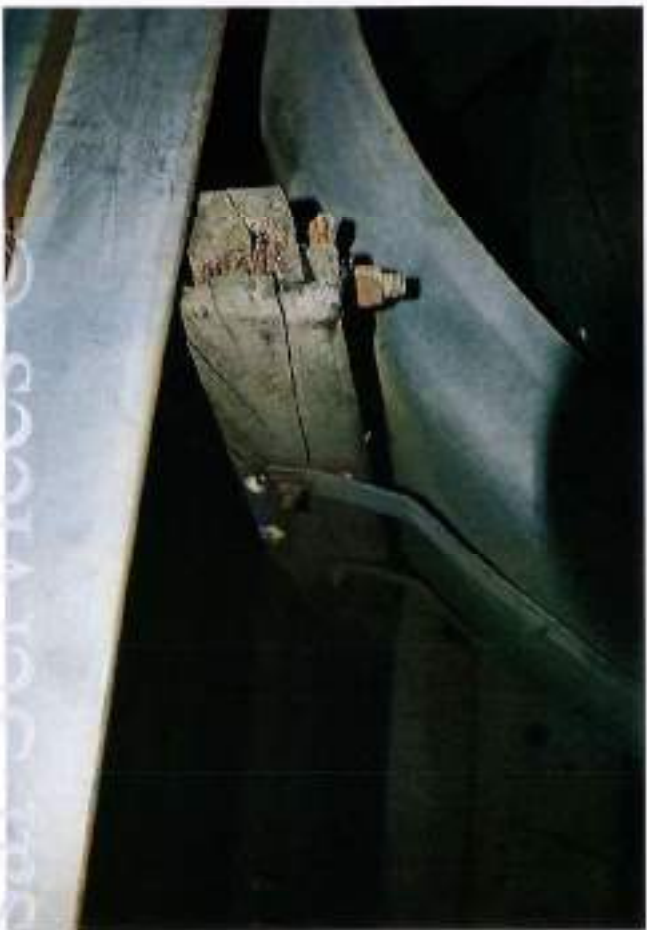
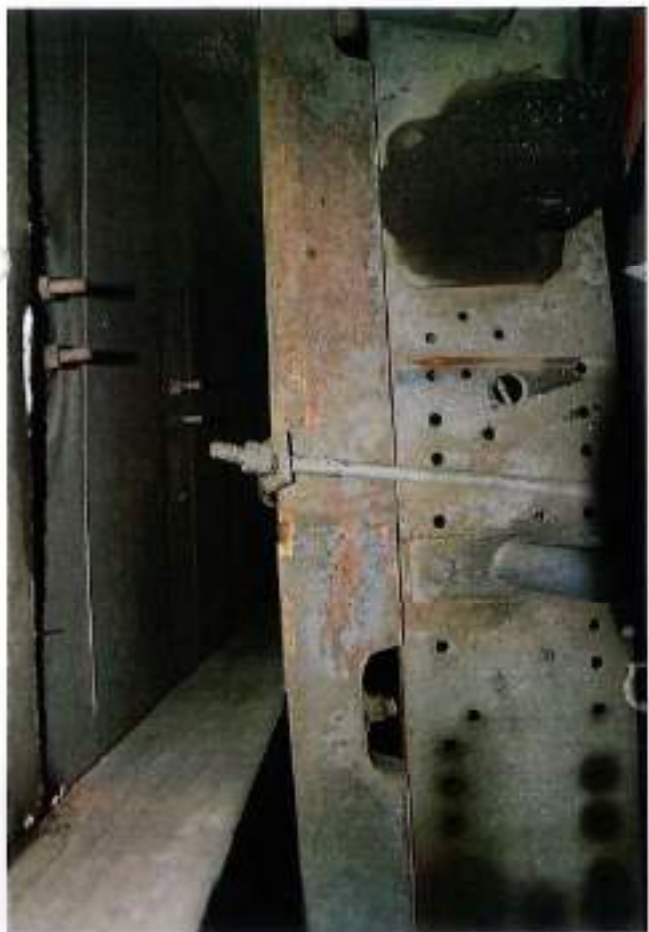
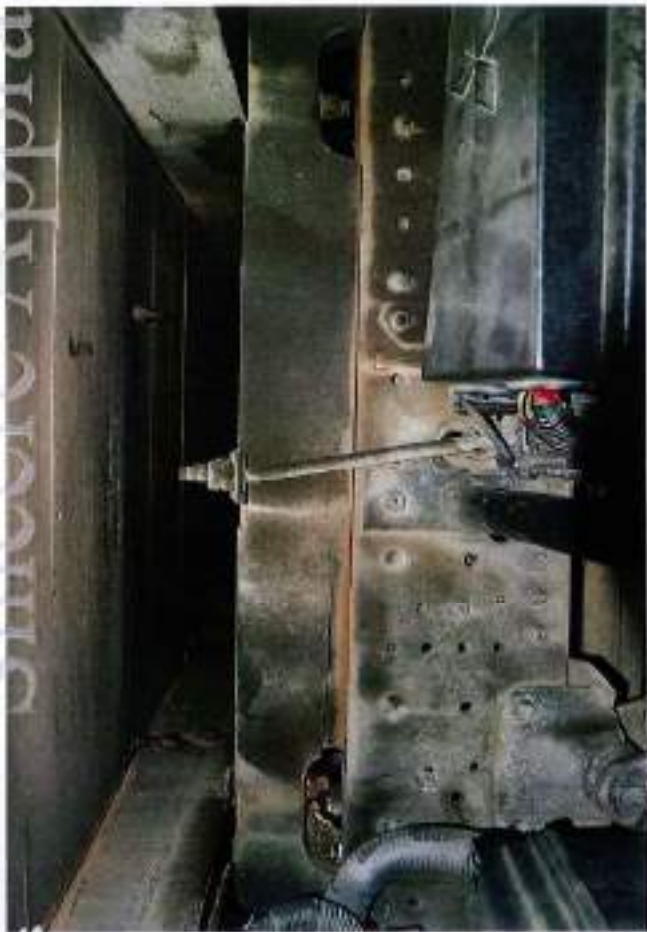
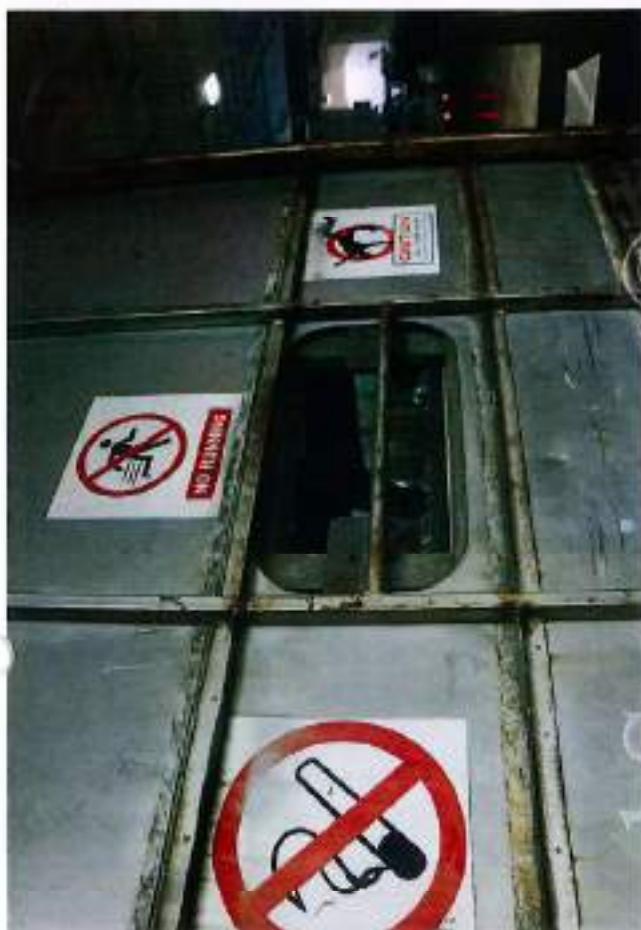
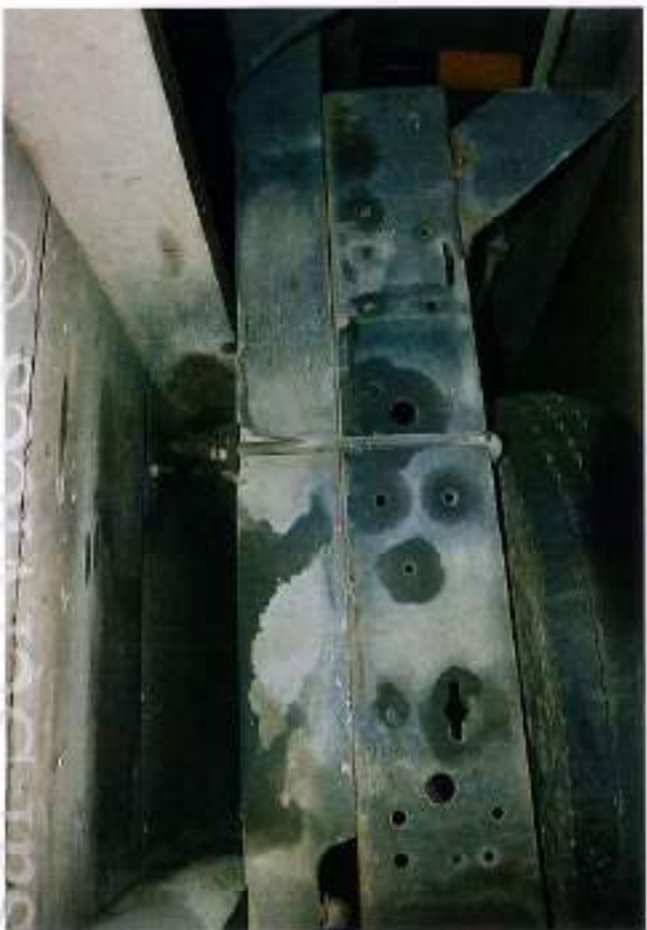
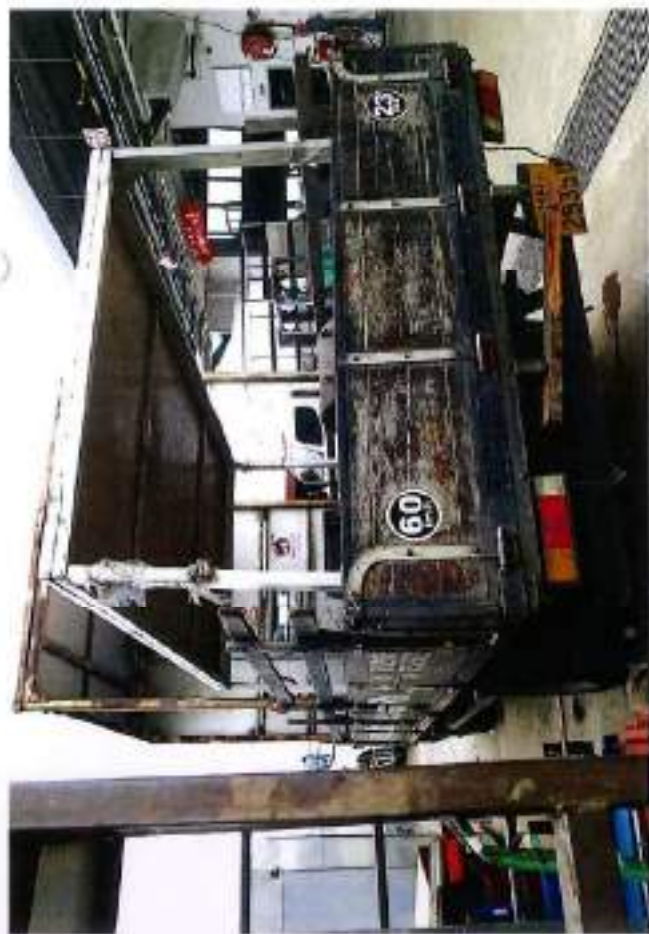
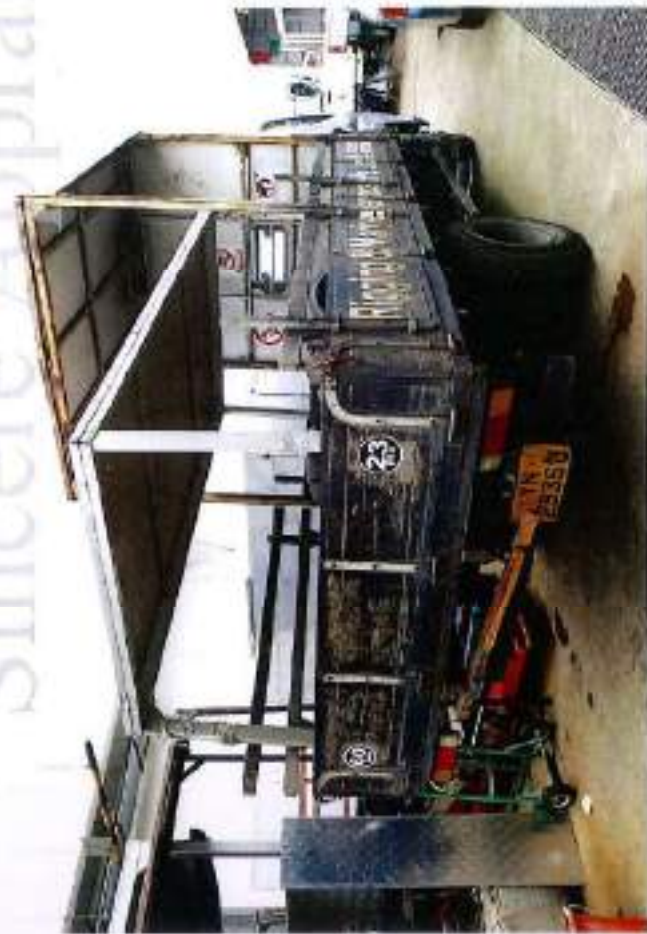
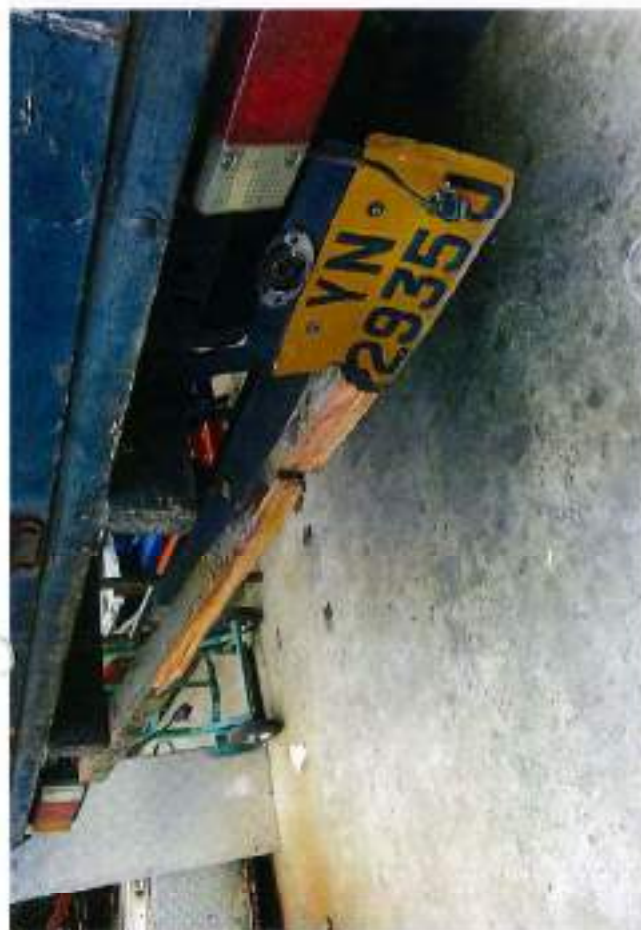
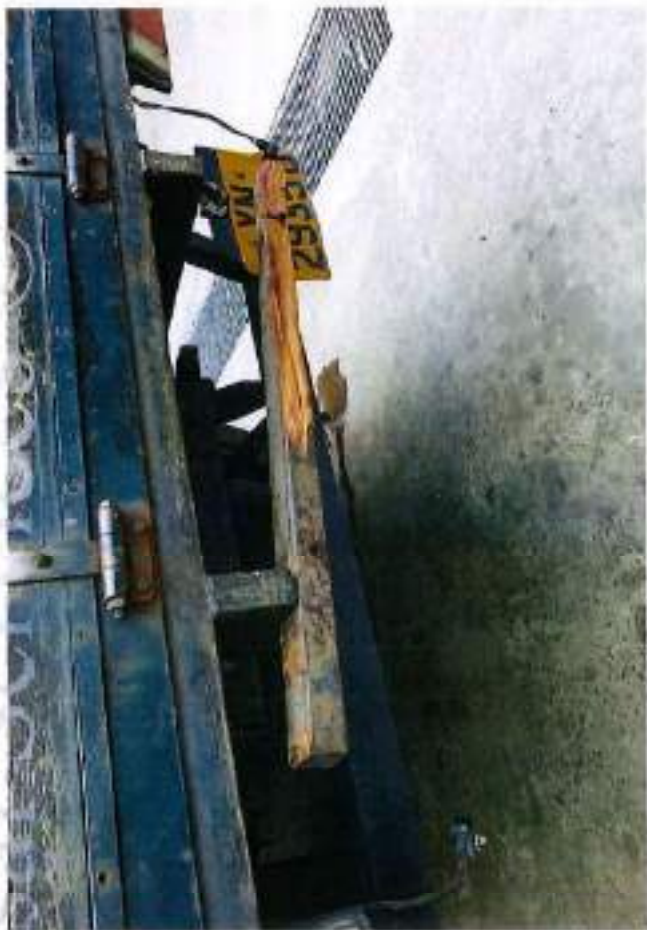
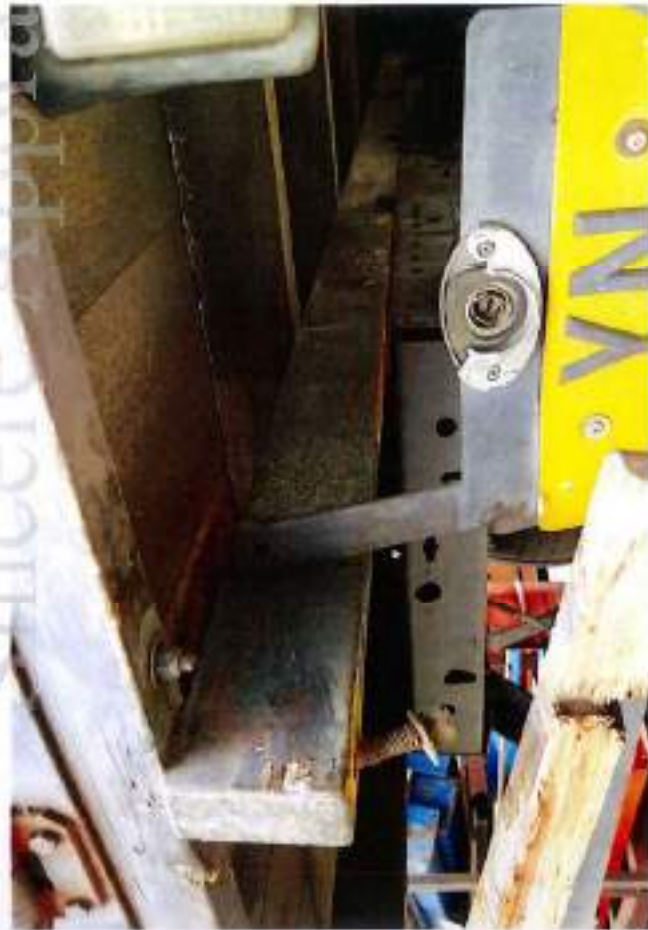
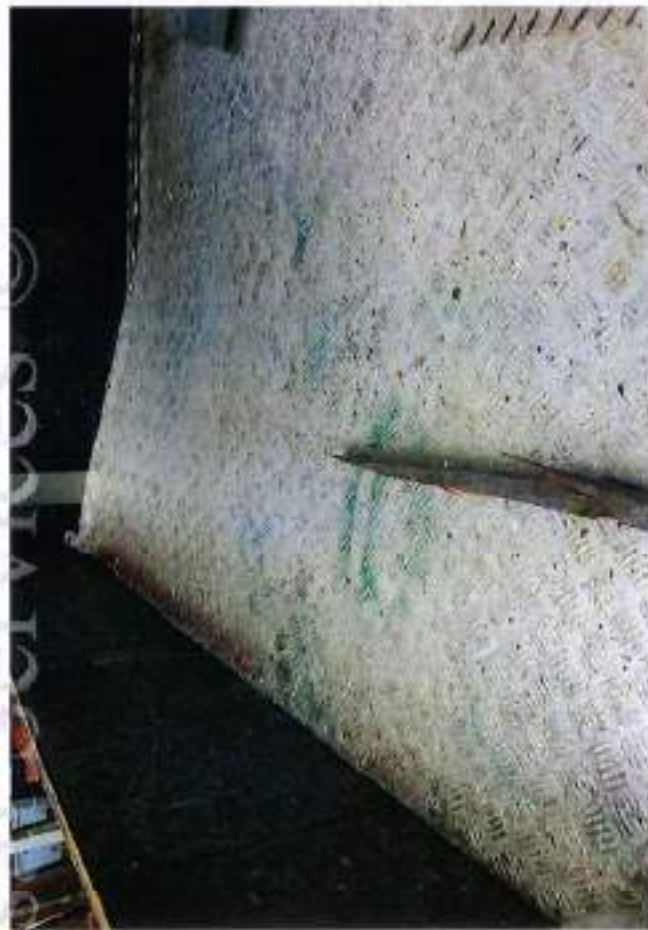
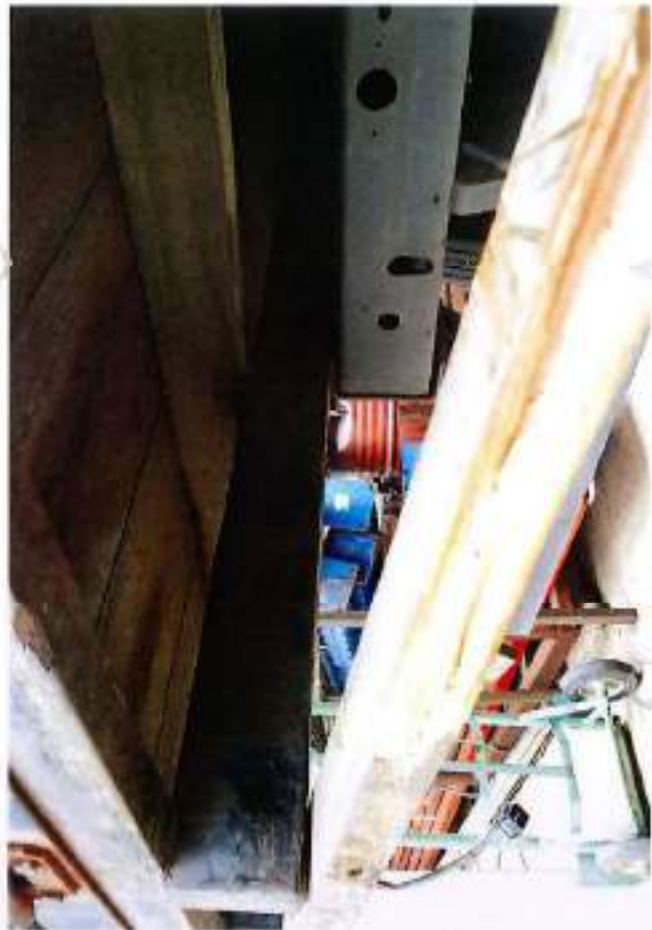
Our visual inspection of the vehicle revealed that the damages noted are at the rear portion.

We have inspected the actual damages found on the vehicle and recommend the replacement of parts and repairs accordingly. The estimated repair cost is \$24,191.50. The repairer has agreed to undertake the repairs at our adjusted lump sum amount of \$16,500.00.
