Your Ref: Honda Engine  
(number K20A5801775)  
Our Ref : CI/TP20012166/D

09 November 2020

**INSPECTION REPORT OF A HONDA ENGINE WITH NUMBER K20A5801775**

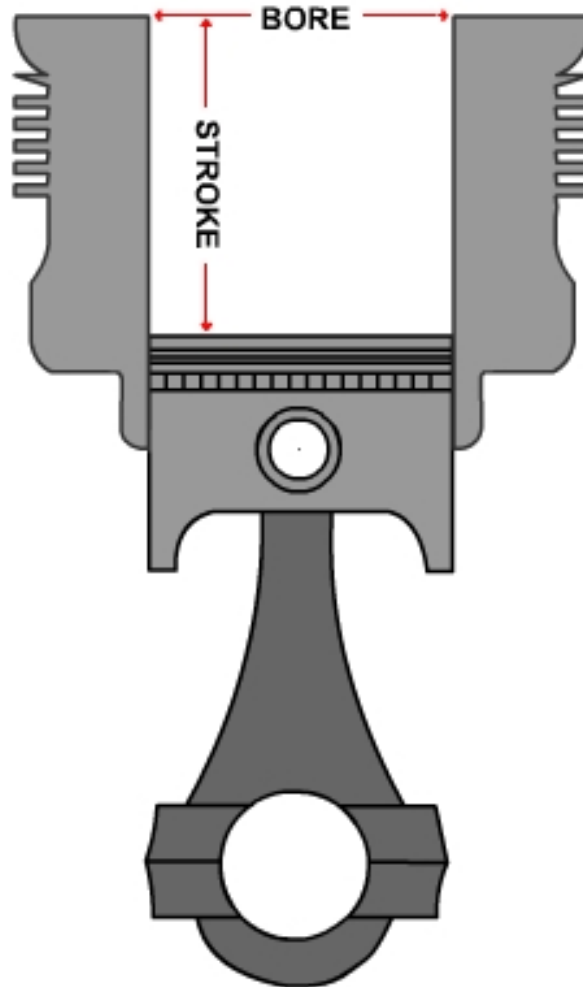
9. The bore refers to the measurement of the inside diameter of the cylinder while the stroke refers to the distance the piston moves in one direction of upward or downward movement in the cylinder. See diagram below for illustration purposes.
